Main Contract

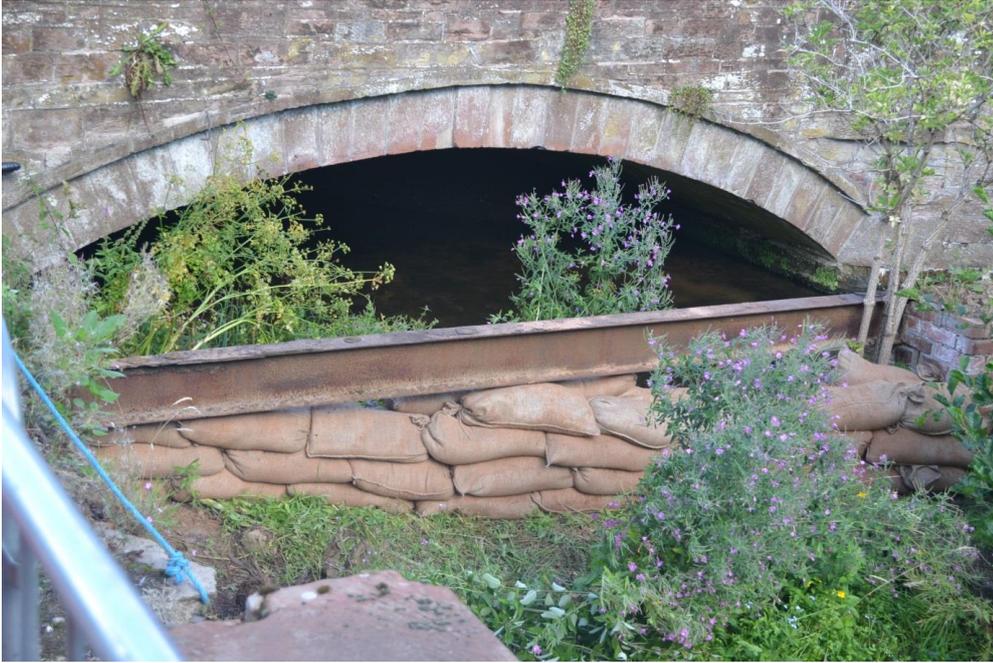
Figure 1 Cofferdam in place to prevent back flow of water from the river into the tailrace

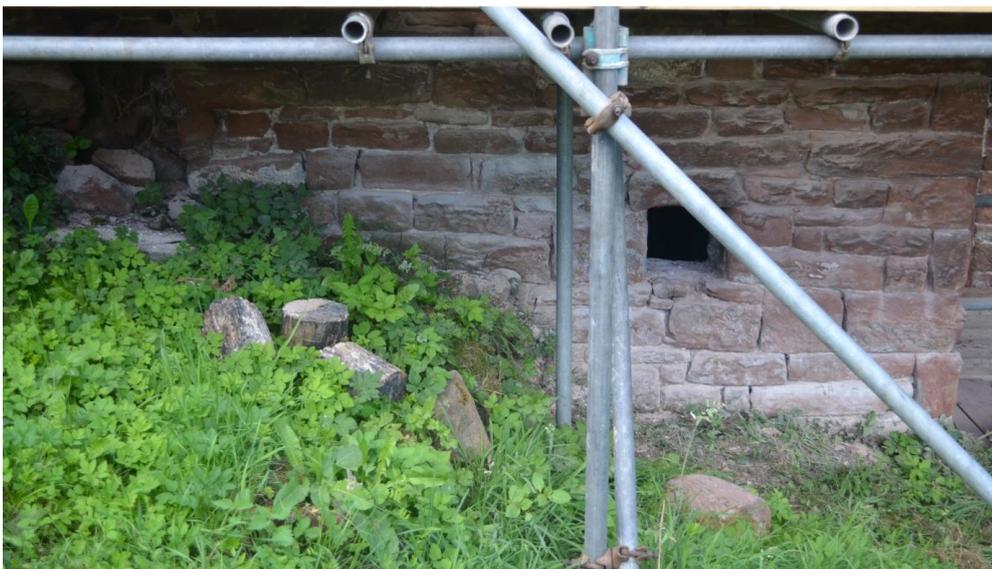
Figure 2 Section of wall with old mortar removed ready for re-pointing

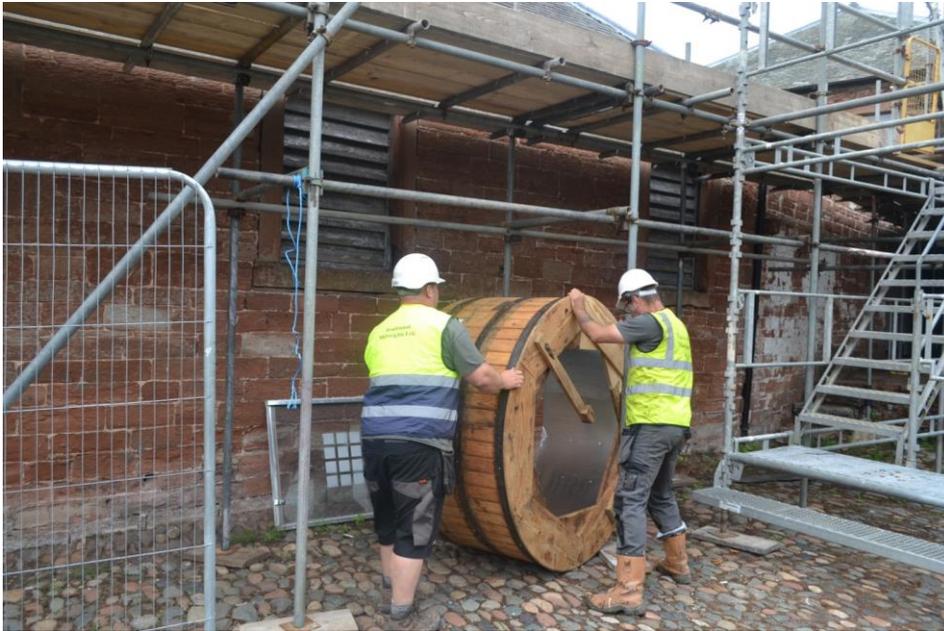
The millwrights have also been on site, finishing off the fitting of the control gate, which directs water into the wheel, and shuts it off again. They have also returned two cleaned and refurbished millstone casings, with food safety compliant aluminium linings ready for use on the two sets of stones we will be milling with.

Figure 3 refurbished tuns

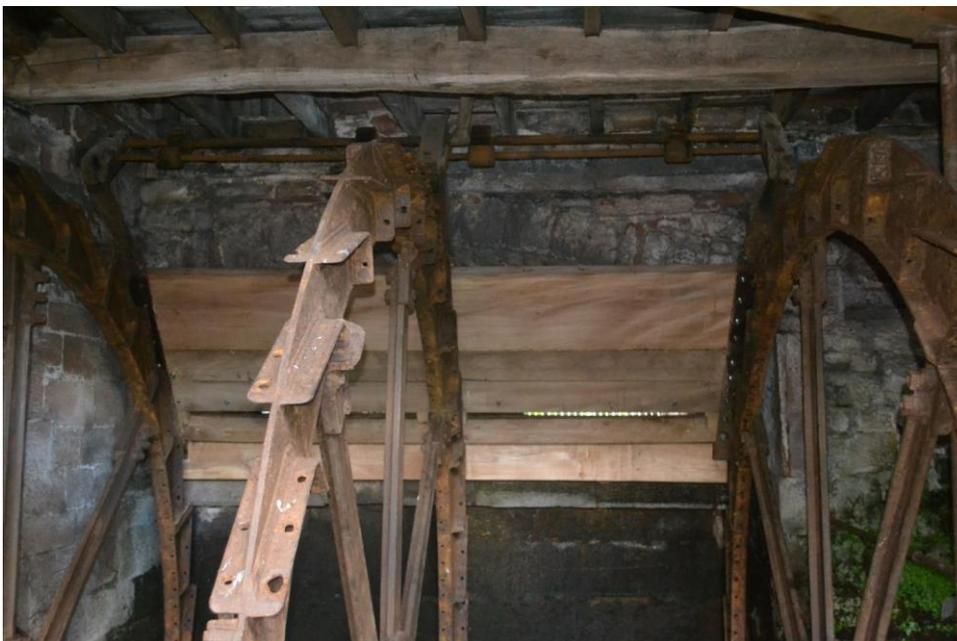
Figure 4 Control gate insitu in wheel pit

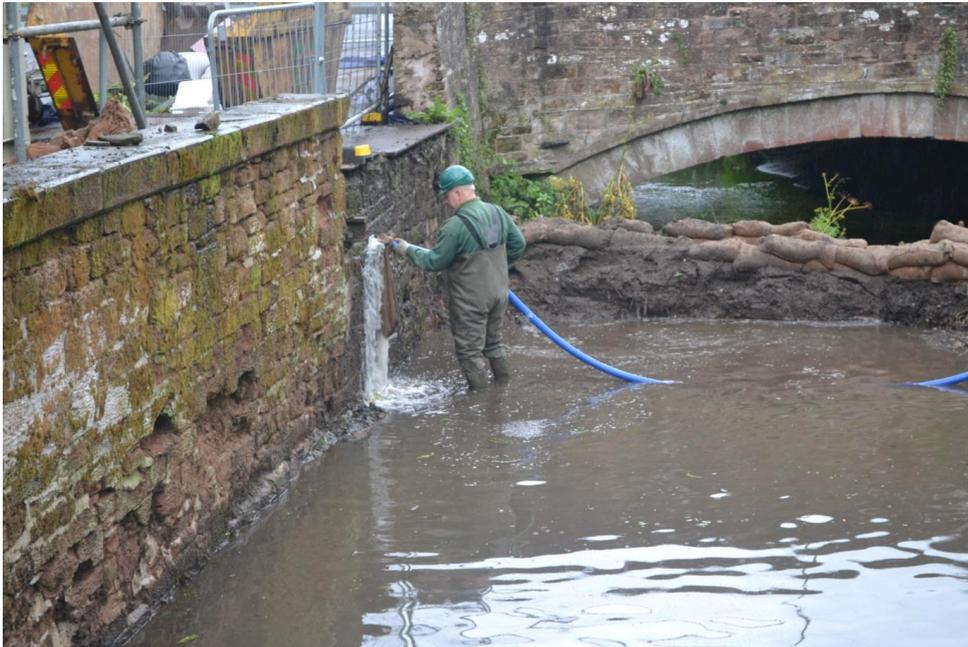
HPR have cleared the vegetation, silt and debris from the tail race and the culvert that takes water away from the wheel. During which we have uncovered a set of old sandstone steps leading down into the tail race from an access gap in the wall that has been blocked at some point. The bottom one of these steps was in fact an old millstone, but it is in two pieces. They have also installed more site protection, temporary electricity supplies and have prepared pointing samples for inspection by

Figure 5 cleaning stonework in tailrace

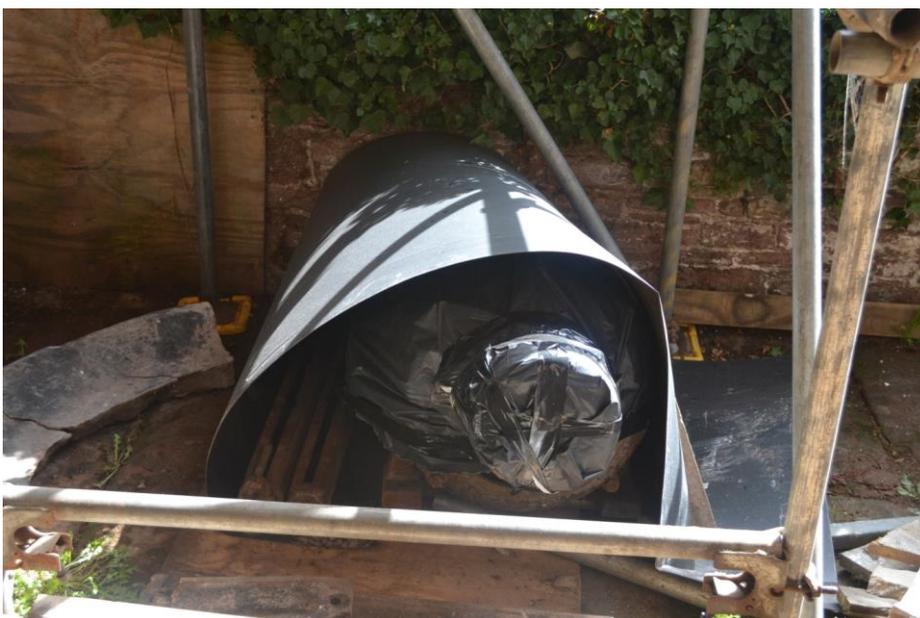
Figure 6 Large electric motor moved from tower and protected

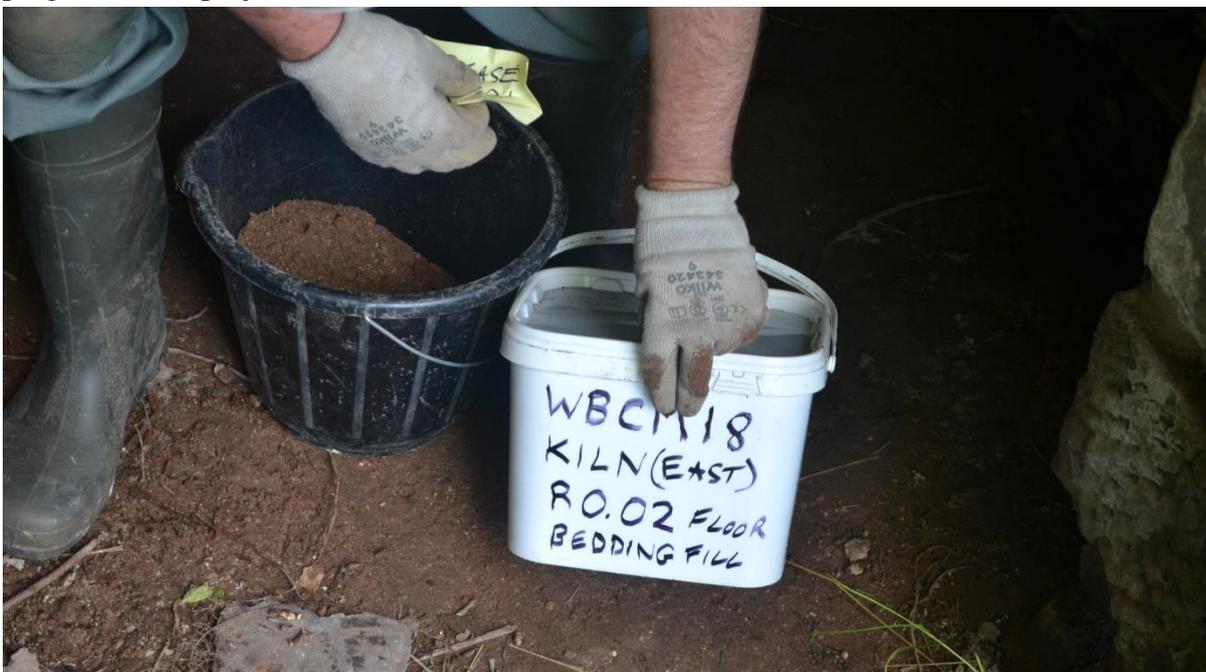
Figure 8 archaeologist taking samples from the drying kiln floor
