Warwick Bridge Corn Mill – progress update October 2018

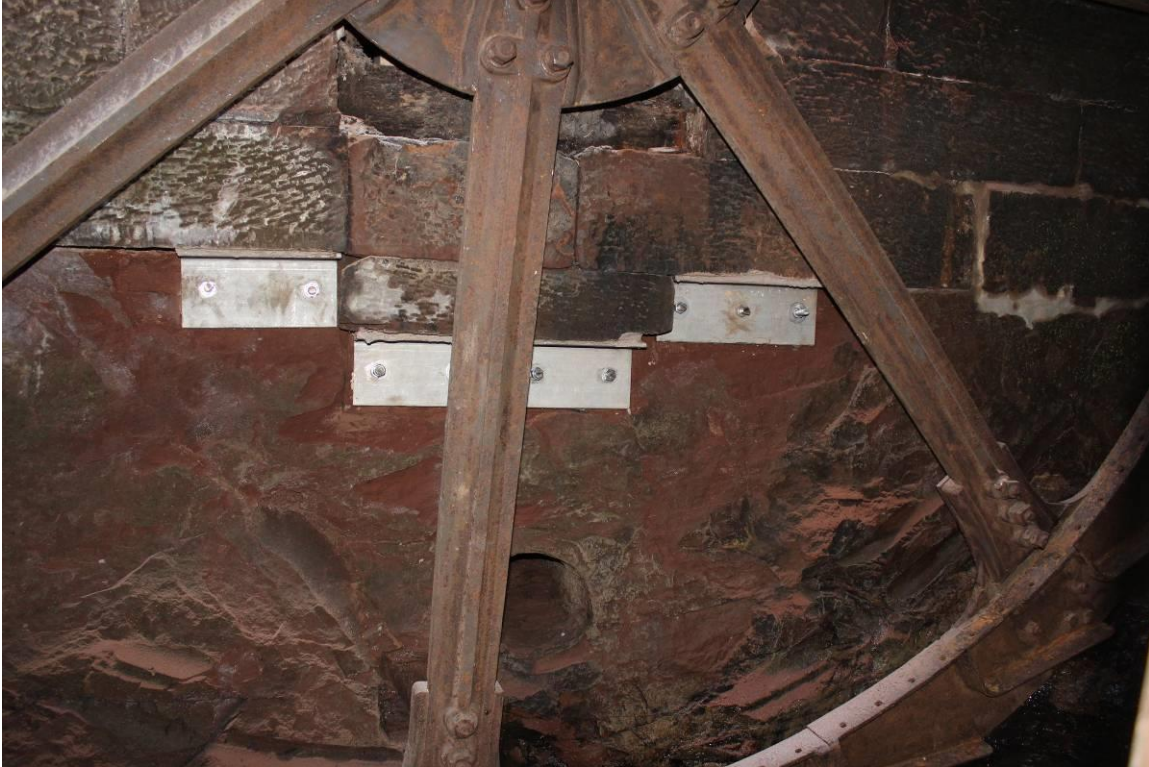
Steel angles bolted into the bedrock on the north side of the wheel pit. The circular opening low down is a drain from the pit wheel pit below the hurst

Works in the watercourse concluded towards the end of September, with steelwork installed to support the ashlar blocks forming the upper part of both sides of the wheel pit.

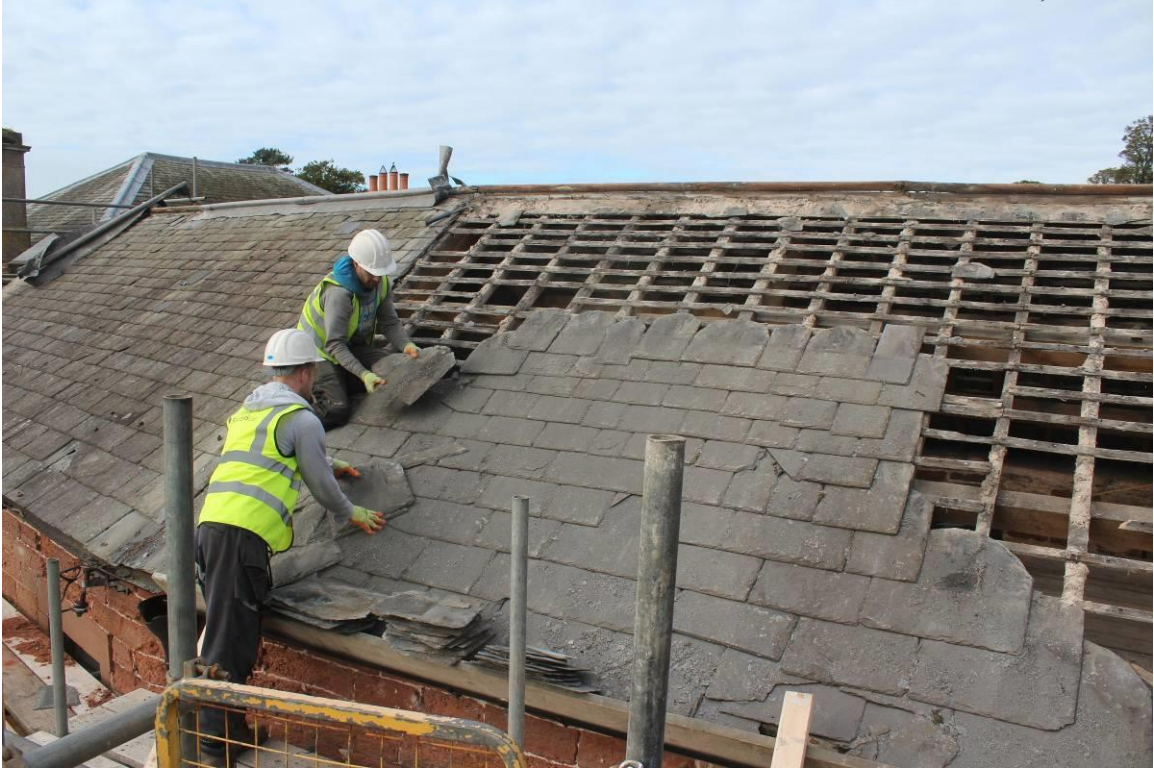
Stripping the graduated slates from the east side of the barn roof

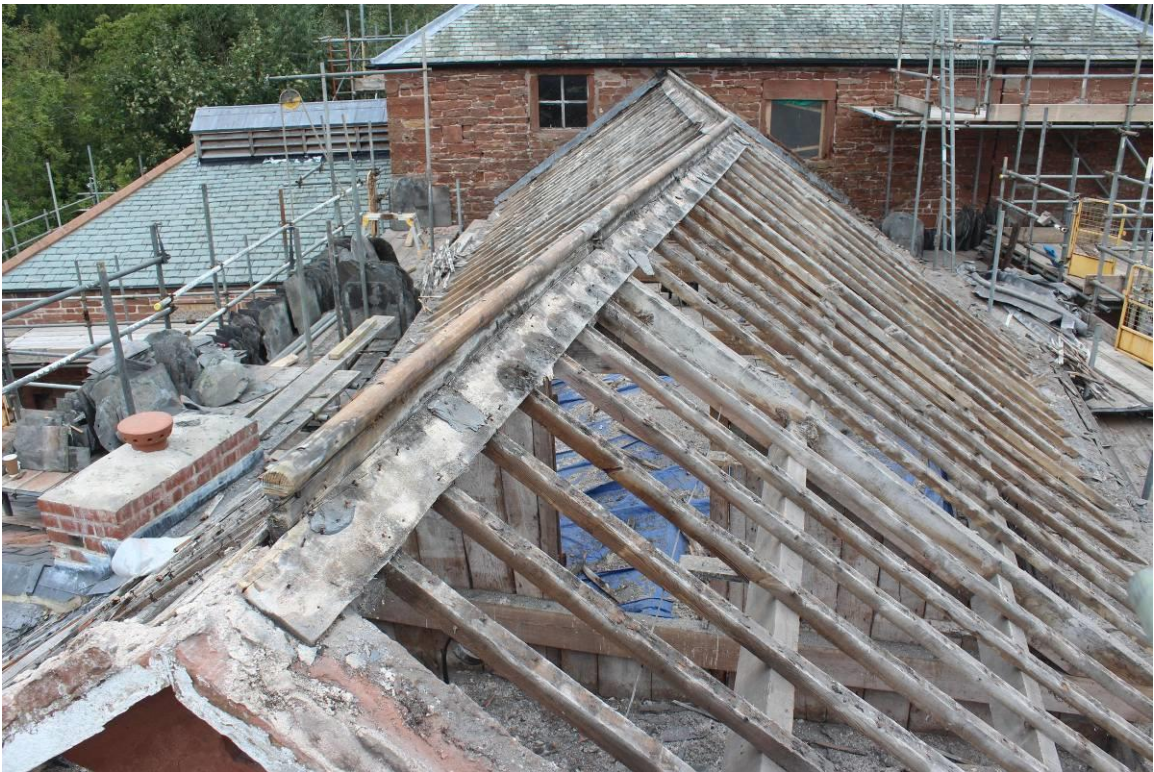
Looking along the barn roof timbers from the south end. The change in alignment of the building is evident

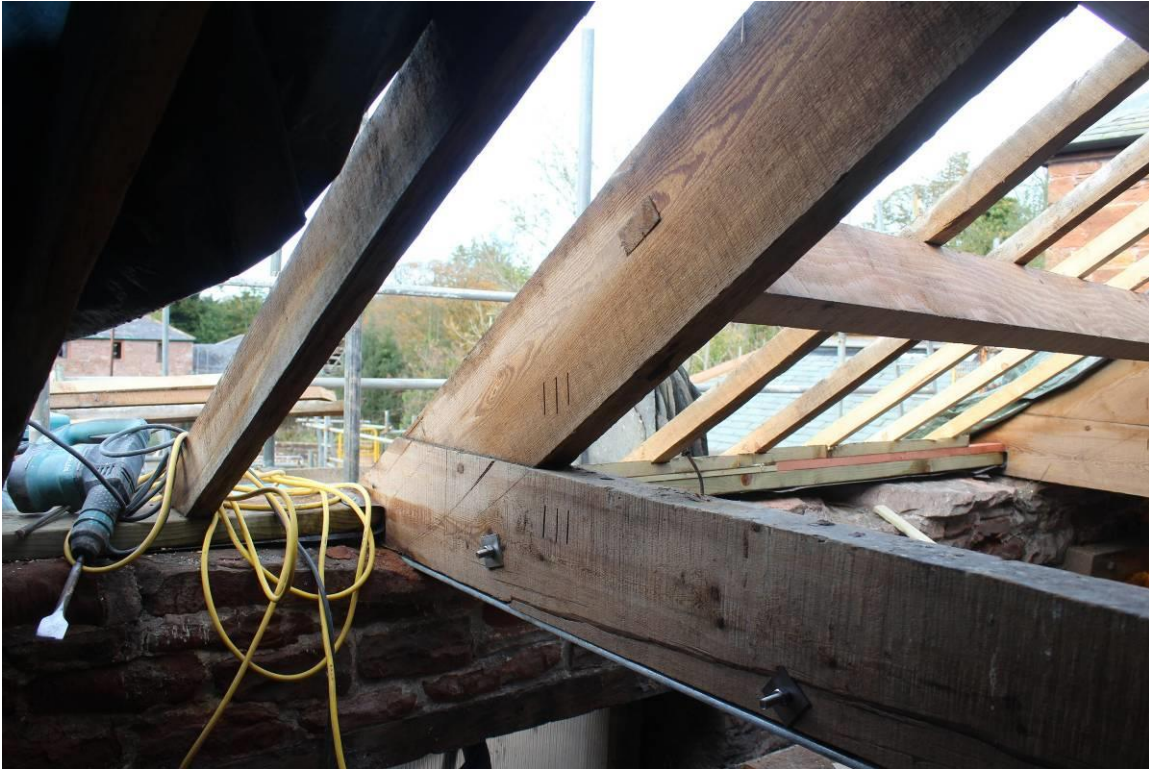
Steelwork repairs to Truss 3 and replacement rafters between Trusses 3 and 4. The peg securing the tenon at the base of the principal rafter can be seen along with the assembly marks on the timbers

Stonework repairs have continued apace and October has seen dramatic progress with the buildings, including the stripping of the slated barn roof and replacement or strengthening of failed roof timbers.

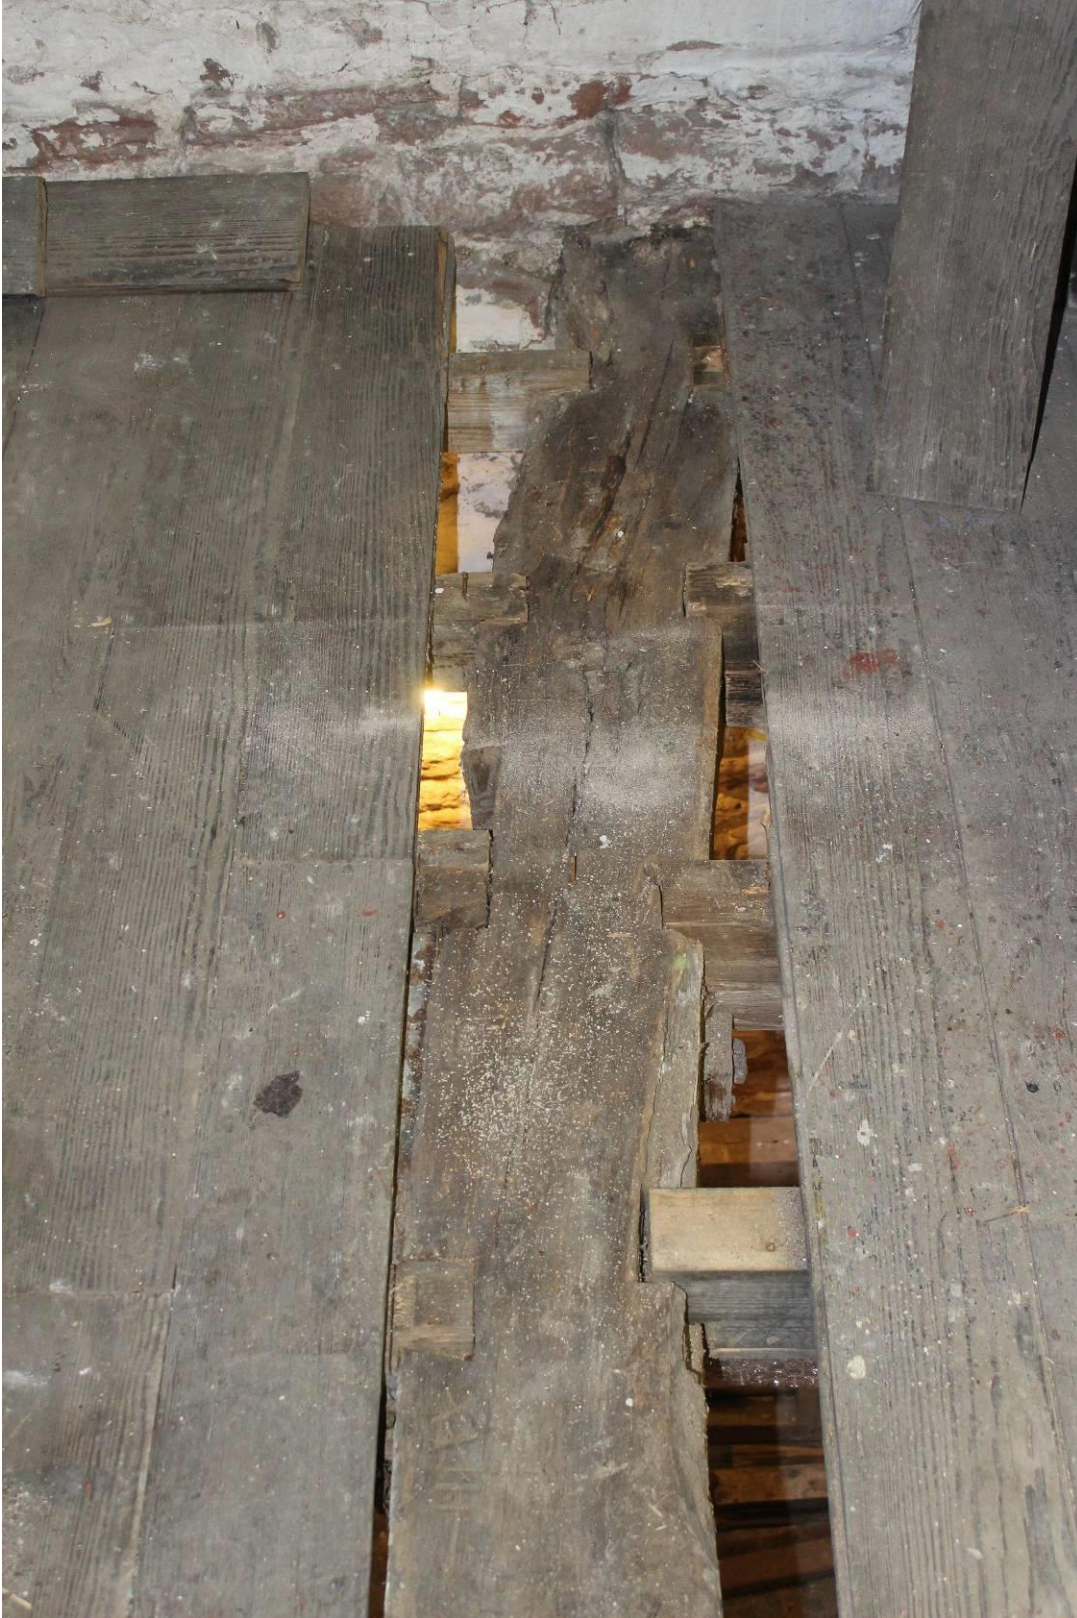
Within the barn and mill opening up of floors has revealed the poor condition of a number of the larger supporting timbers which will require repair. Embedded timbers in the barn gable and supporting the barn wall over the wheel pit have required replacement with infill brickwork or stone. A further round of timber treatment for woodworm has been undertaken.

The floor beams of the Garner Floor show the curve of the original tree trunk. Assembly marks can be seen alongside the floor joists notched into the beam

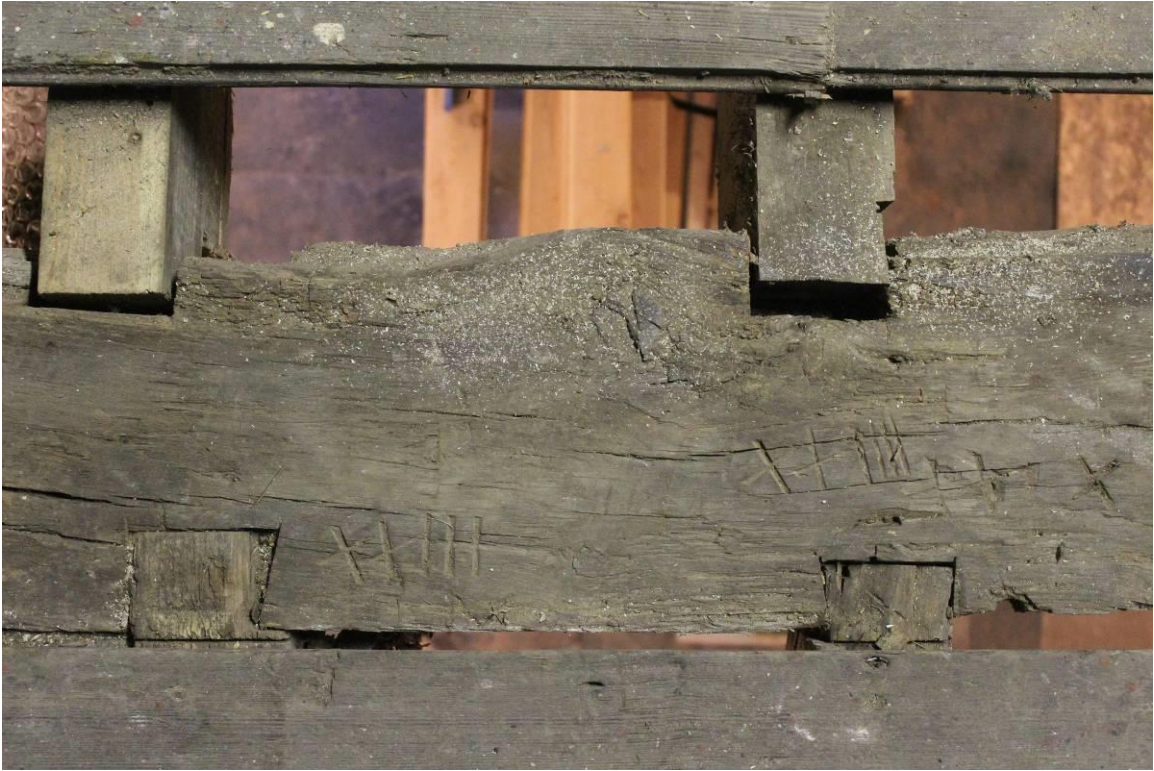
Assembly marks alongside original half dovetailed joists with a modern replacement top left

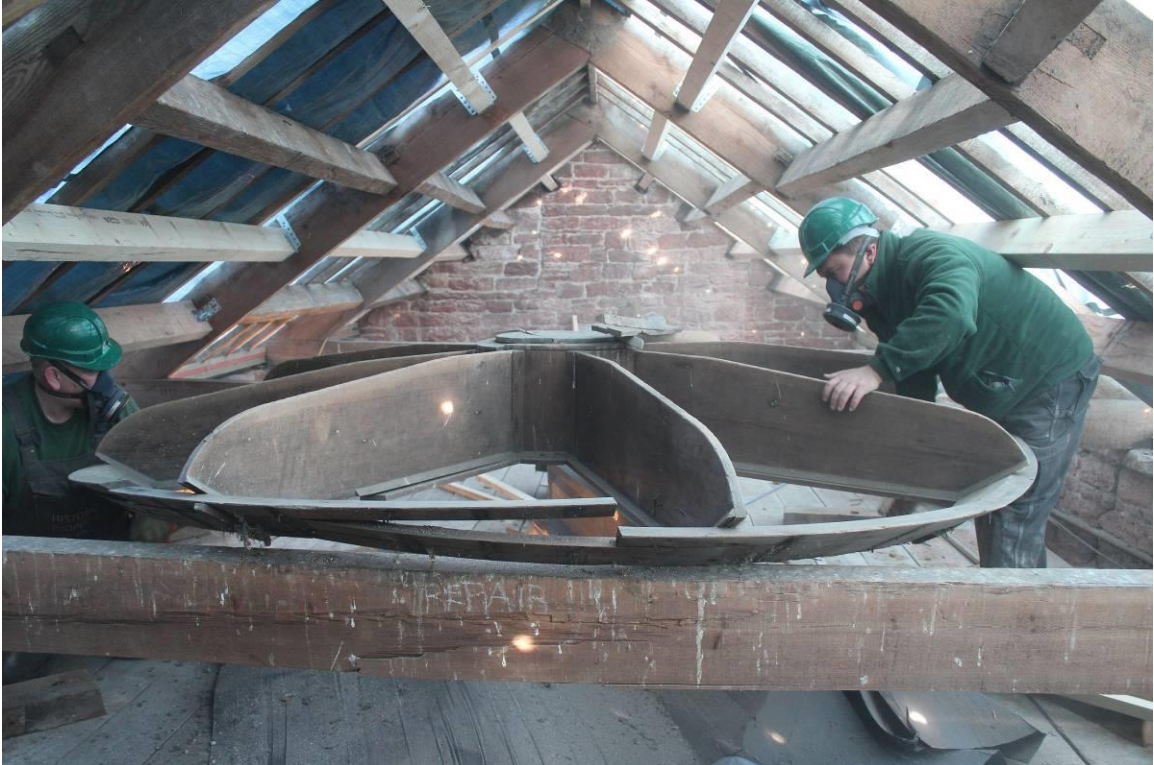
Cleaning the Pit Wheel casting template ahead of woodworm treatment

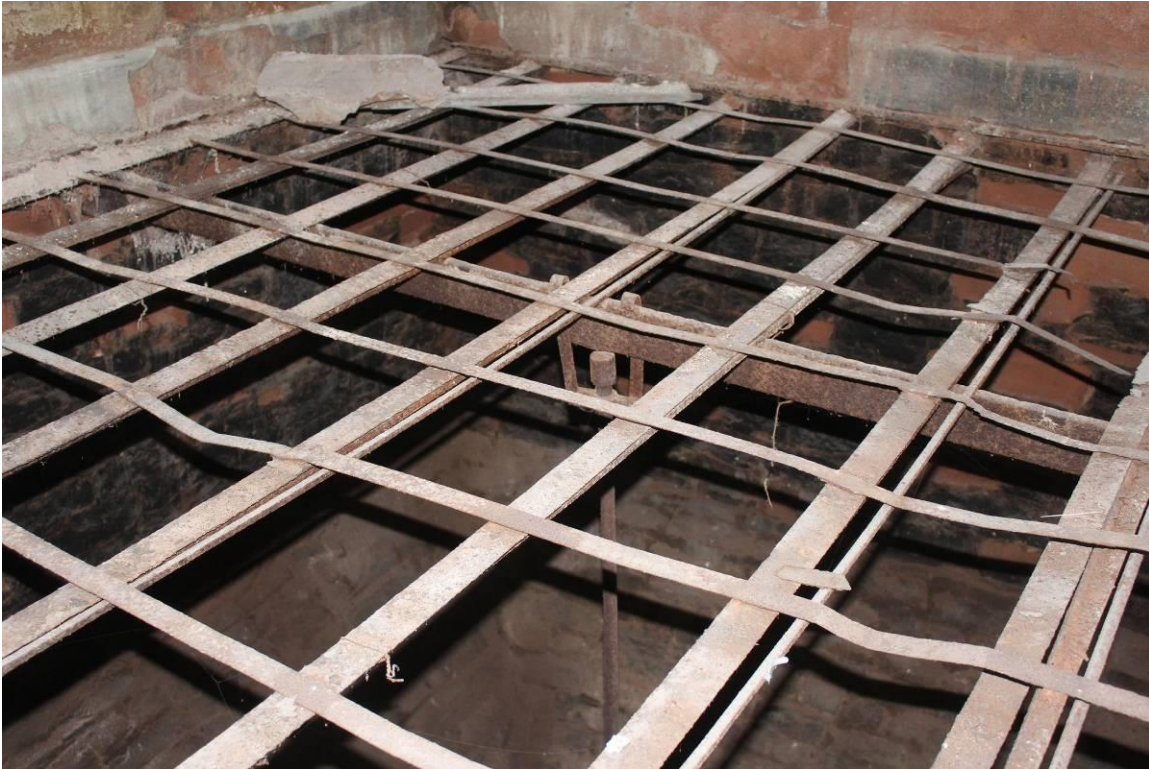
Specialists in metalwork conservation have surveyed the structure of the drying kiln floor and made recommendations for conservation and repair. Cleaning the debris from the kiln and the firegrate below revealed more about the form and function of the kiln and the wrought iron floor supports proved more complex than first appreciated.

The web of wrought iron which supported the cast iron kiln plates of the kiln floor

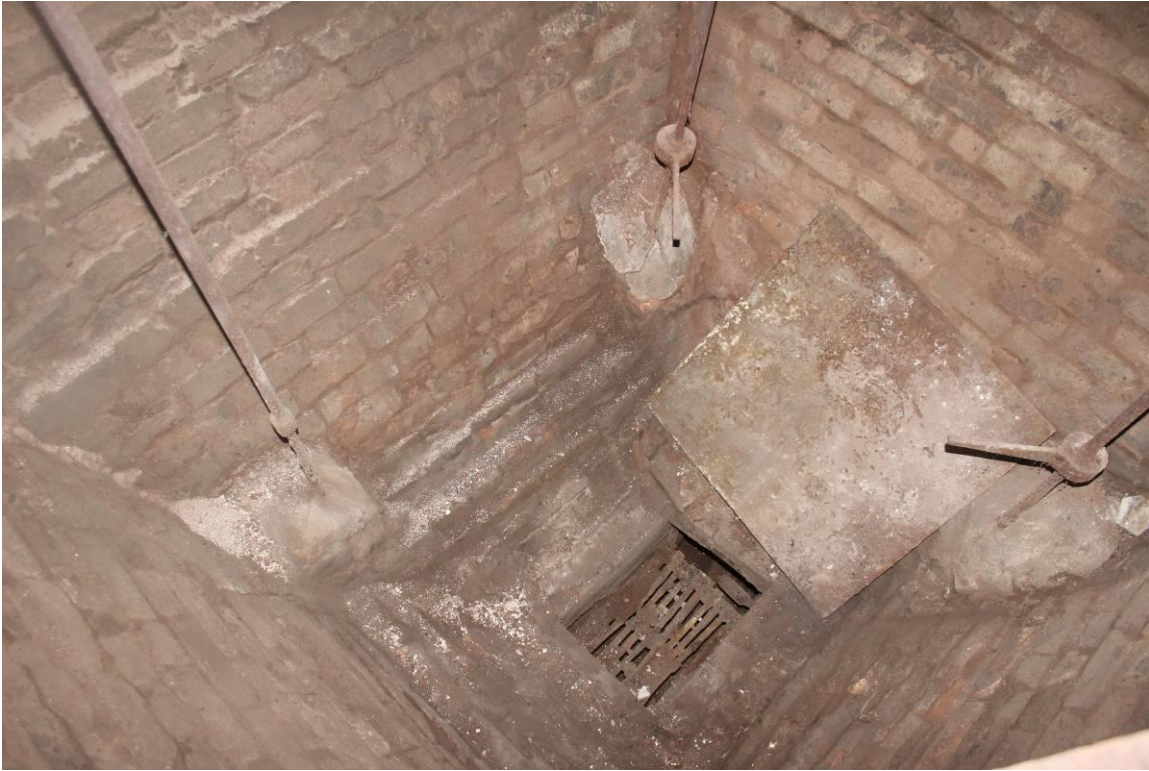
Looking down on the open top of the fire grate. The large iron plate, which rested on the supporting brackets on the uprights, acted as a baffle to disperse the heat evenly

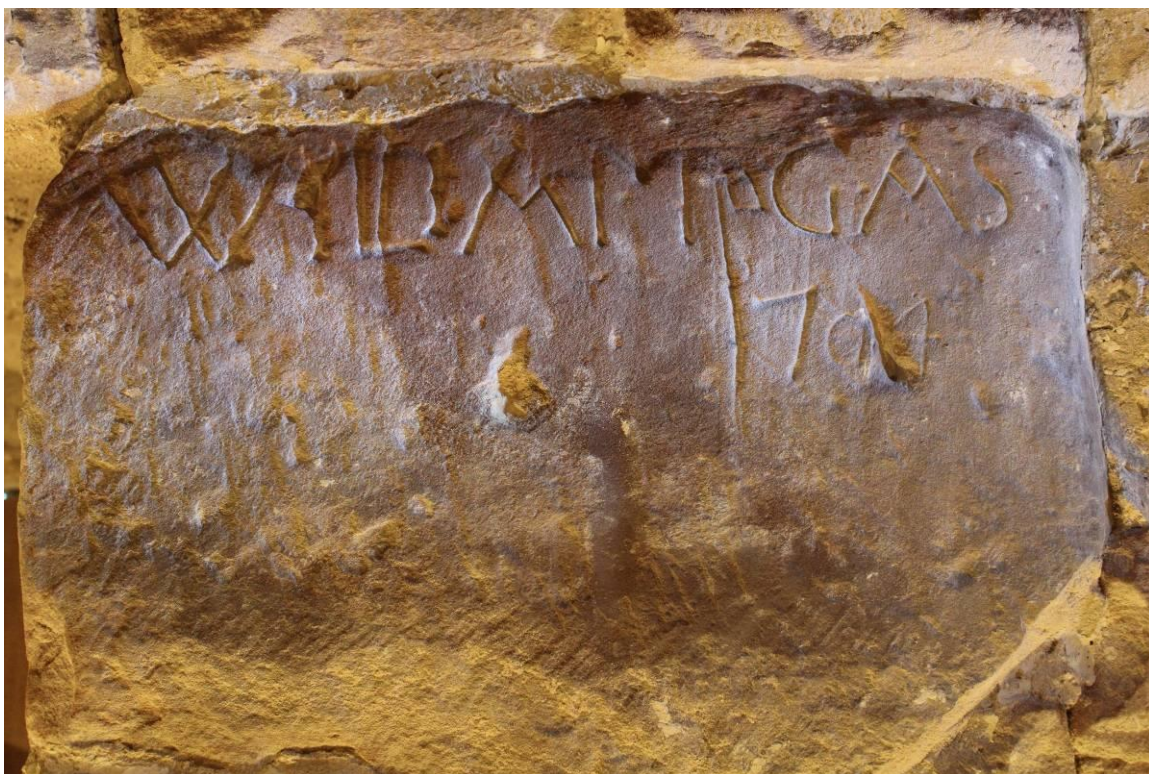
Removal of a trial area of unbonded limewash from the north wall of the Hurst Floor of the mill revealed a re-used inscribed stone, apparently reading WILLIAM GAS... 1704.
