Warwick Bridge Corn Mill update December 2018

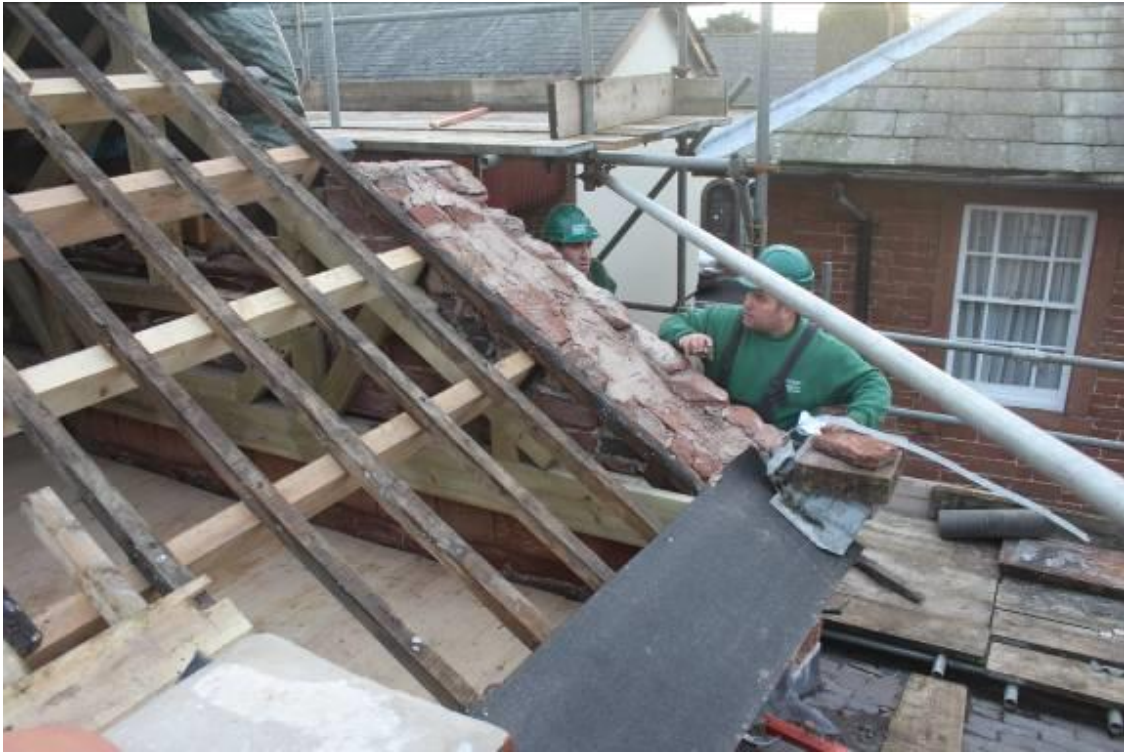
Sean, Site Manager, guiding consolidation work in progress on the south gable of the barn

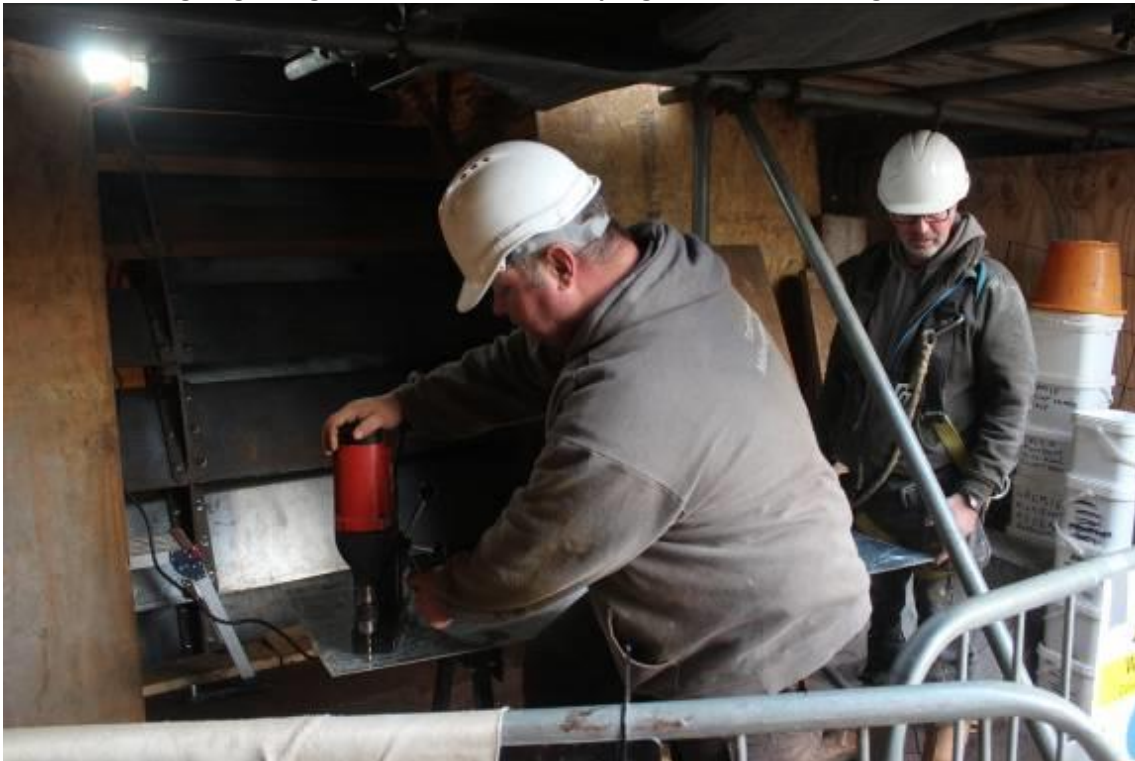
Jon drilling bolt holes in one of the new sole plates

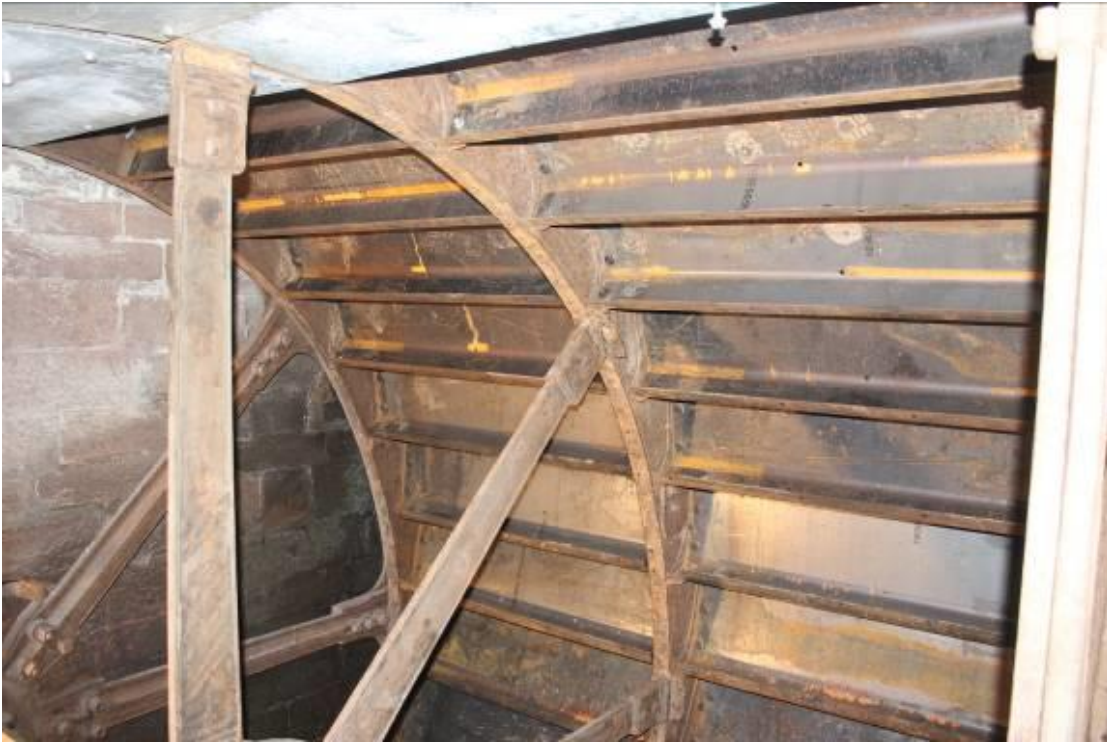
New buckets in place and sole plates, forming the inside of the buckets, partially completed (top left)

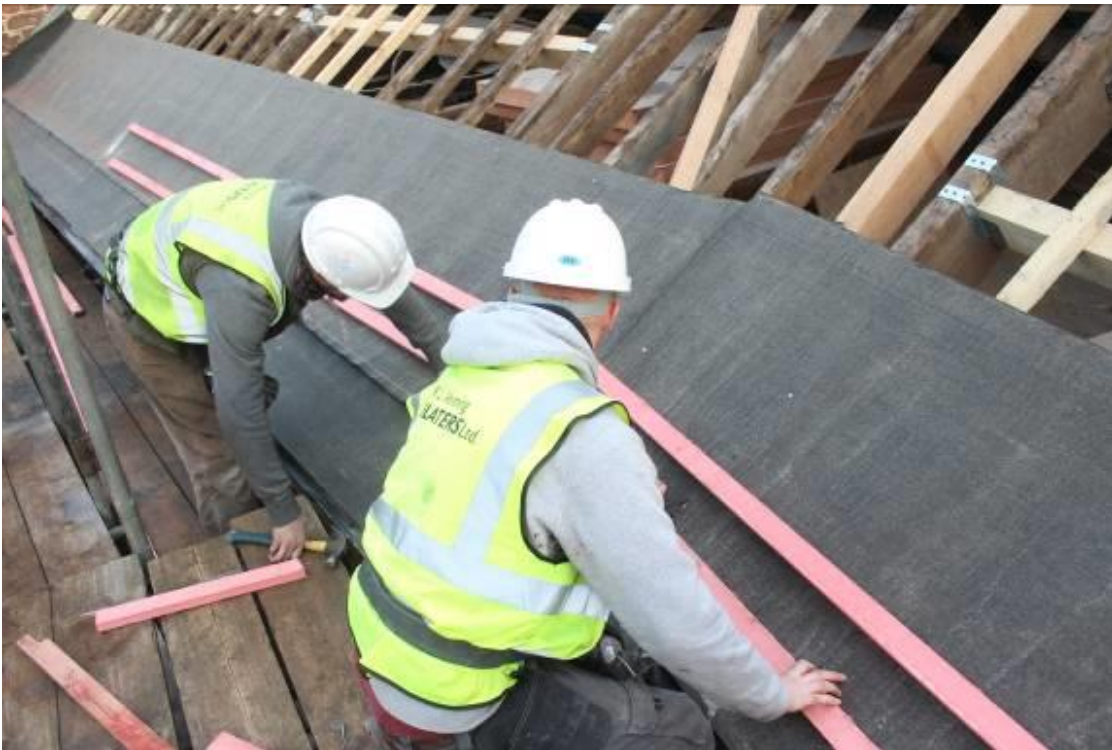
Work commencing on felting and fixing battens for the new slate roof for the barn

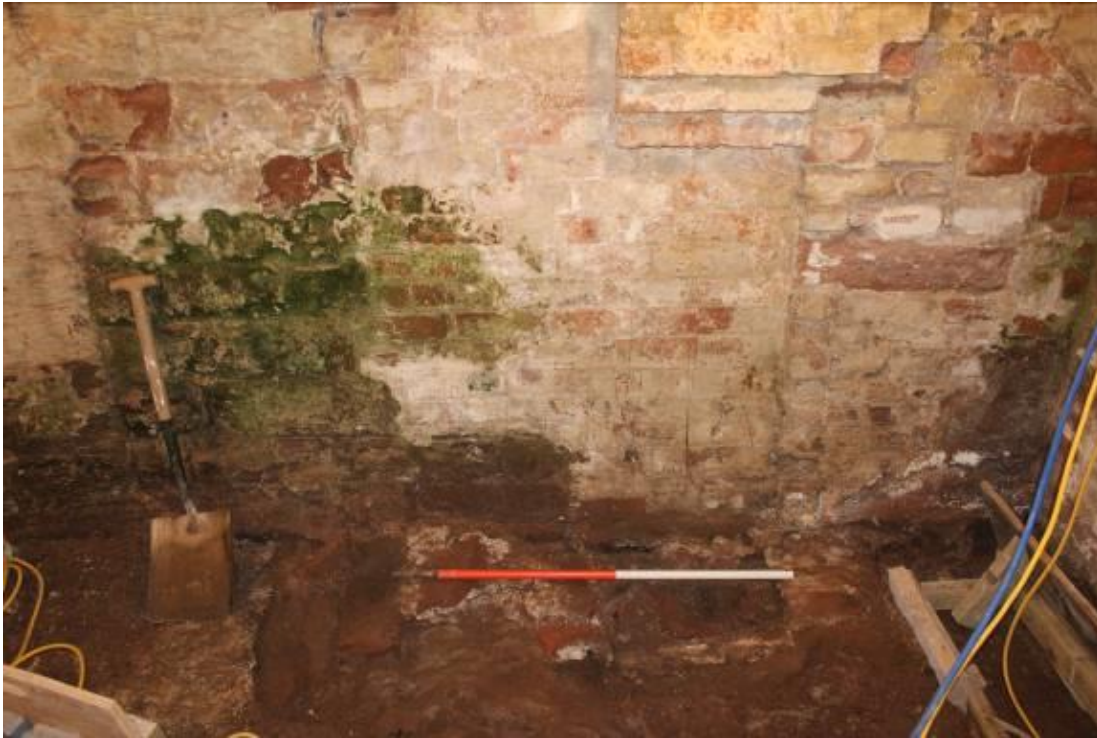
Excavation work to underpin the partition wall on the south side of the ground floor store revealed bedrock at no great depth and additional trial pits were dug to inform future drainage excavations required in this area. The test pit against the south wall revealed mortared stone and brickwork and was expanded to determine its full extent, which corresponded with the blocked in flue cut into the east wall and presumably represents the base of the fireplace or perhaps a small range which stood against this wall.

The base of a fireplace projecting below the brick blocking in the east wall of the store

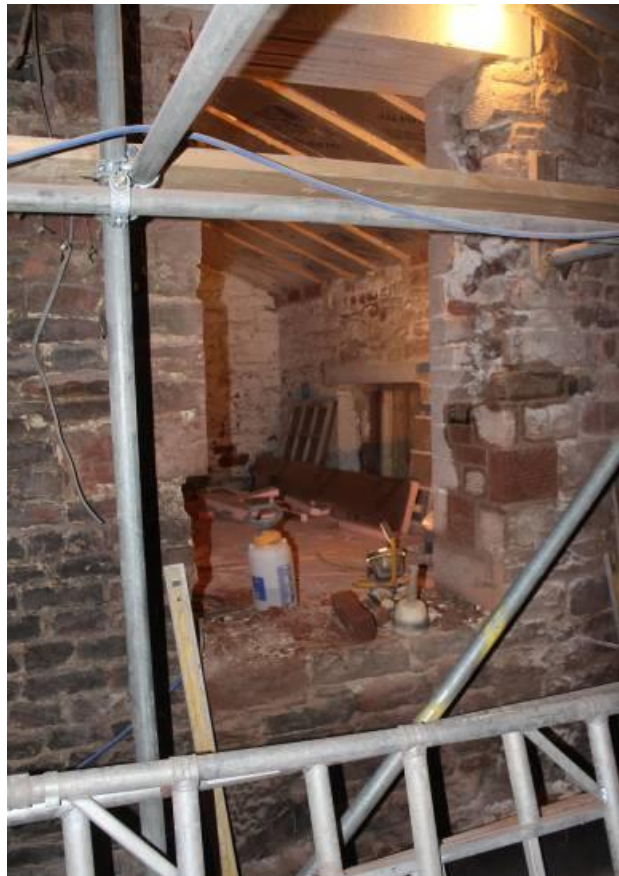
Forming the jambs for the new door opening between the barn and the upper floor of the extension, above the store, revealed the brickwork of the fireplace flue, which is cut into the older barn wall.

The blocking brickwork of the flue cut into the barn wall can be seen to the left of the new doorway
