Warwick Bridge Corn Mill Progress February 2019

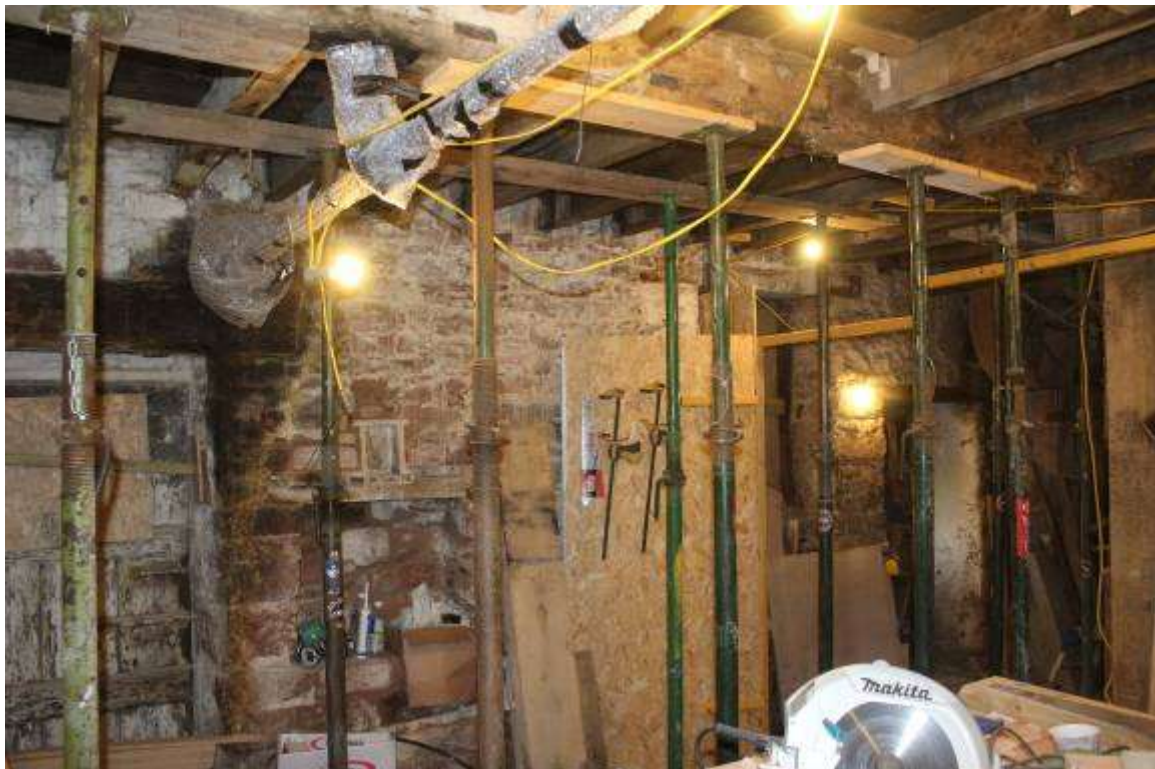
A double row of temporary props spanning the Hurst Floor are supporting the weakened Stone Floor beam

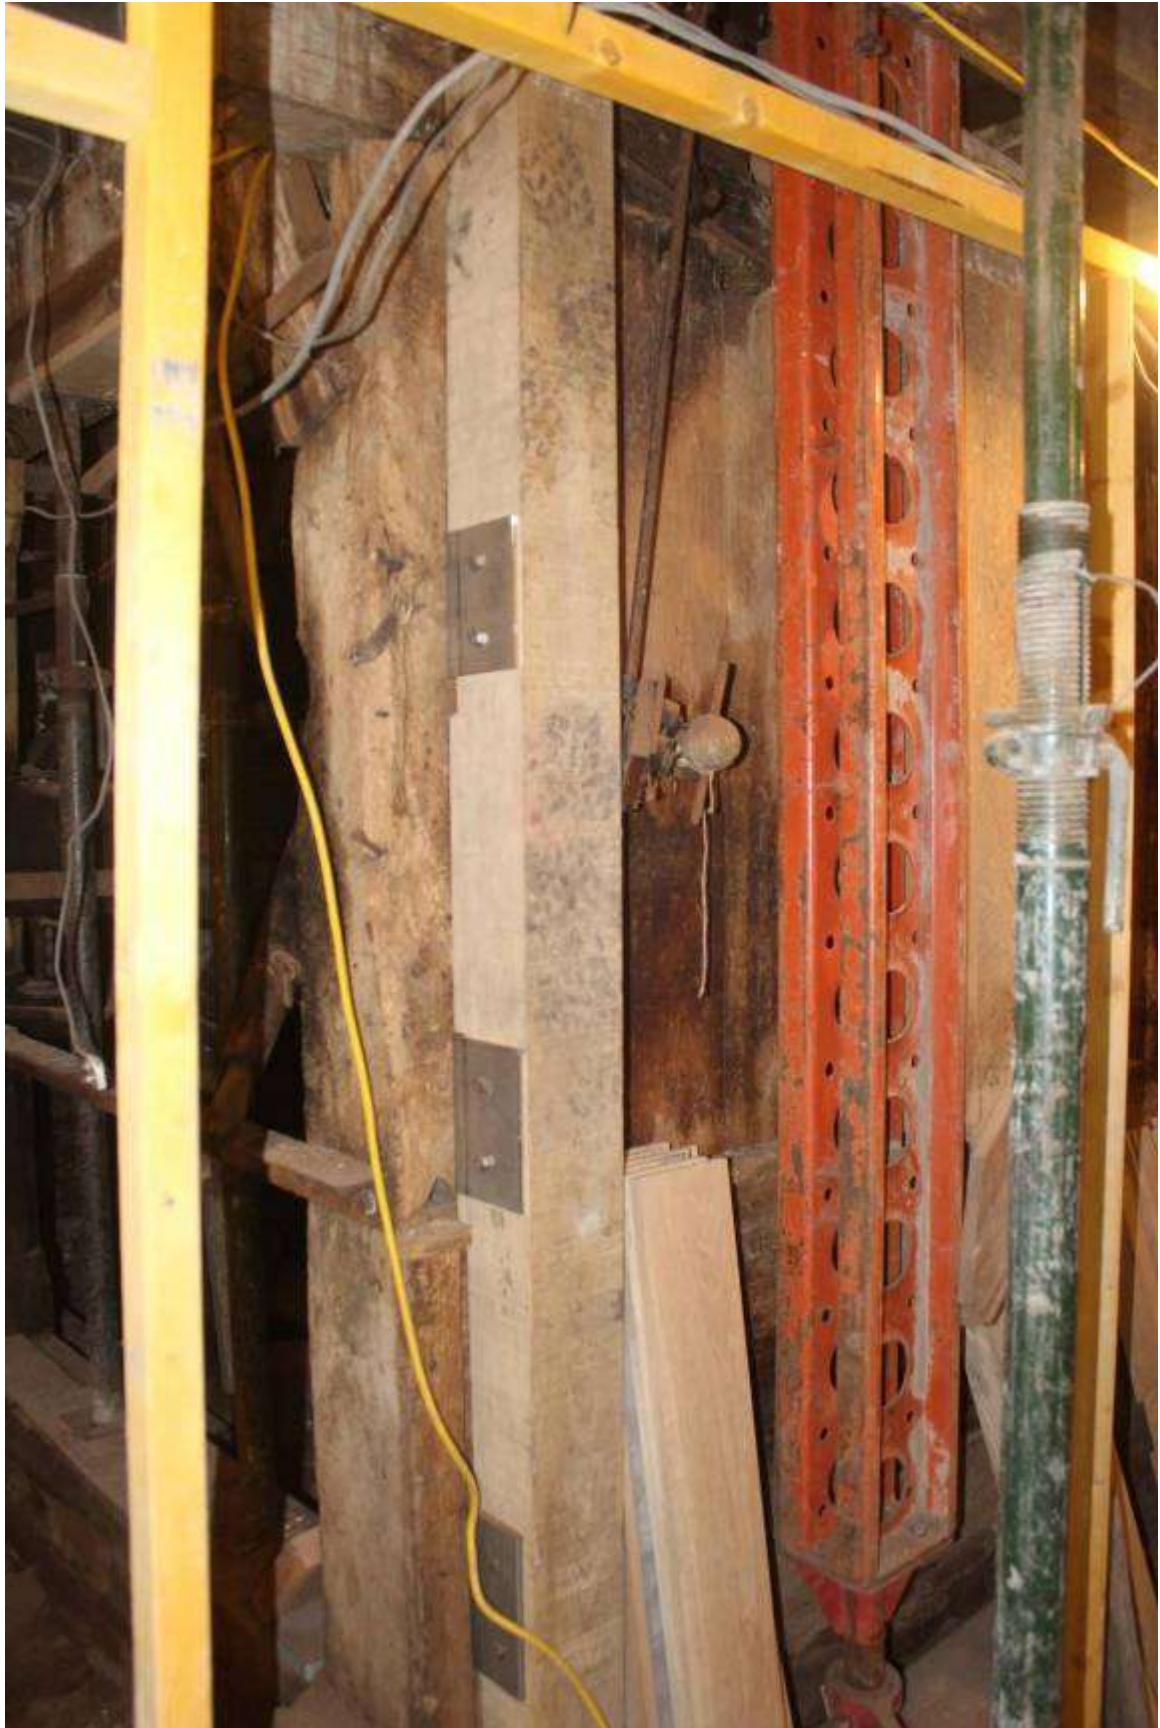
The new supporting timber at the NE corner of the Hurst. The steel soldier beam to the right is taking the load from above during the repairs

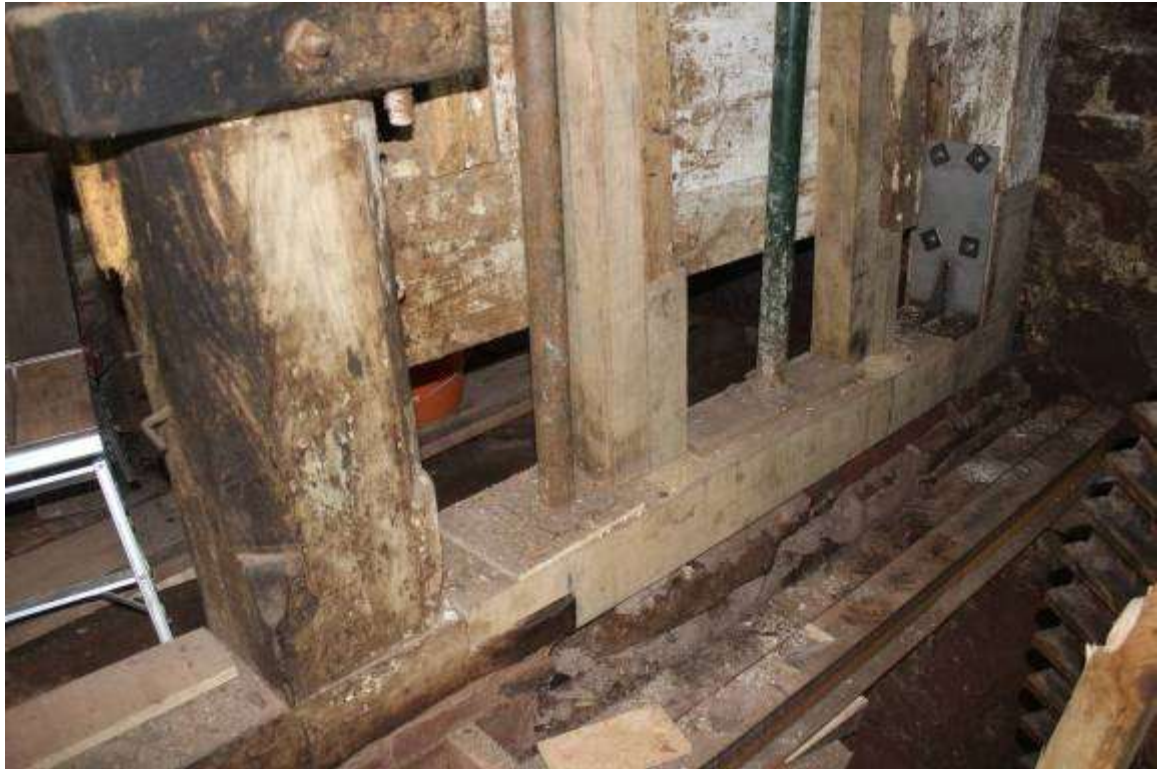
Repairs to the sill beam on the upstream side of the Hurst

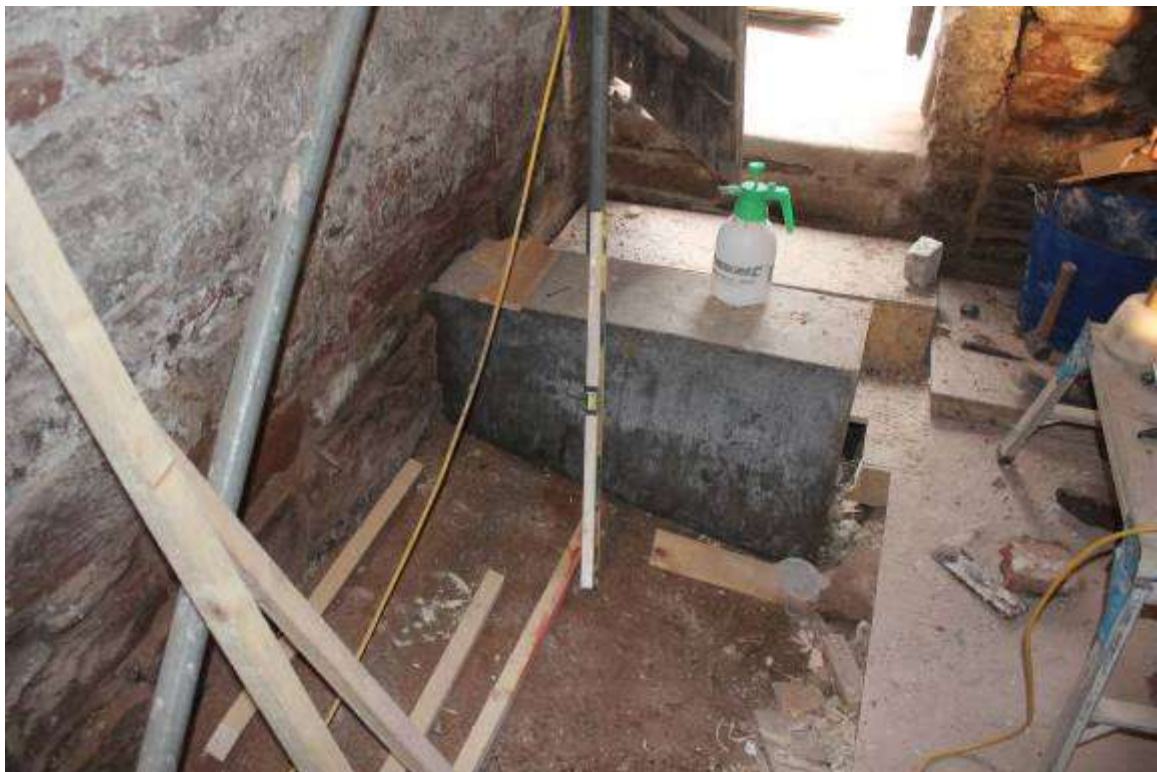
New support block for a staircase beside the drying kiln. The slope of the bedrock here is evident

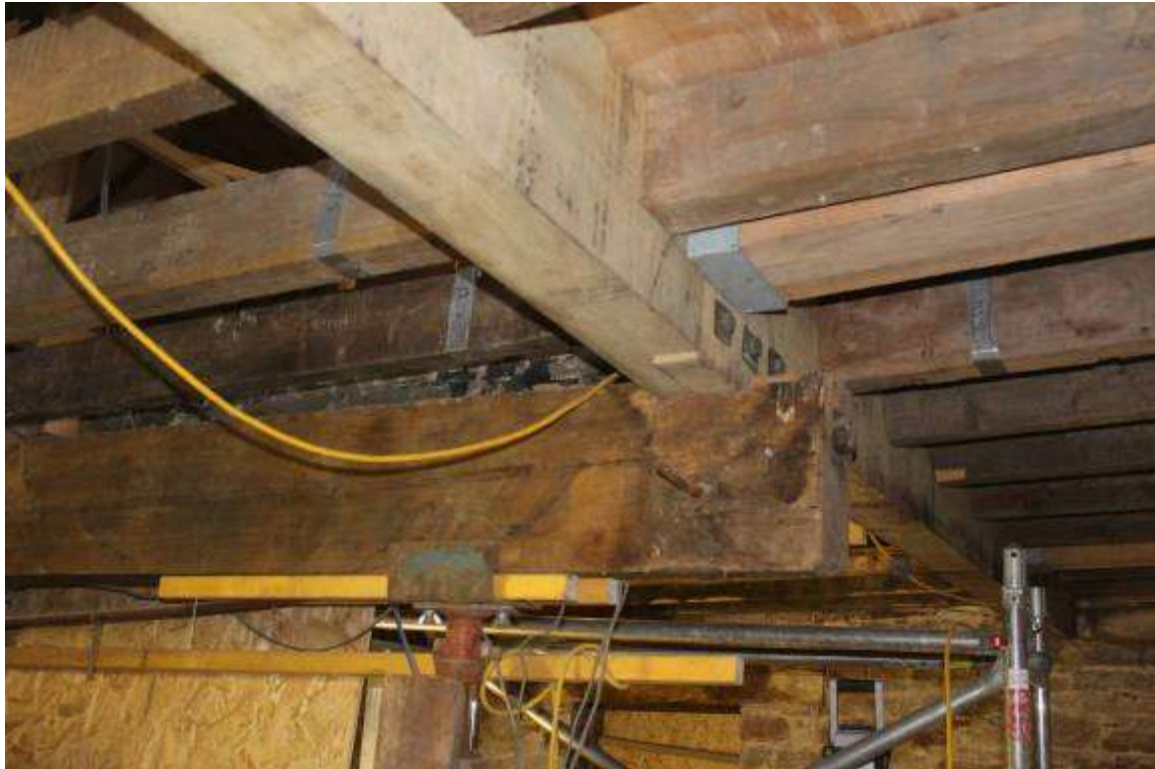
New Garner Floor Oak beam, installed in two lengths and plated together above the Bowstring Truss added by the Victorians to accommodate the fifth pair of millstones

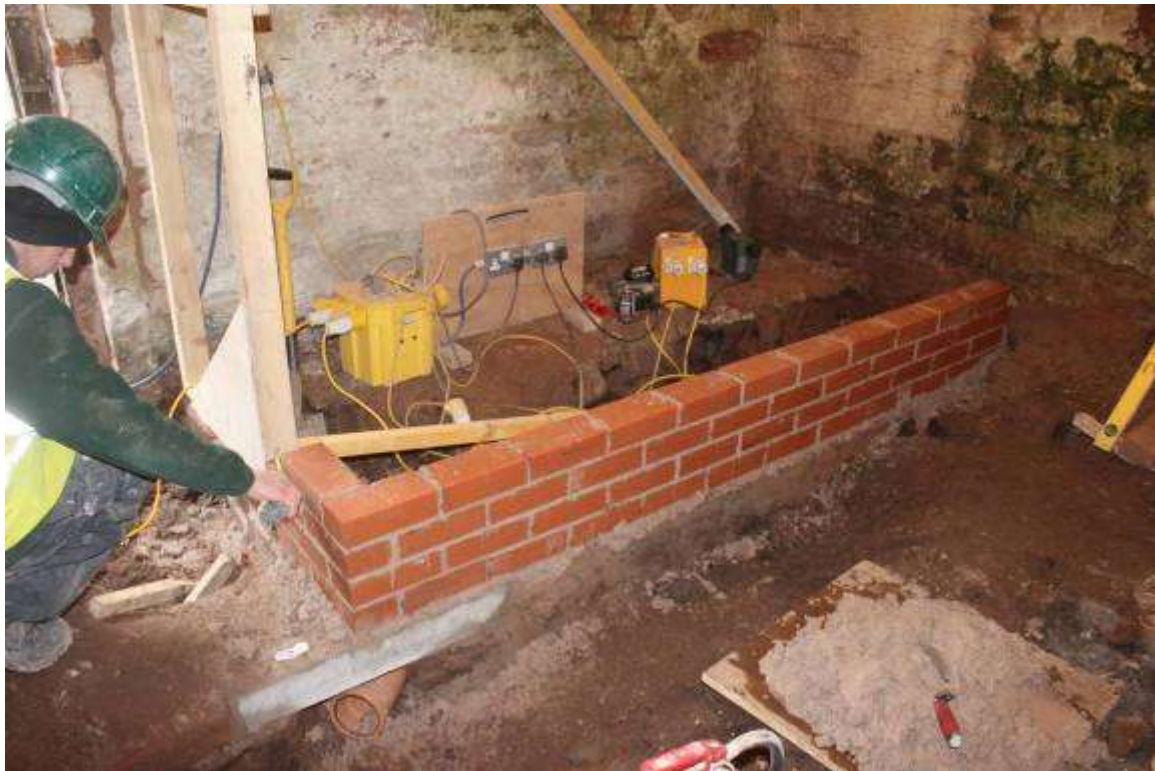
Partitions being installed over the earlier foundation in the ground floor Store

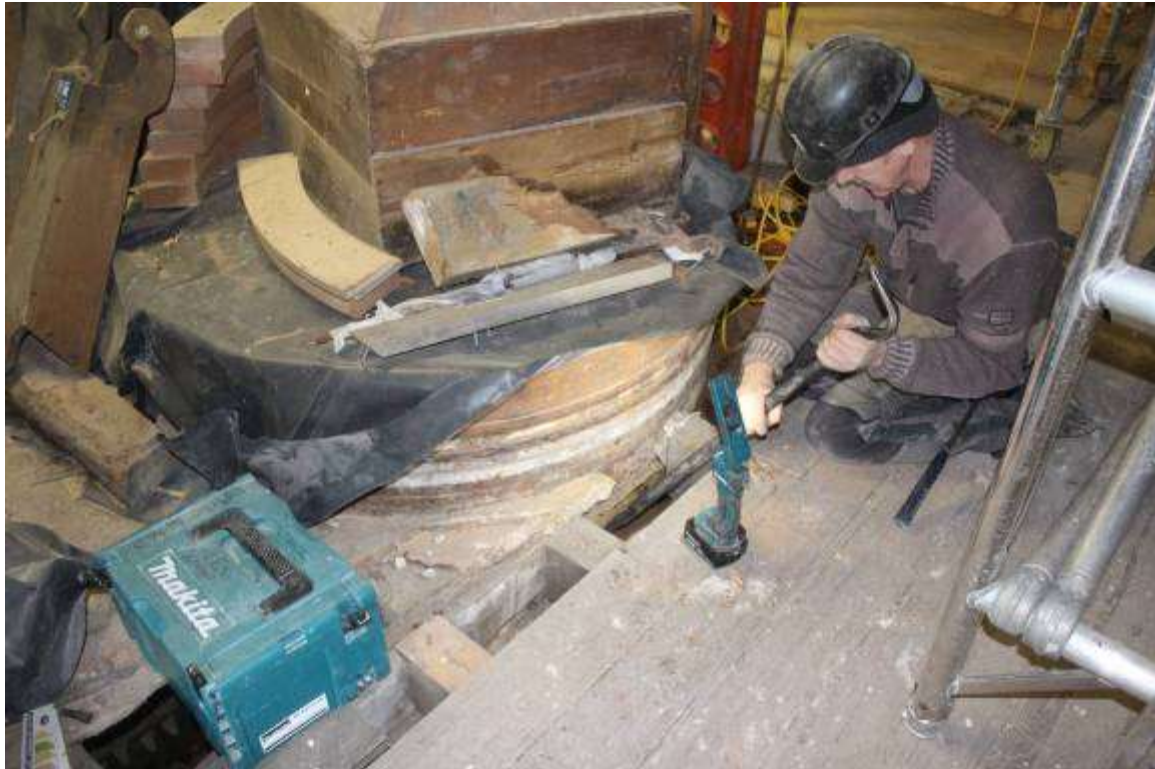
Digging out softened wood from the Stone Floor beam ahead of resin repairs

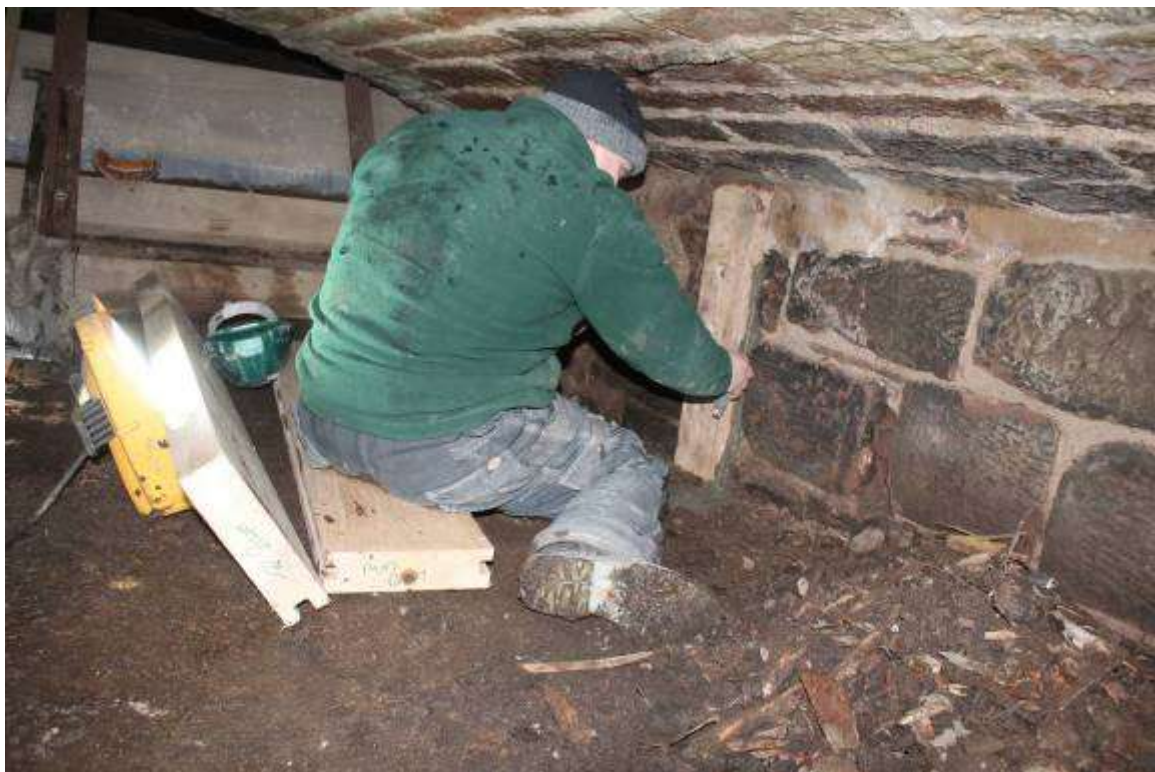
Pointing in a new timber for the box lining within the Head Race culvert

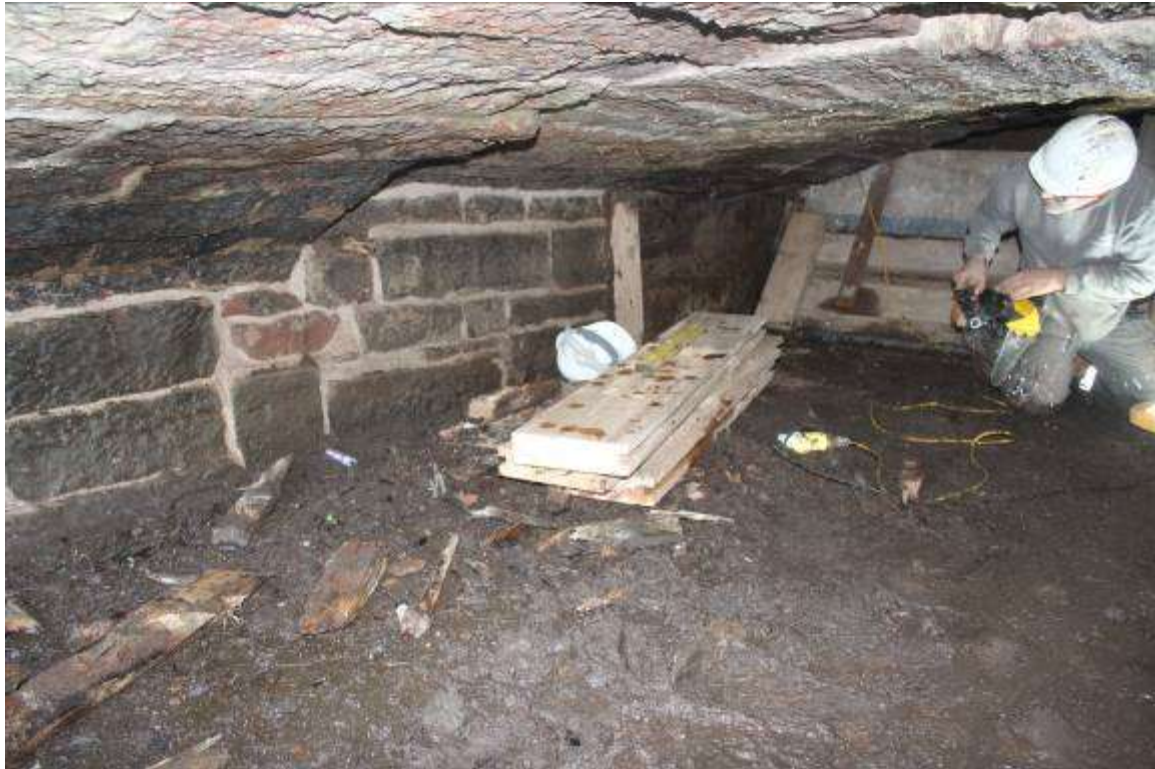
Work in progress on the south side of the culvert

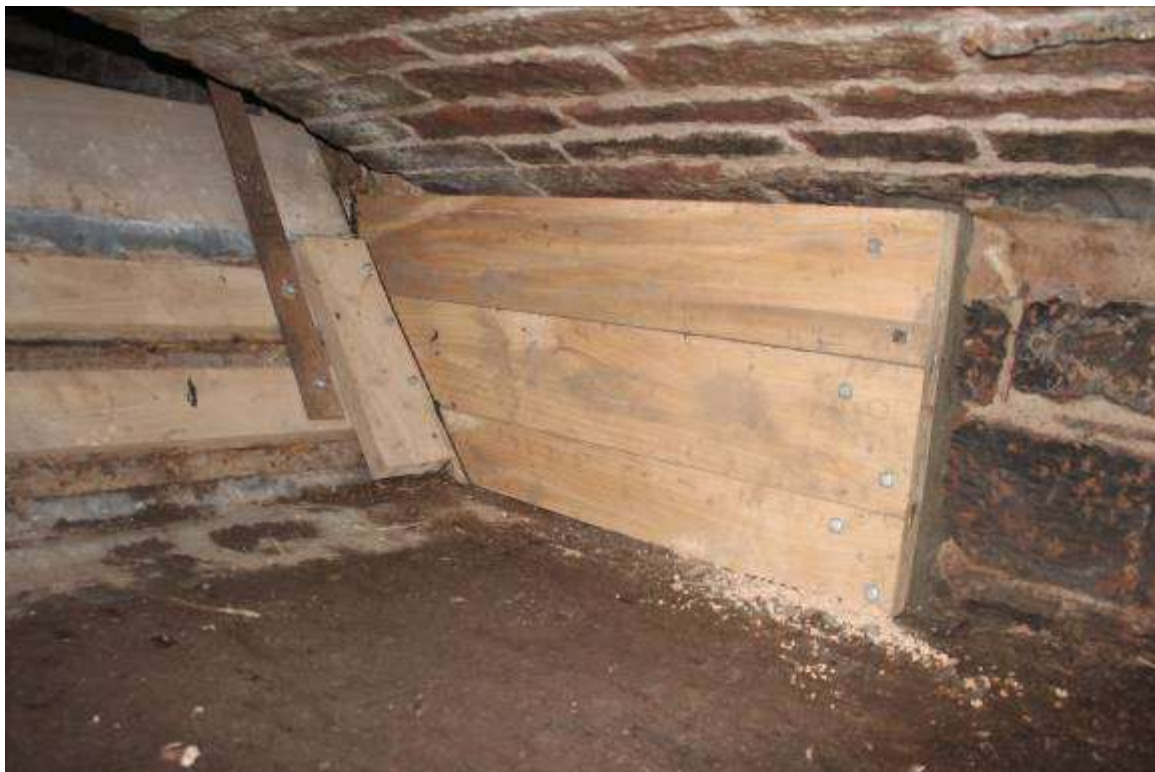
New lining timbers completed on the north side of the culvert

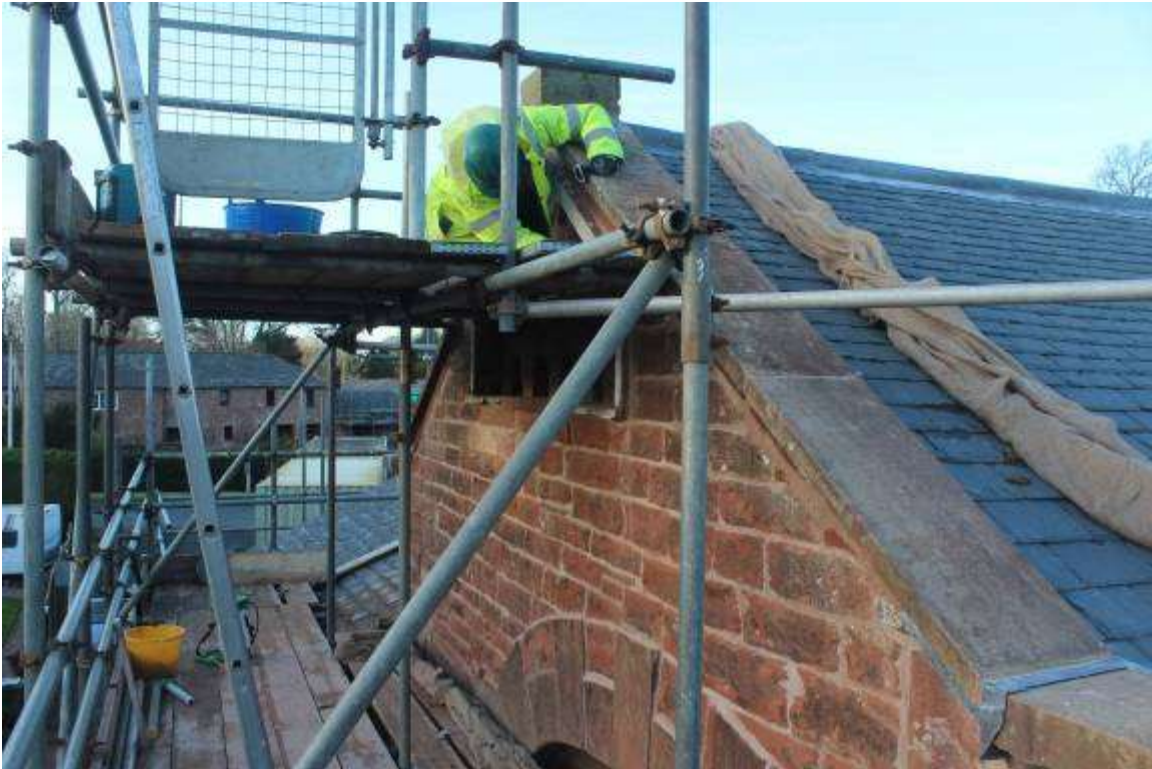
Alan putting the finishing touches to the gable of the Barn

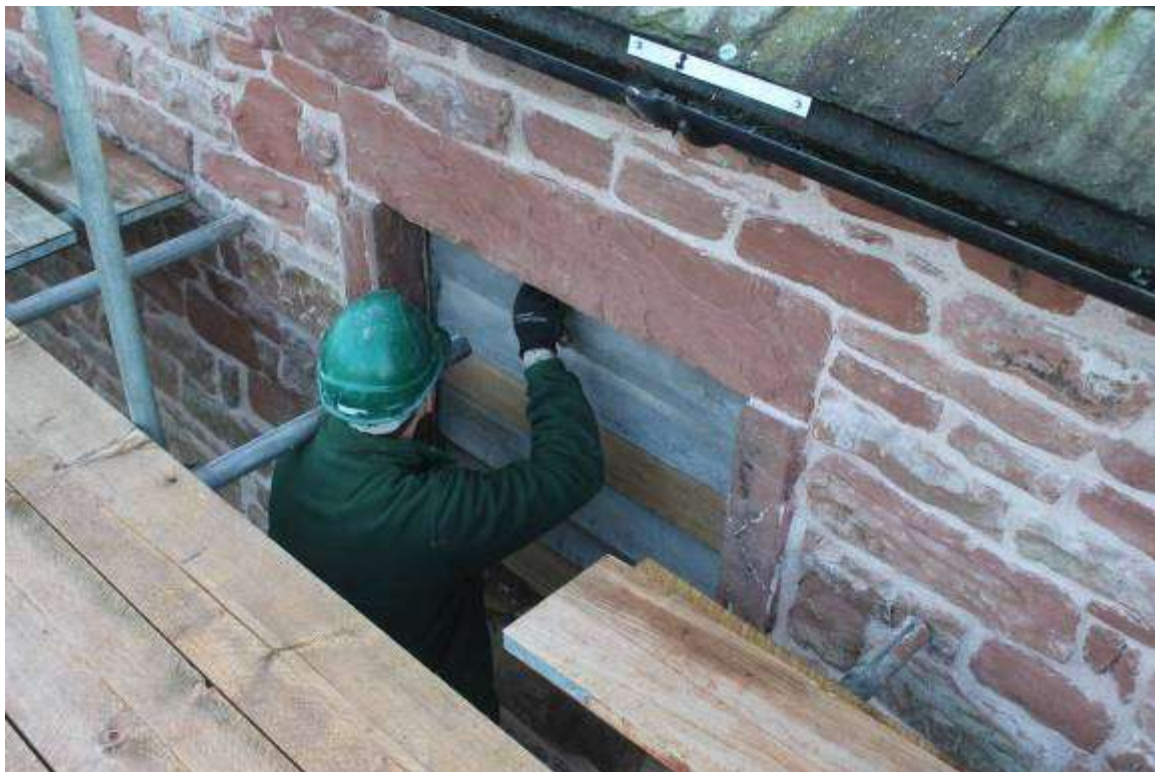
Pointing around a repaired louvre on the north side of the Garner Floor

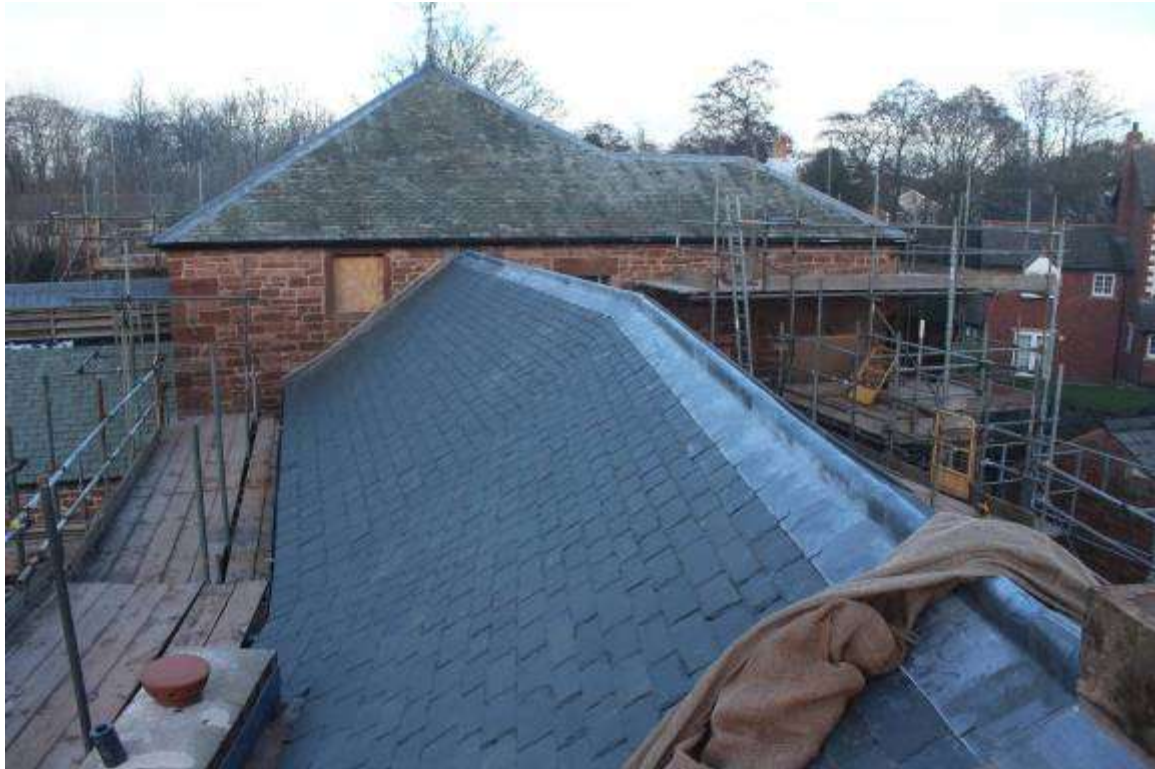
New roof on the barn completed

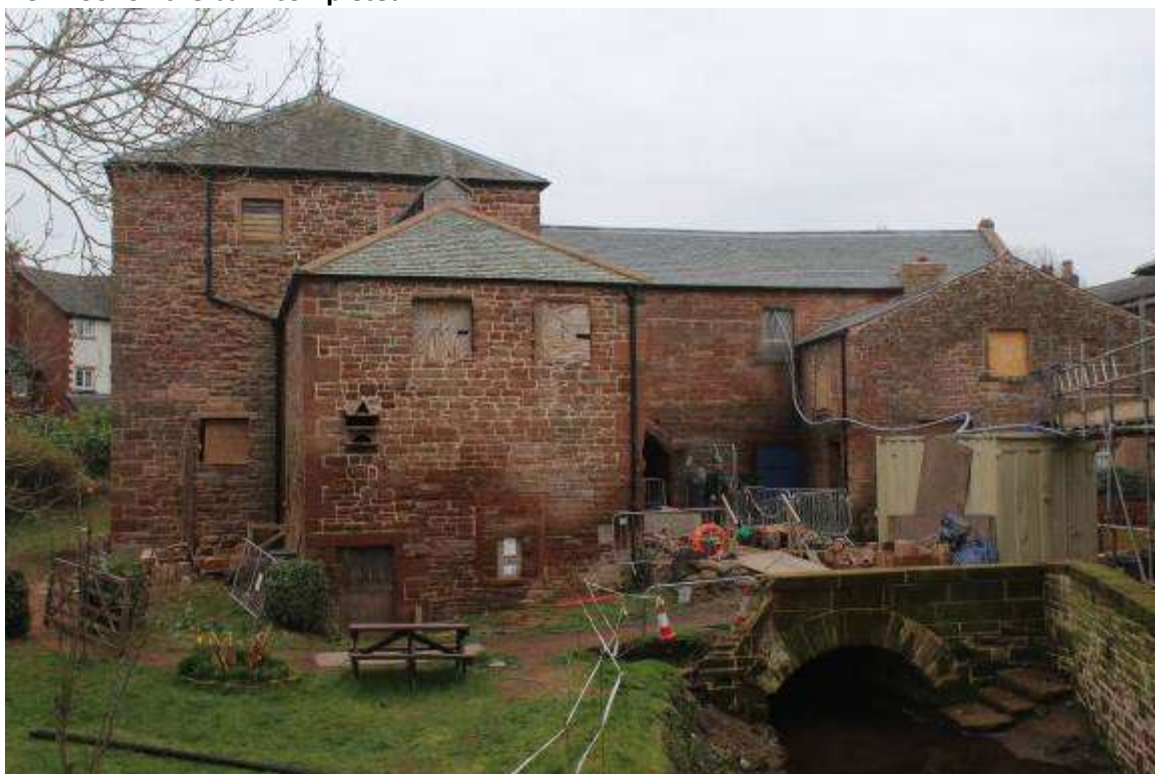
Scaffolding gone!
