Warwick Bridge Corn Mill Progress March 2019

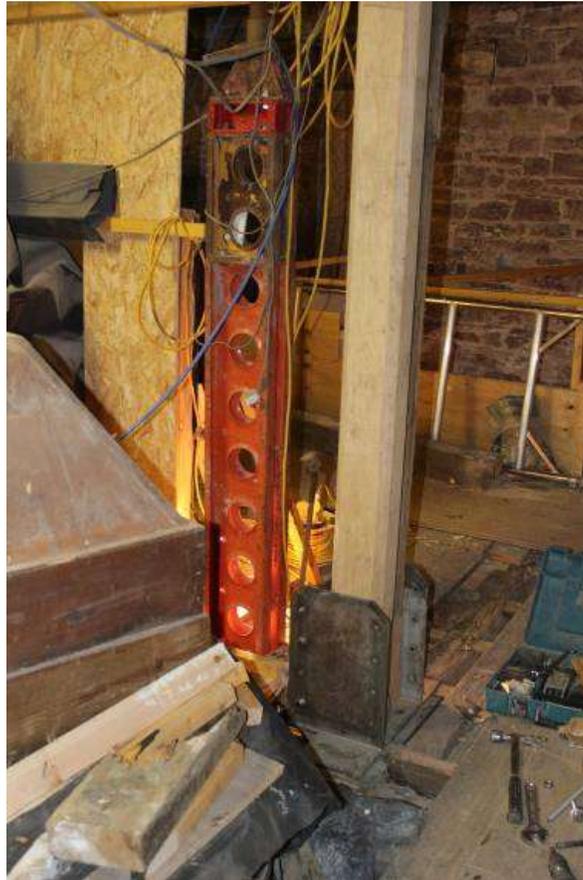
A new supporting timber and steel shoe being installed above the repaired beam on the Stone Floor

The month saw the conclusion of major structural repairs to the floor beams which had been weakened by rot. One beam was replaced completely in Oak and a second was reinforced by a resin repair which avoided the need to disturb one set of French Burr stones.

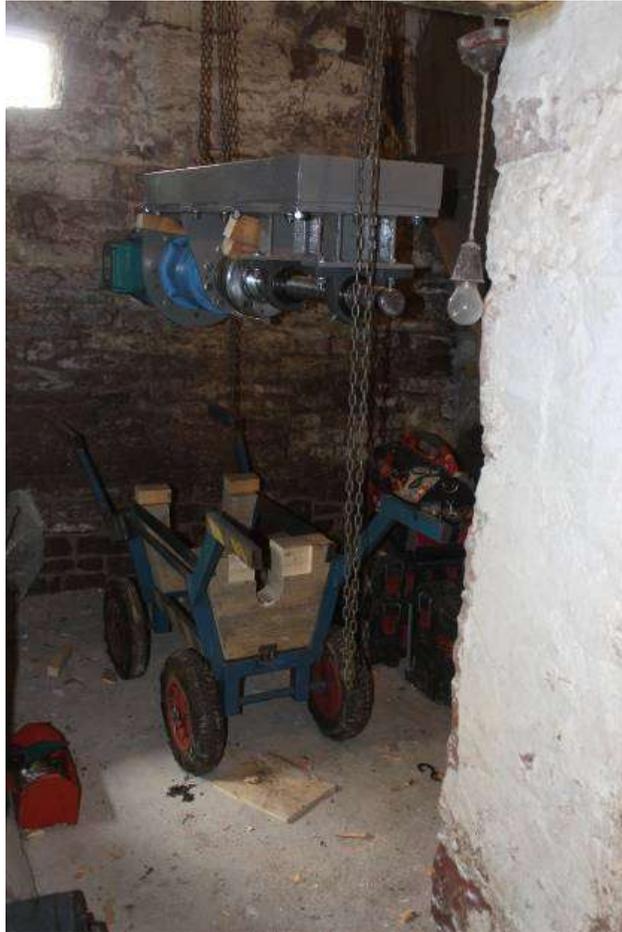
The new generator being lifted from its transport cradle

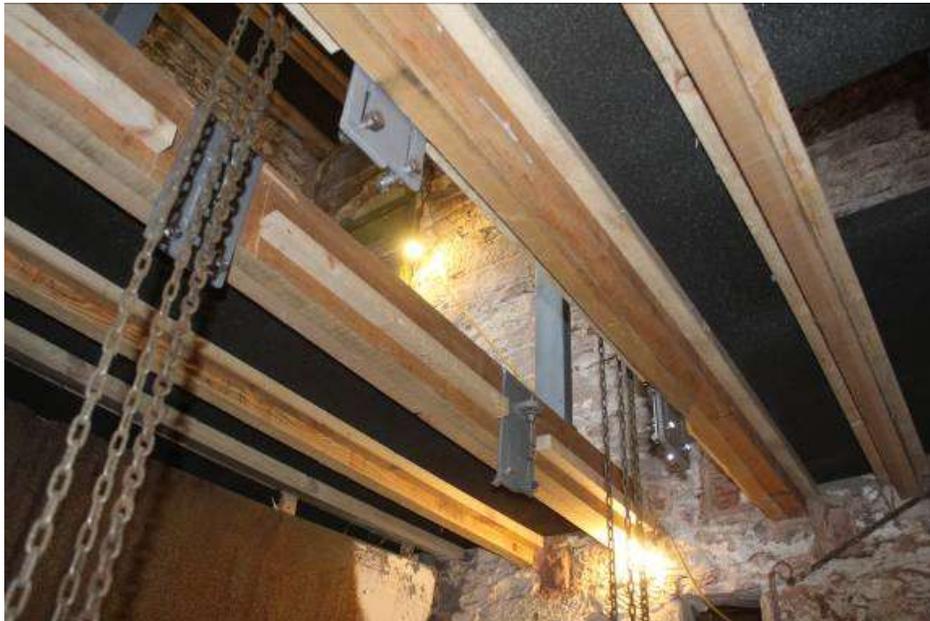
A temporary lifting frame was installed at first floor level and fixings for the generator in place

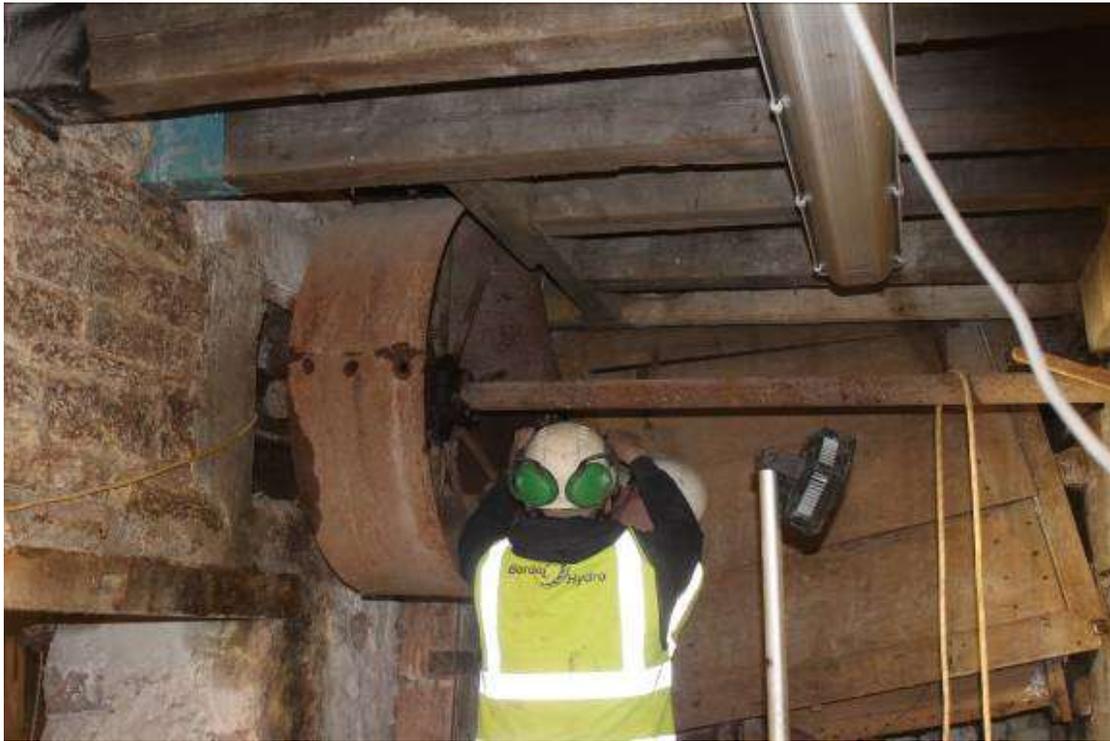
Starting to dismantle the pulley wheel on the lay shaft

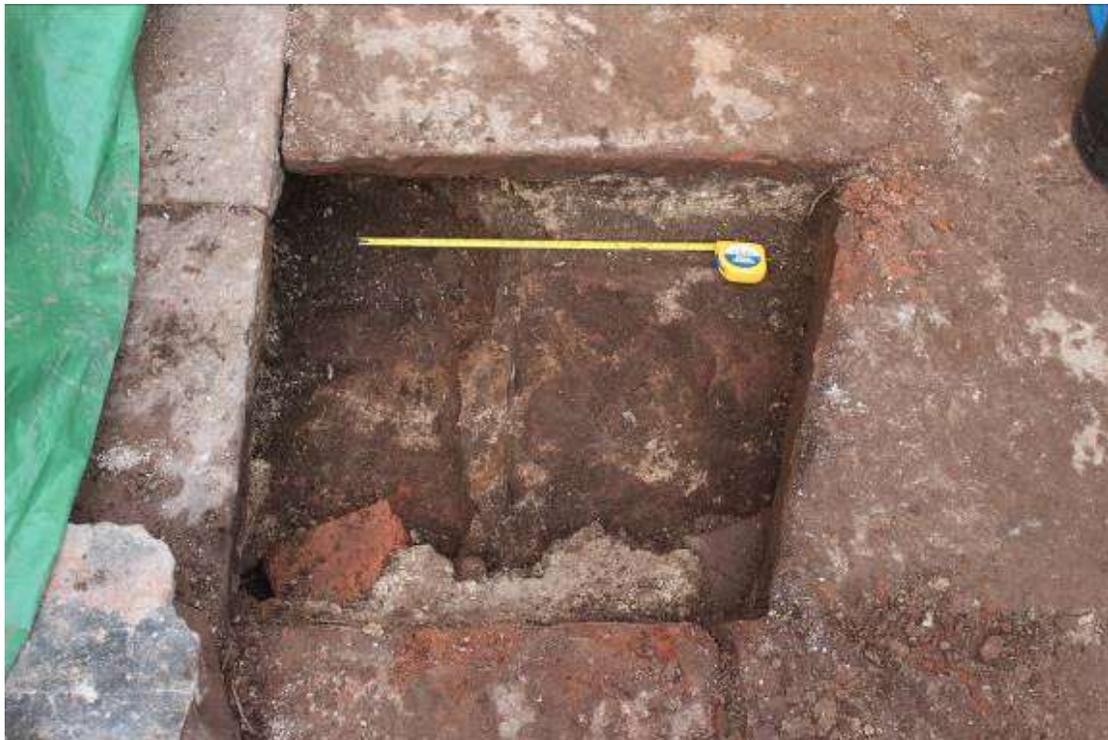
A small test pit investigated the depth of cover available for the proposed drainage run from the mill extension. It showed that the crown of the head race culvert was just below the paving, leaving no room for the pipe run.

The crown of the head race culvert showing just below the paving of the loading dock

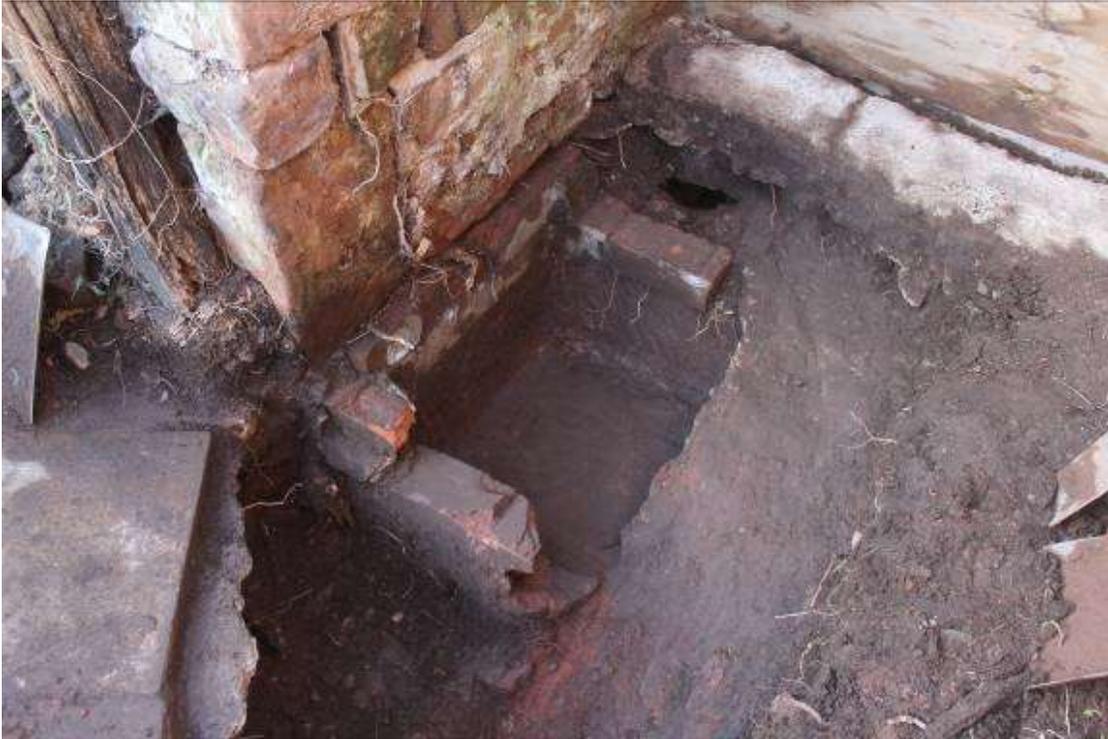
The need to resolve drainage for roof water from the barn saw another trial trench opened to the east of the loading dock. This revealed a stone trough at a lower level than the parapet wall.

Stone trough cut through by concrete supporting the race wall and overlain by the parapet wall for the loading dock

The levels did not work so another solution was proposed, to investigate the original drainage arrangement to the wheel pit.

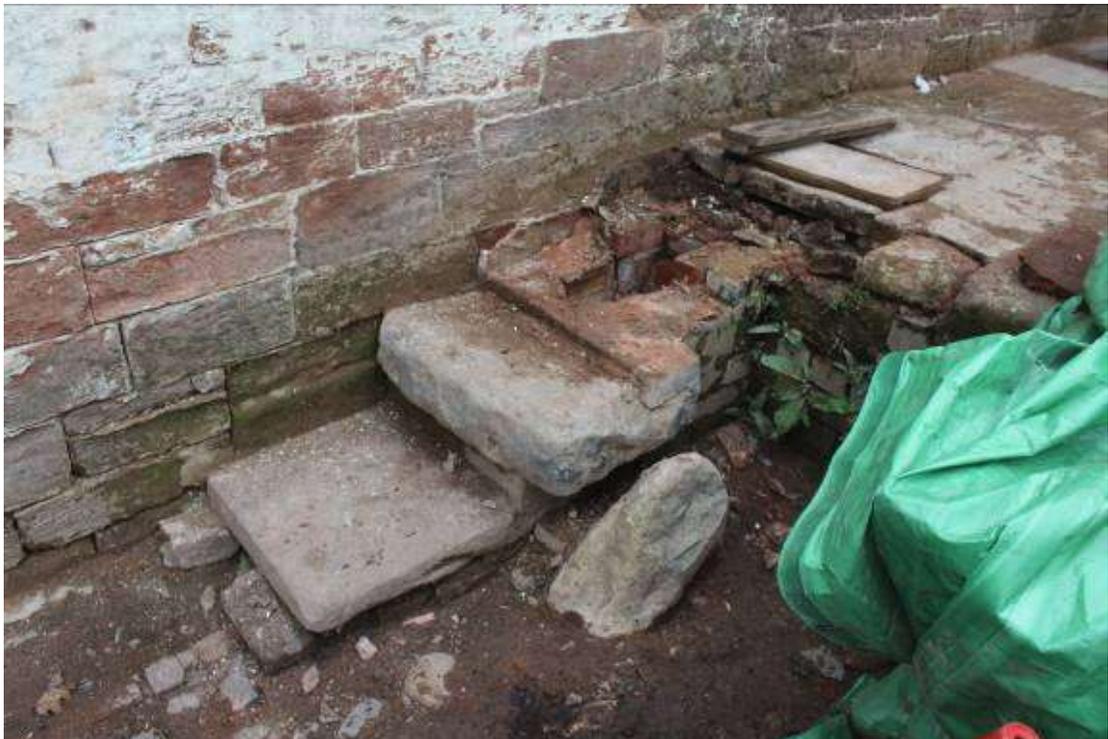
Steps to the loading dock being dismantled to investigate the original drain run below.

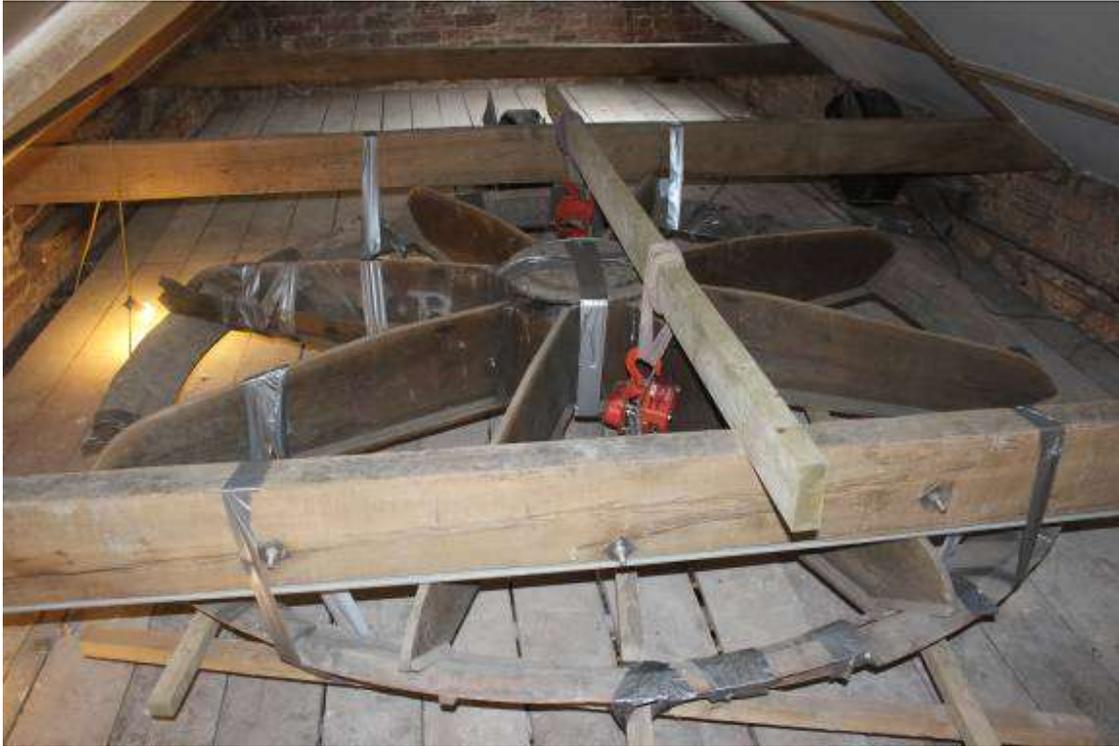
The wooden casting pattern for the Pit Gear ready for lowering from the barn roof where it had been stored. WB on the pattern identified the job

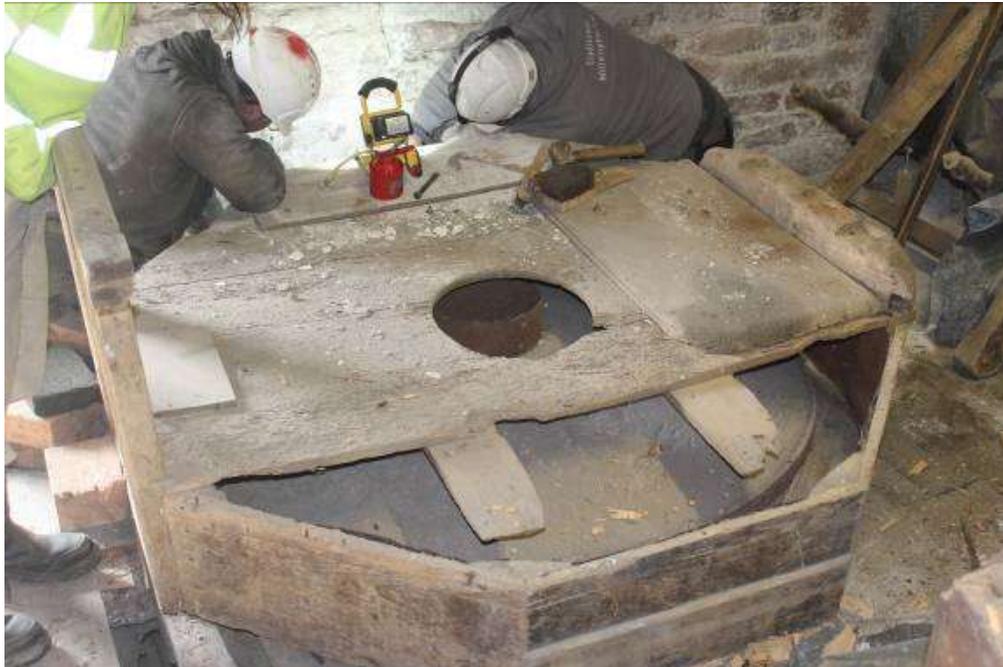
The millwrights working on the control gate operating mechanism

The millwrights have been working on the control gate operating mechanism and improving the seating of the valves on the gate.

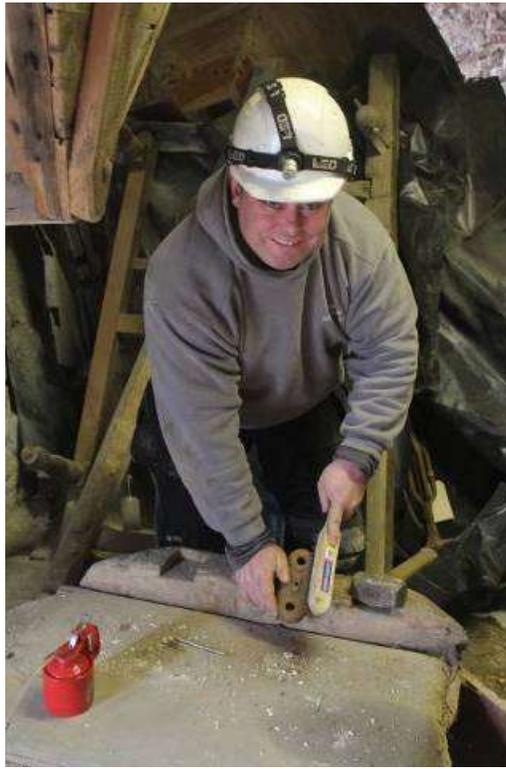
Millwright Jon cleans up a very dry Bearing on the control gate lever on the Stone Floor

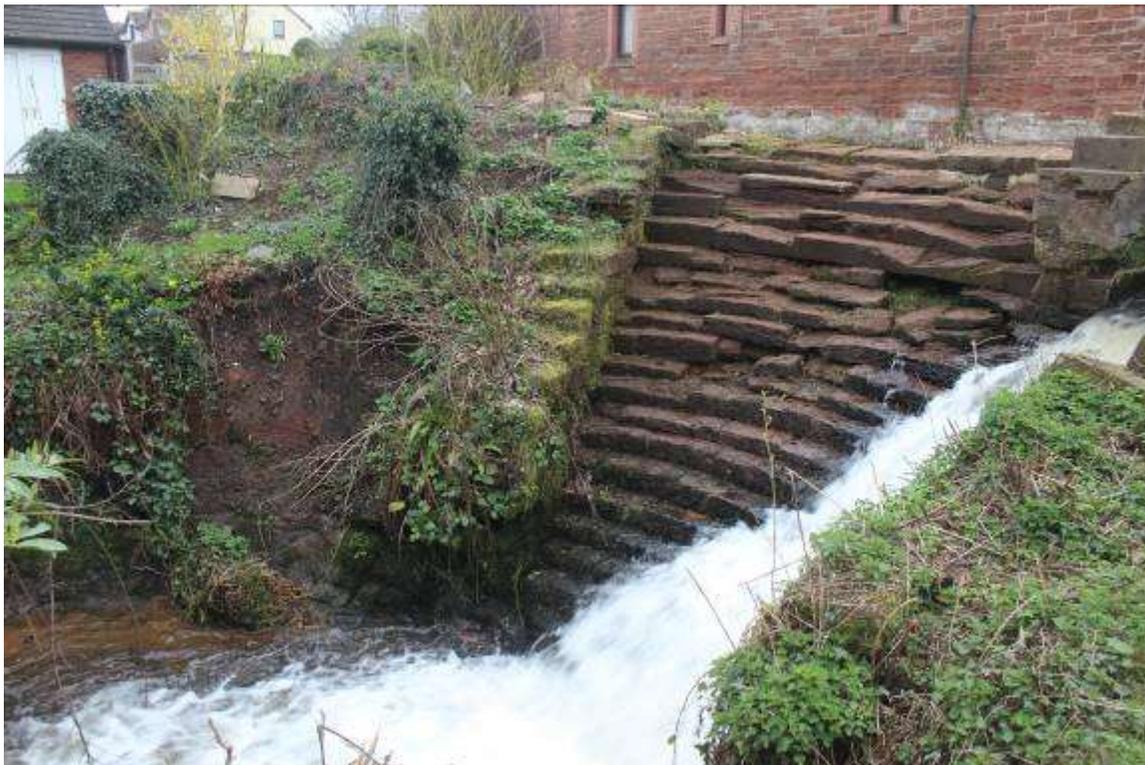
The spillway was cleared of vegetation to allow inspection of the stonework

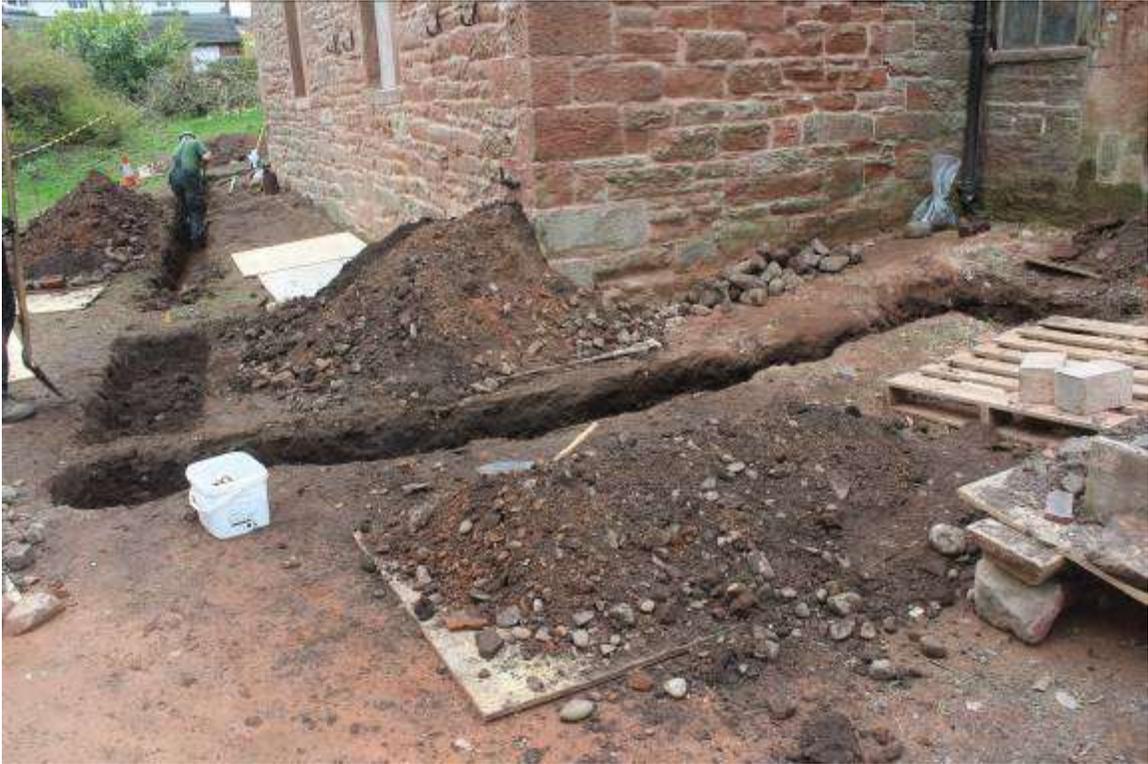
Work in progress on the drainage trenches to north and west of the mill

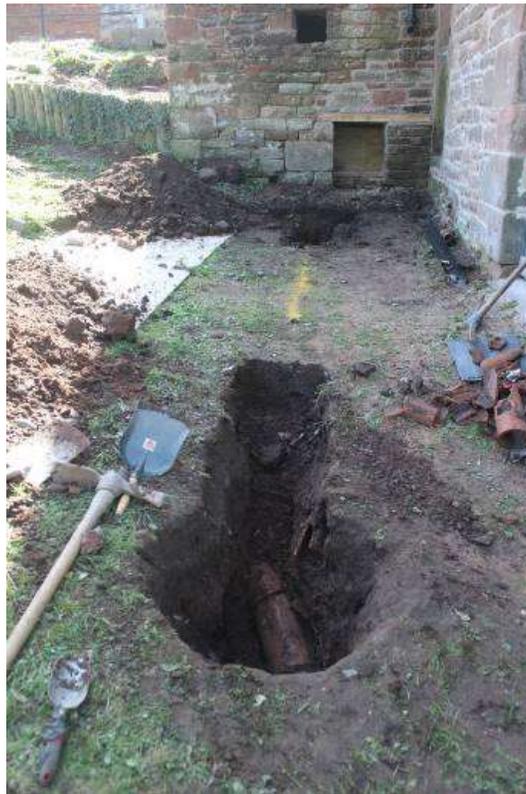
Land drains of different periods at the NE corner of the mill

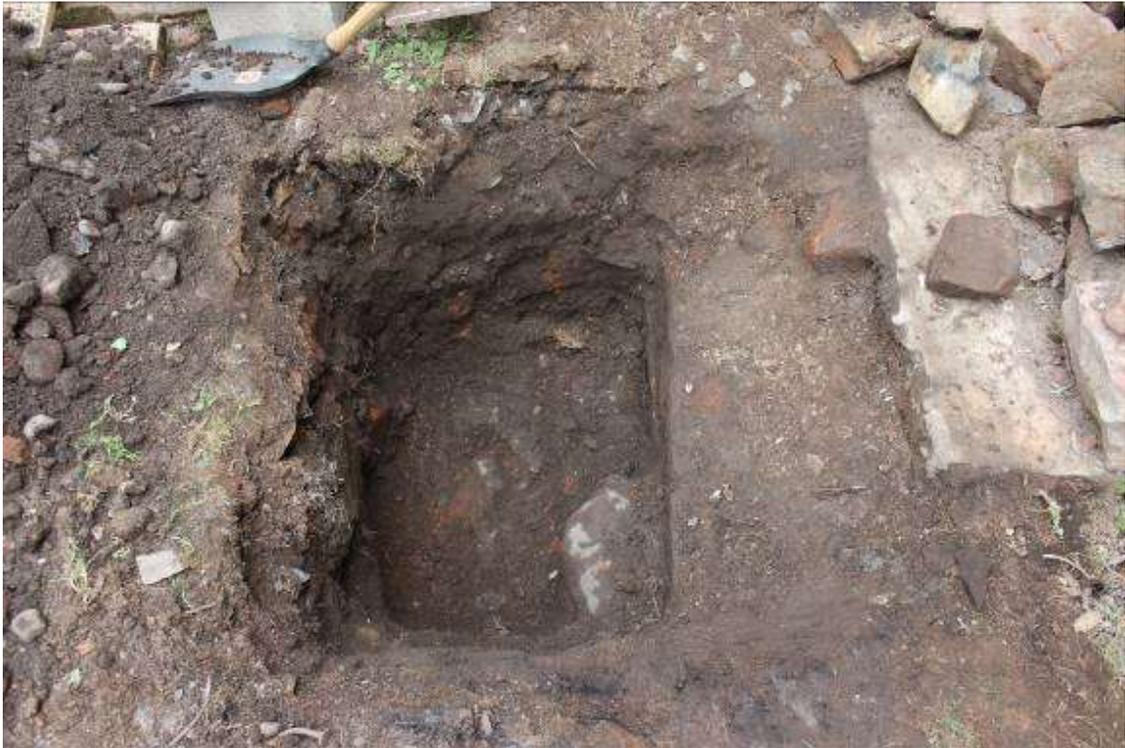
Foundation of small lean-to on the north side of the kiln, looking east

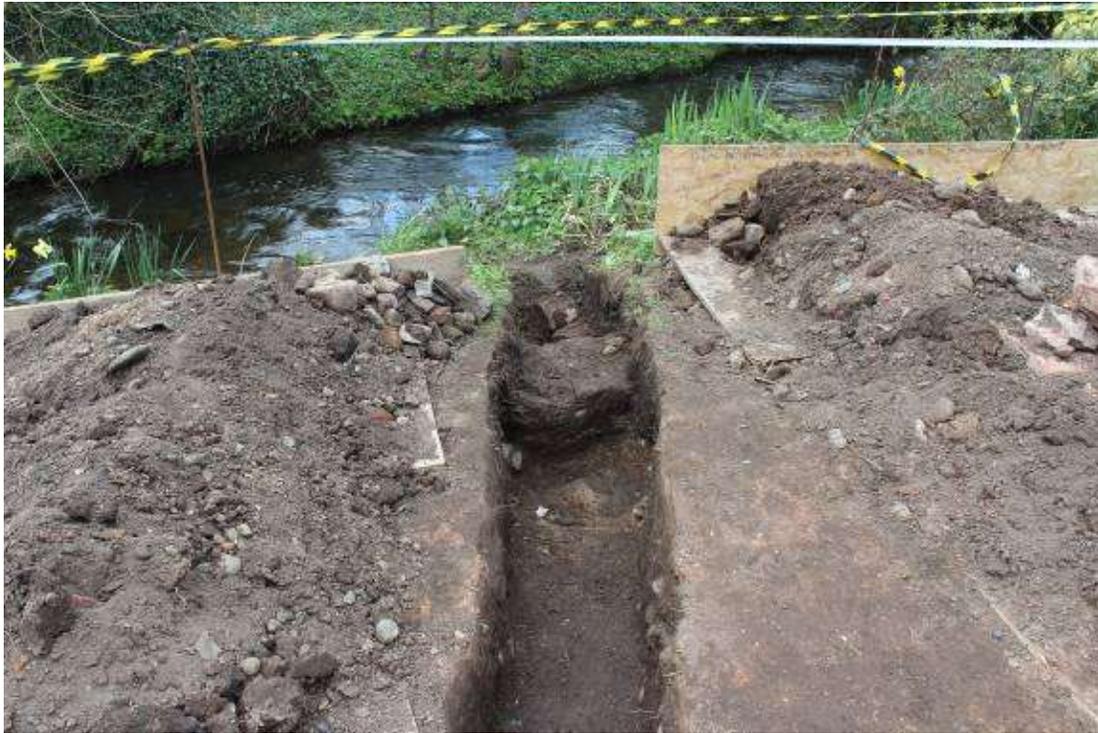
Wall foundation alongside the Cairn Beck

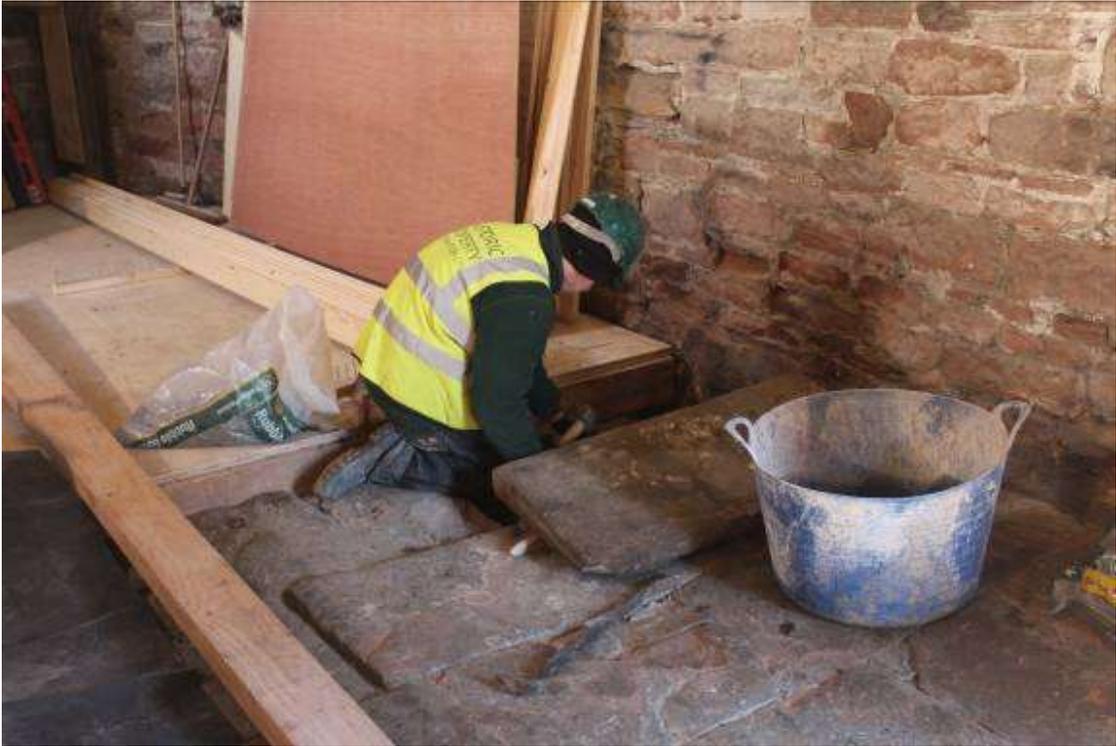
Flagstone lifted for re-bedding

Four flagstones in the barn floor were lifted and re-bedded.
