Warwick Bridge Corn Mill – update November 2018

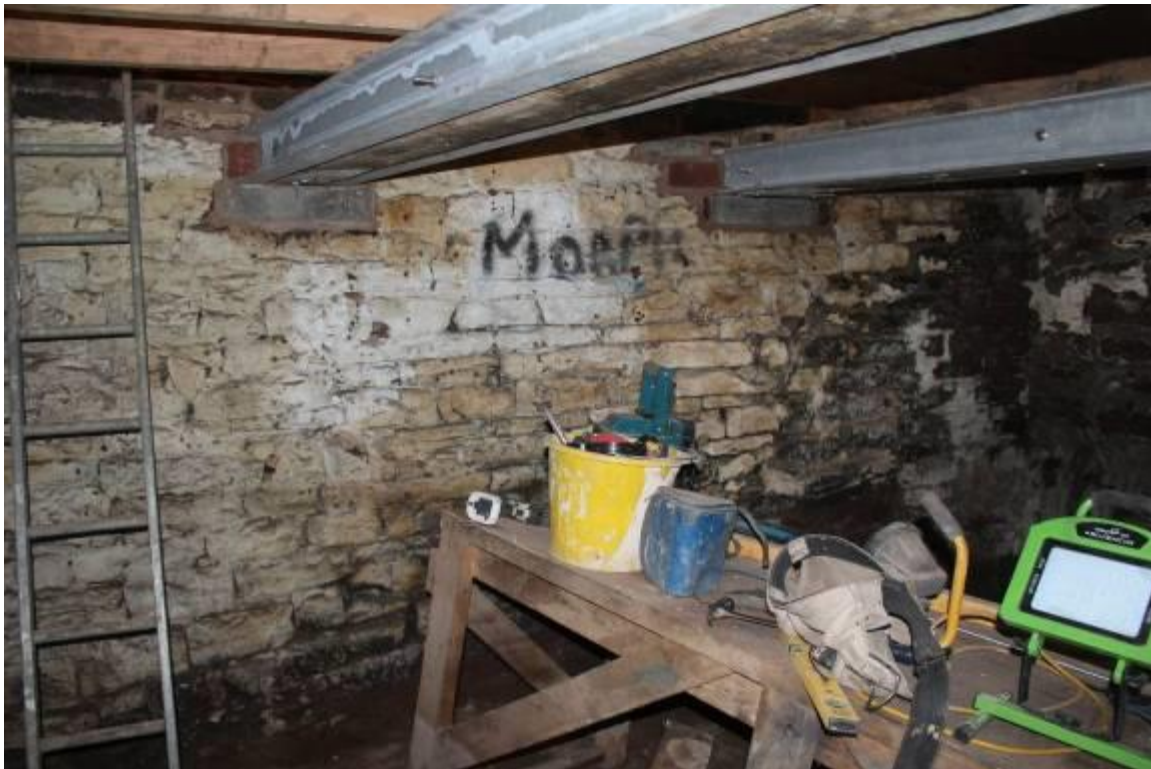
New reinforcing steel beams, on concrete block padstones, provide additional support to the barn floor above. The north wall of the basement store is built off the sloping sandstone bedrock. The spray painted word adds to the range of graffiti encountered in the buildings!

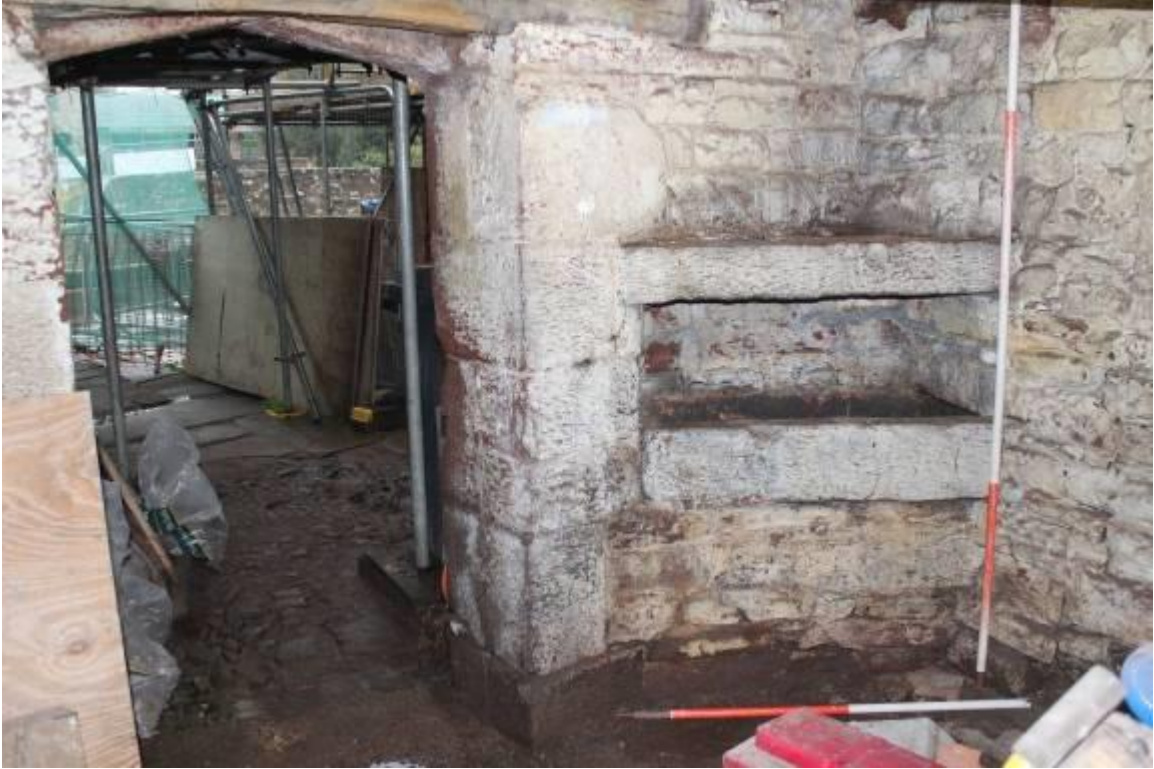
A nicely executed stone trough in the NW corner of the store with a substantial slab above – perhaps acting as a tie across the vulnerable external angle of the earlier range?

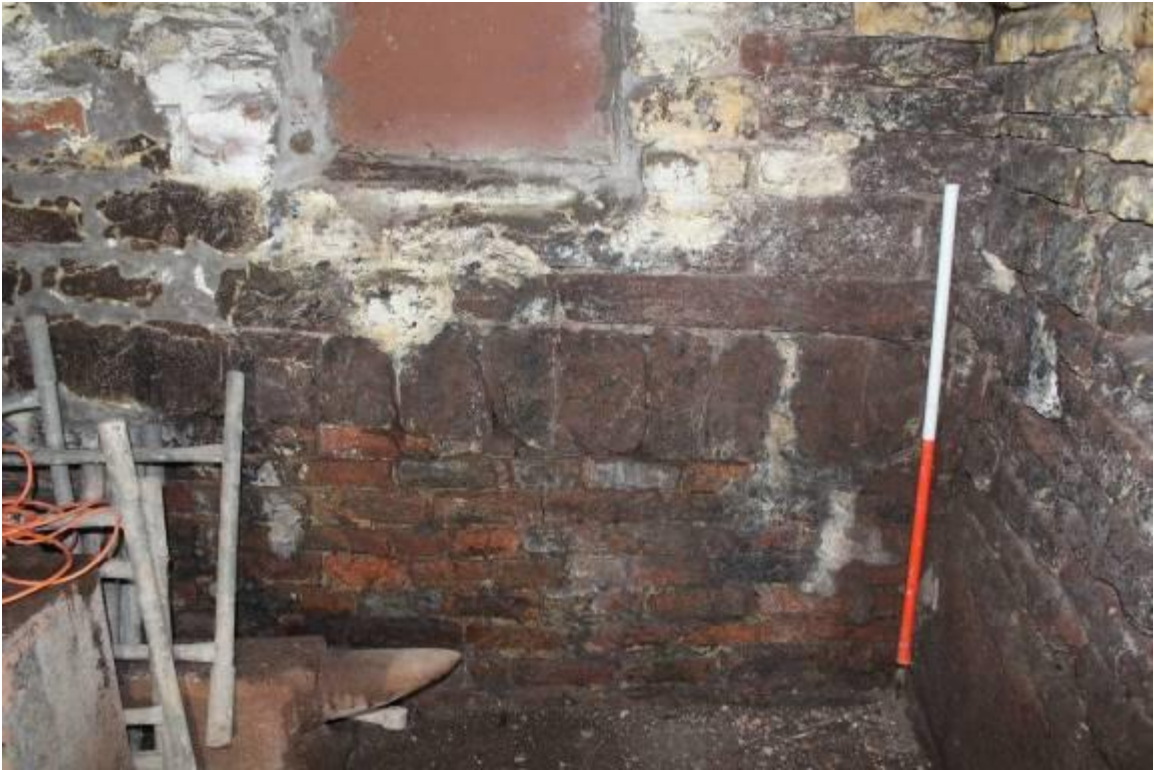
The east wall of the store has a curious construction with a brick and stone infill below a change in the stonework – perhaps patching in against the excavated bedrock behind? The blocked opening above is the base of a chute built through the wall for delivering (Coal?) from the yard above

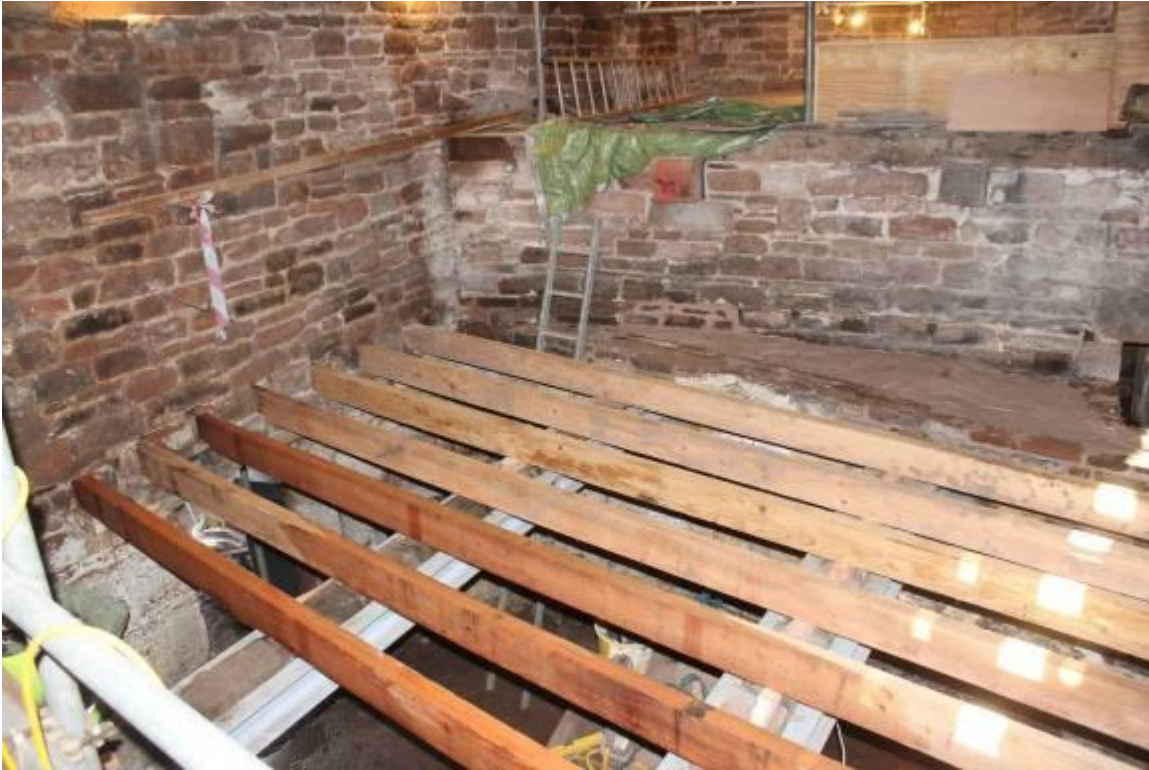
New floor joists, laid above the reinforced beams, will support the new barn floor

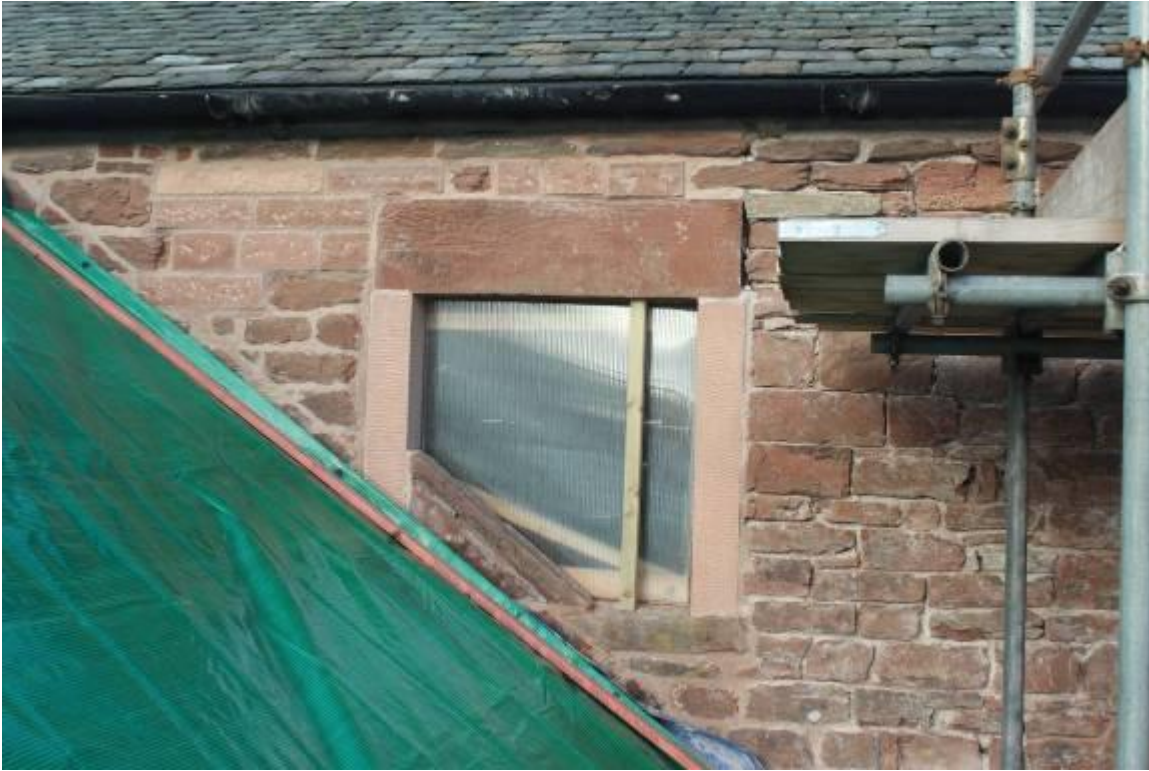
New jambs replacing failed stones at the shutter opening in the south wall of the mill at Garner Floor level. The opening was cut across when the threshing barn was added to the 1839 mill building

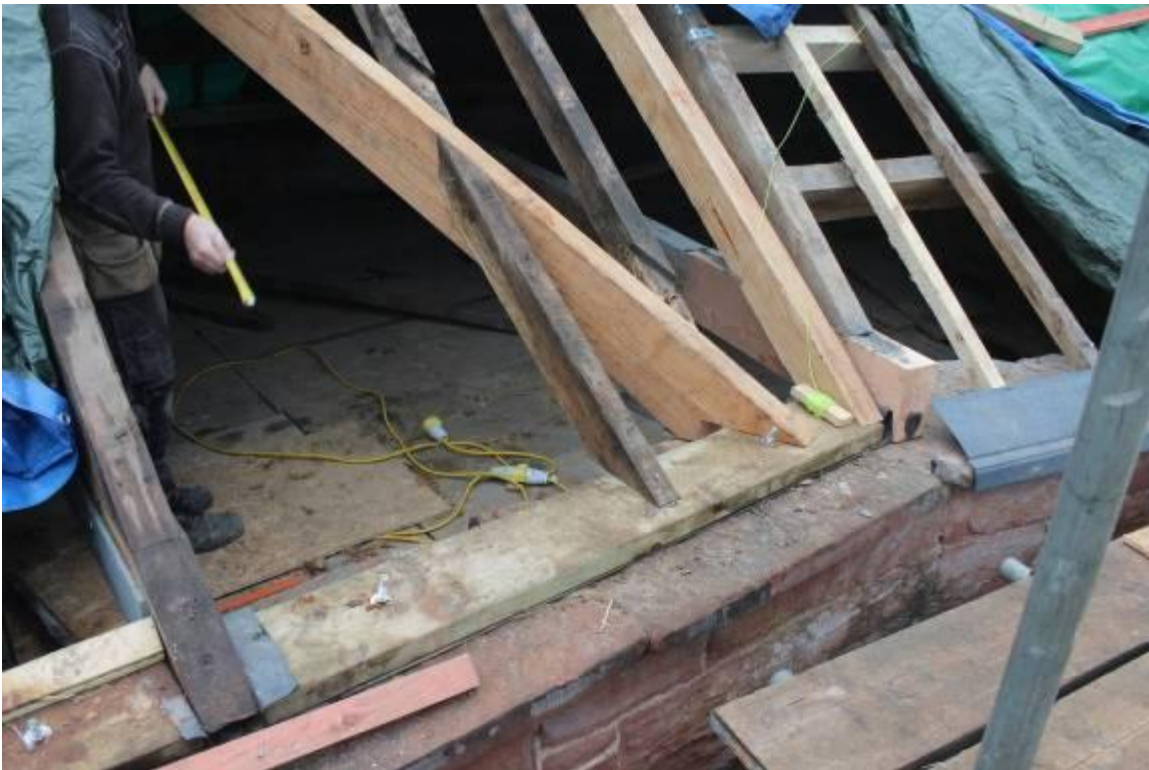
Repairs well underway to the complex joinery on the west side of the roof where the barn range changes alignment. A failed valley had allowed rot to develop in this area. A section of new timber, reinforced with steel and resin, has allowed most of the second truss to be retained.

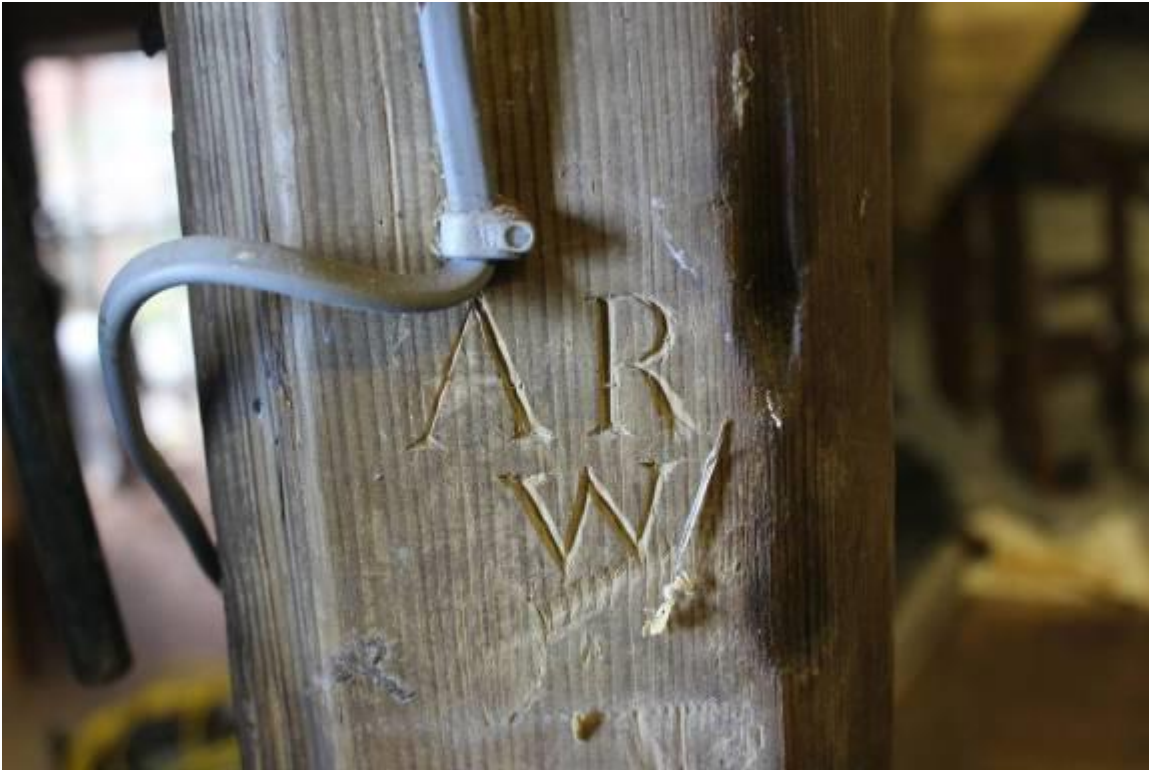
Initials carved in the eastern upright supporting the bowstring truss on the Stone Floor

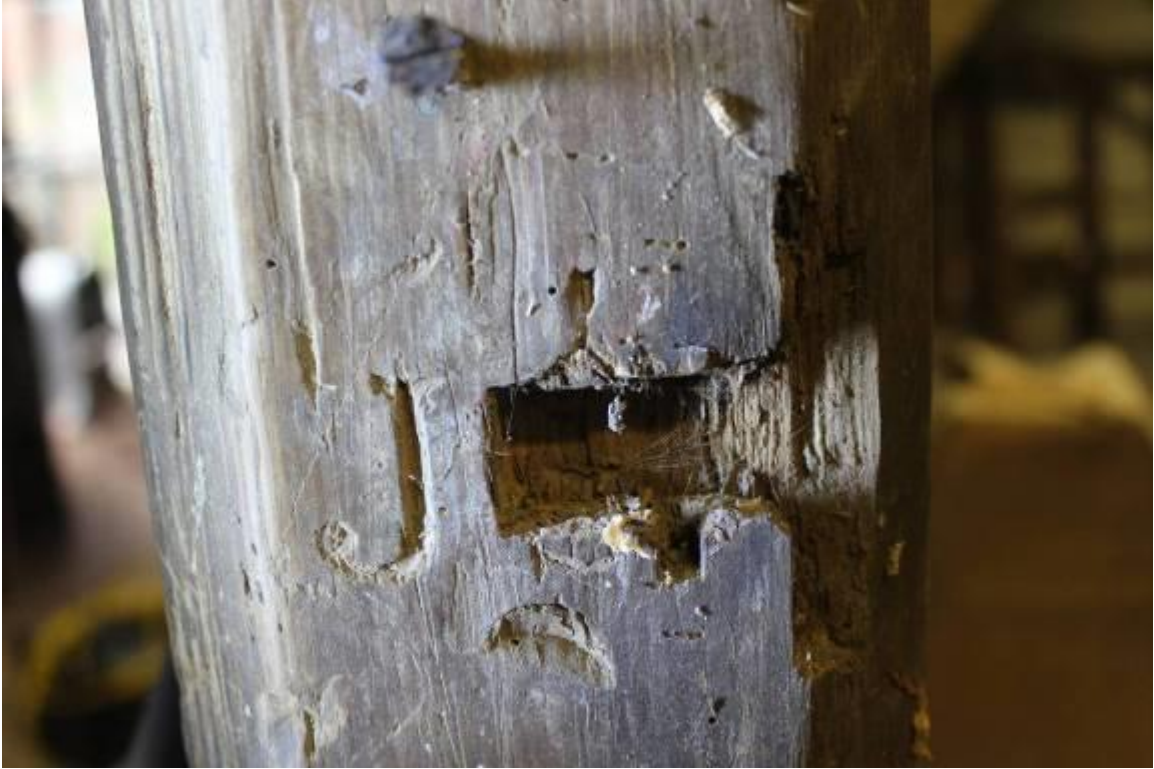
An earlier J, the rest of the initials perhaps removed by a later mortice, below on the same timber

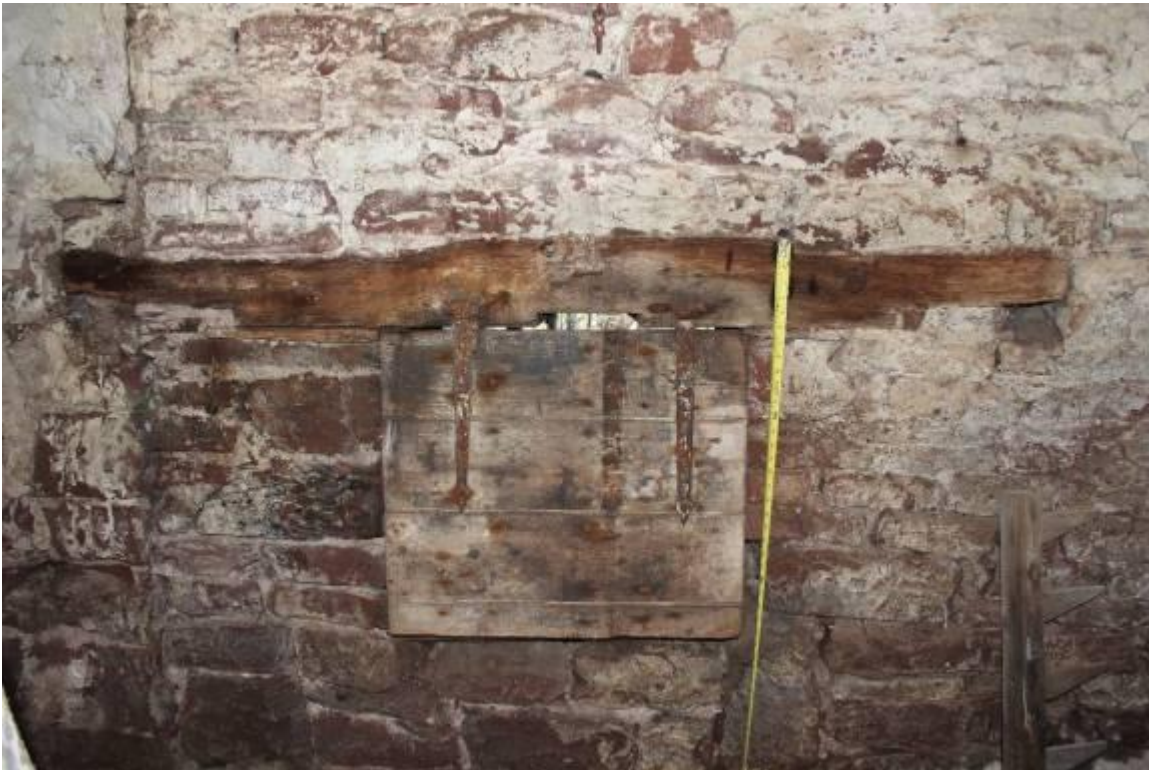
The basement of the extension (Chaff store/Dust Room) has suffered badly from damp penetration at the NW corner and the timber beam spanning the opening in the North wall has become soft and will require replacement. It appears to be another re-used timber, presumably from earlier buildings on the site. The hatch may have been used to shovel chaff out to the yard on the north side of the mill extension where outbuildings, apparently pig sties, are shown on the First Edition of the Ordnance Survey plan.

The shaped timber, with evidence of previous jointing, has been re-used to form the inner lintel of the hatch opening in the north wall of the chaff store

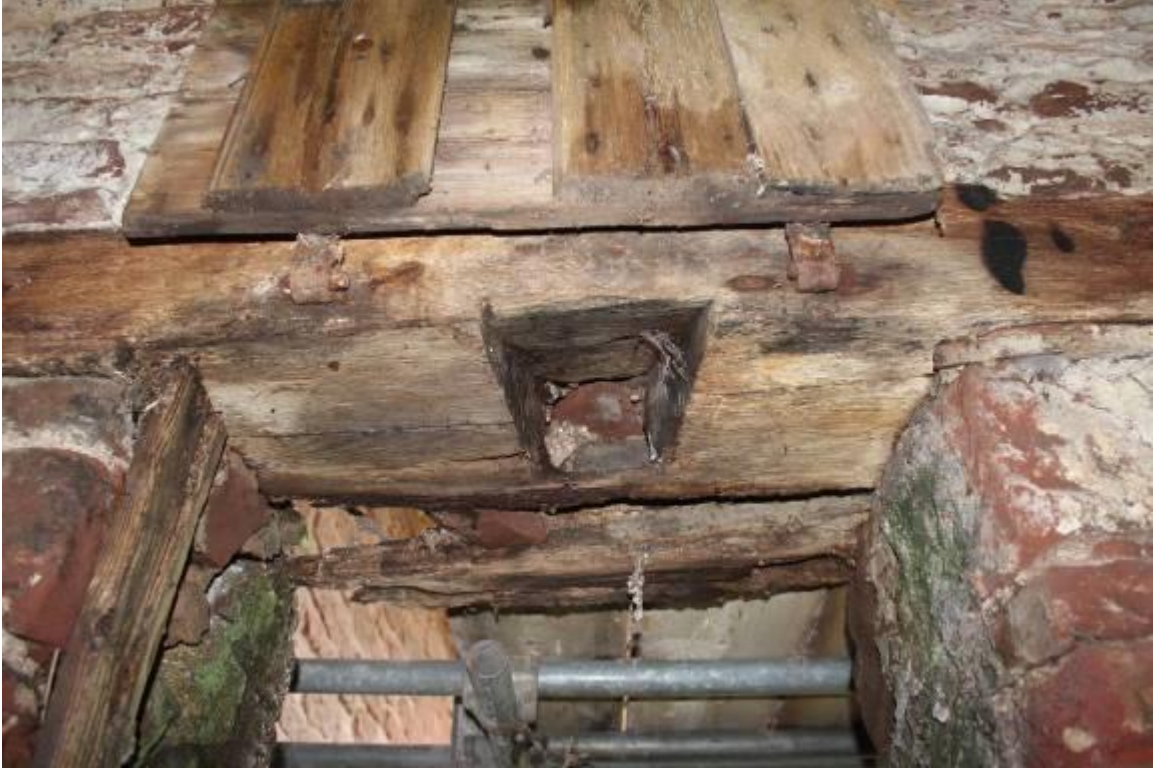
Angled mortice in the centre of the re-used timber. The outer timber lintel is almost rotted away

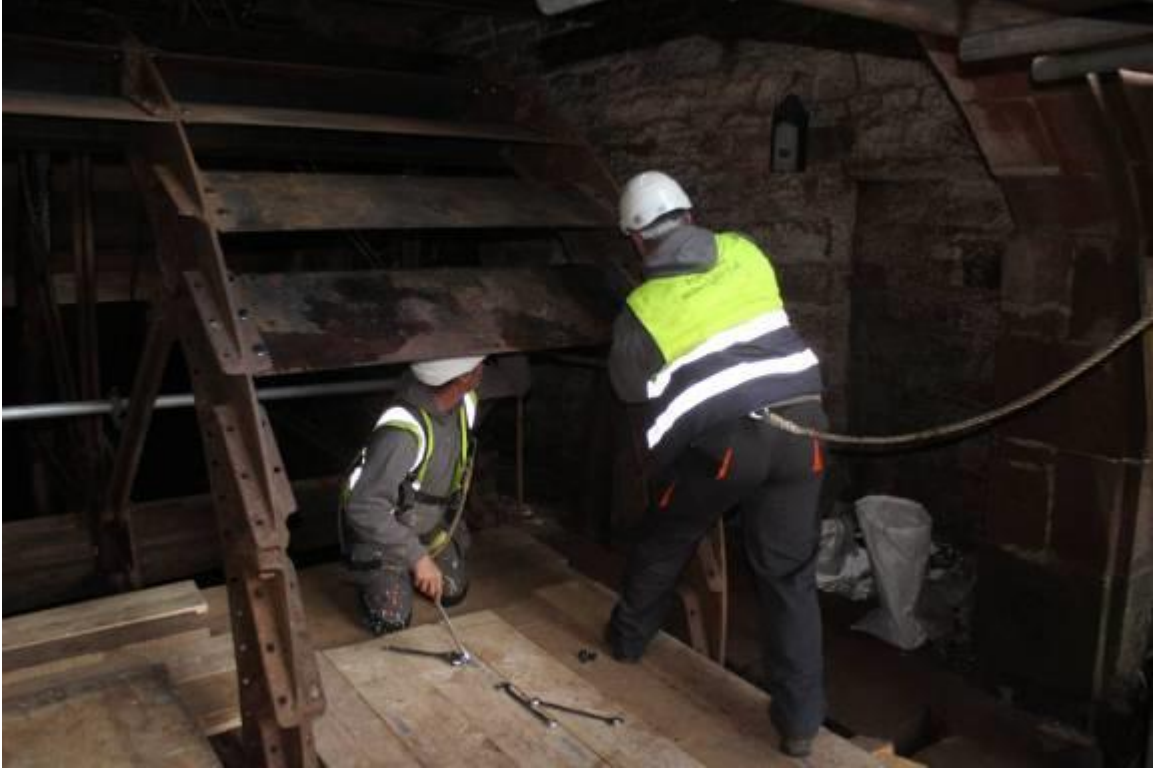
The millwrights installing new buckets on the south side of the wheel
