Warwick Bridge Corn Mill progress August 2019

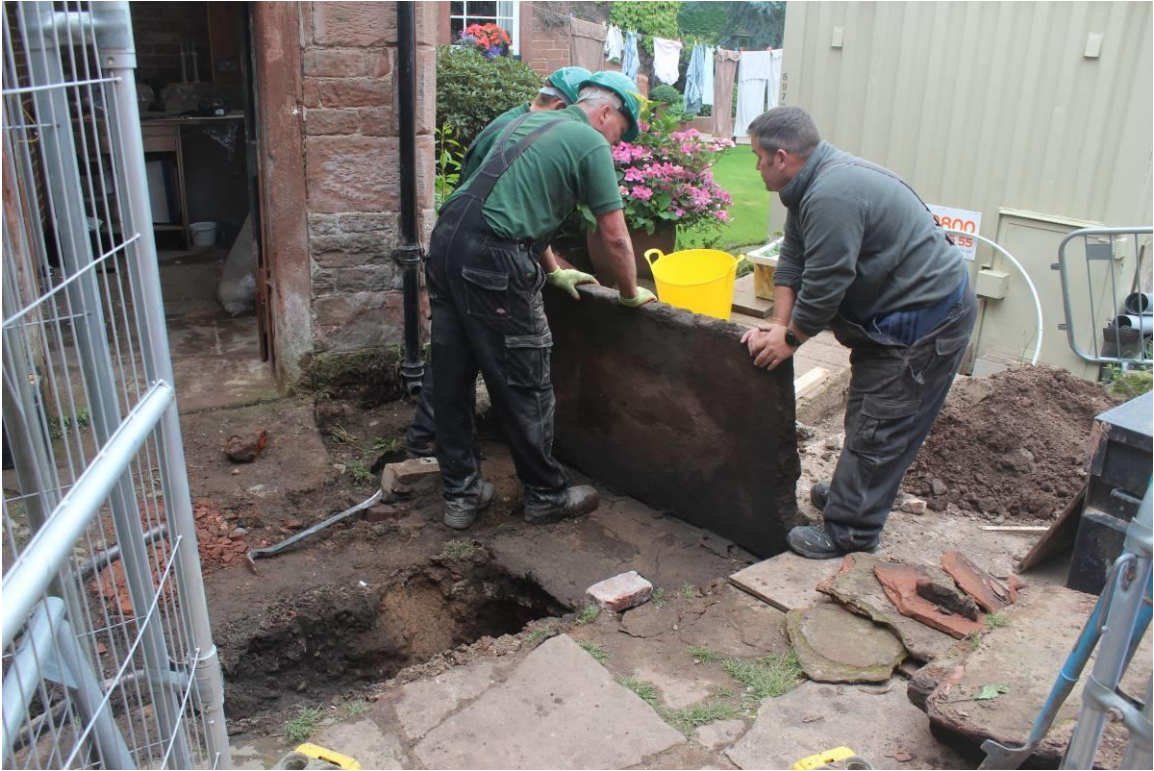
Lifting a large sandstone slab on the line of the drain

Meanwhile, the current work on the mill drew to a close with much completion of the interiors and the digging of a final short rainwater drainage trench in the downstream loading dock. This replaced part of the original run of six inch diameter land drainage pipes from the yard gully and linked in a rainwater down pipe at the corner of the outbuildings to the west of the barn.

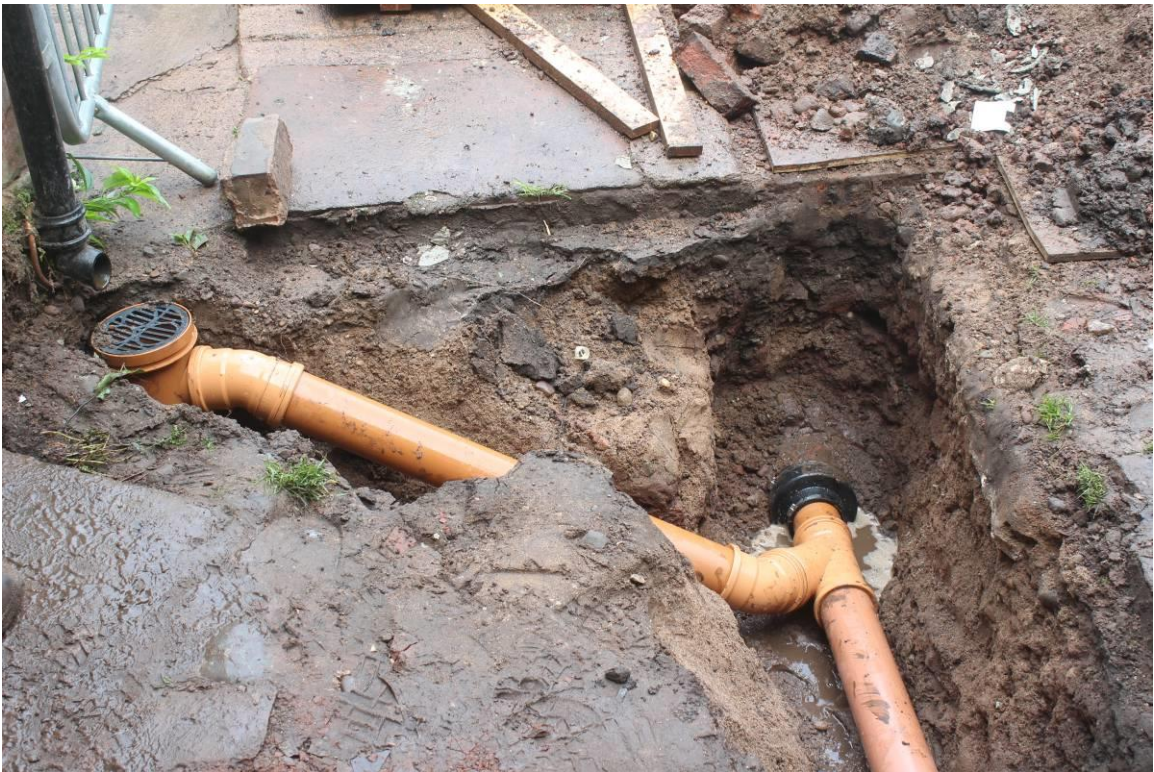
New drainage in place

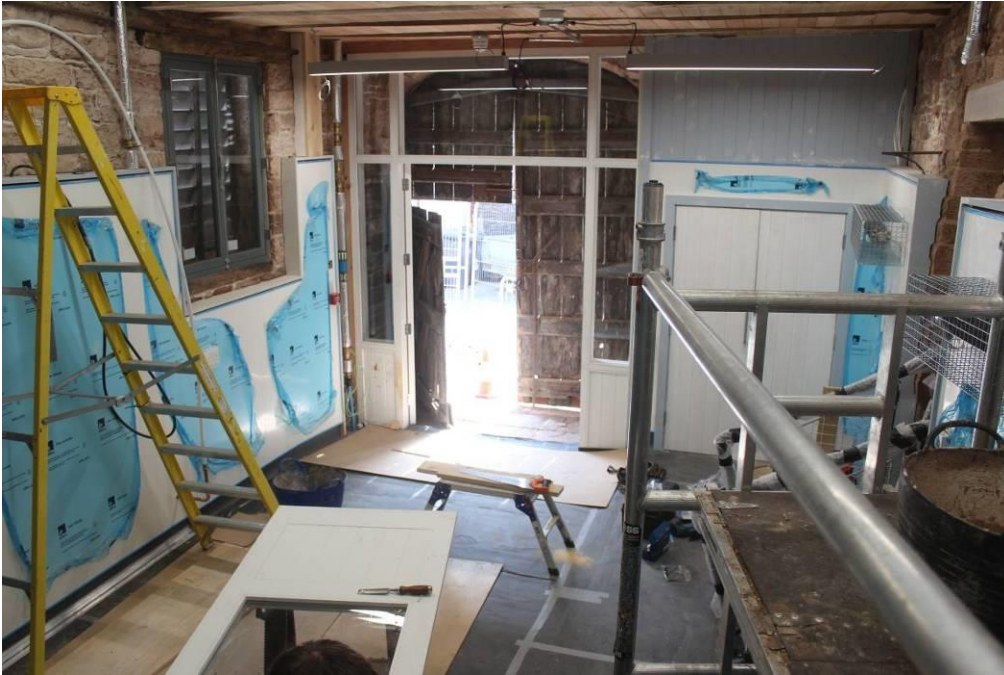
Inside the barn secondary glazing and the screen inside the large cart doors was completed.

Looking south inside the barn

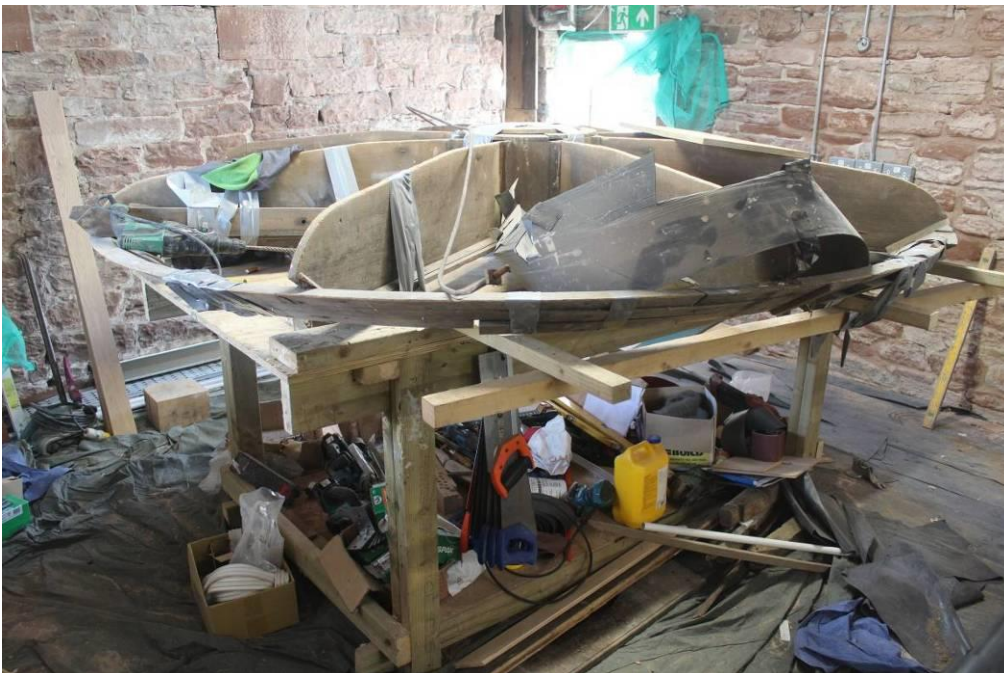
The wooden casting template for the Pit Gear, which has survived in the barn roof since the mid-Victorian upgrade of the mill's machinery, finally made it down to the floor in one piece!

The large template awaiting attention on the joiners' bench

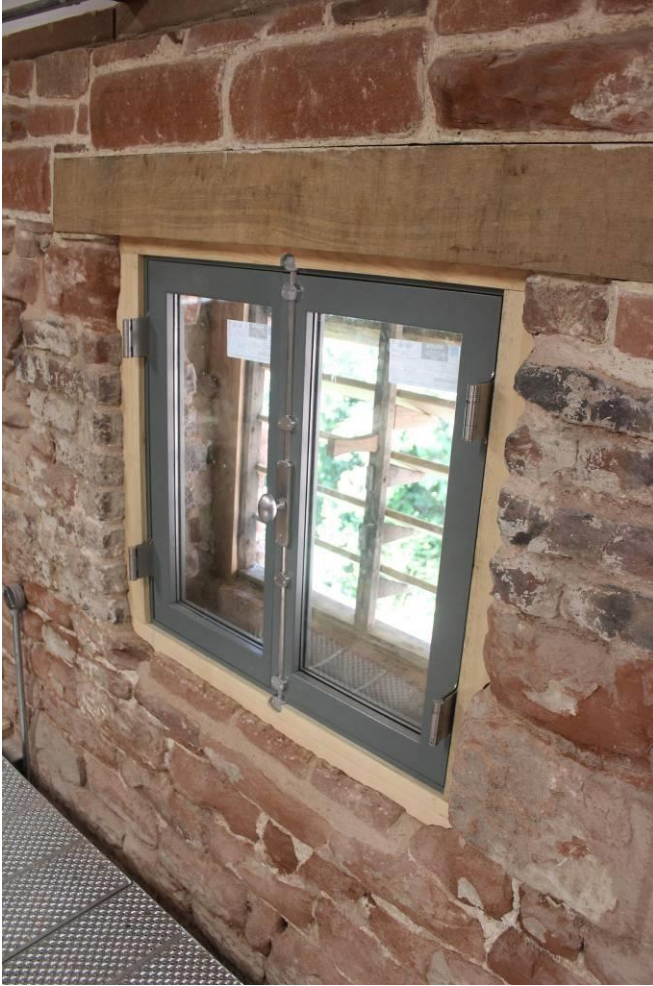
Secondary glazing inside the refurbished shutters in the kiln building

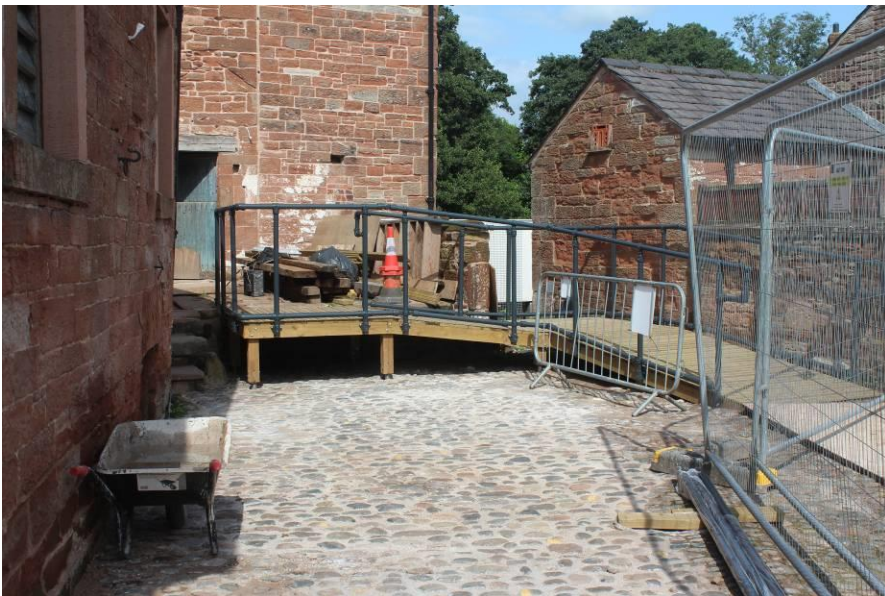
The new access ramp completed in the east yard
