Warwick Bridge Corn Mill Progress Report January 2019

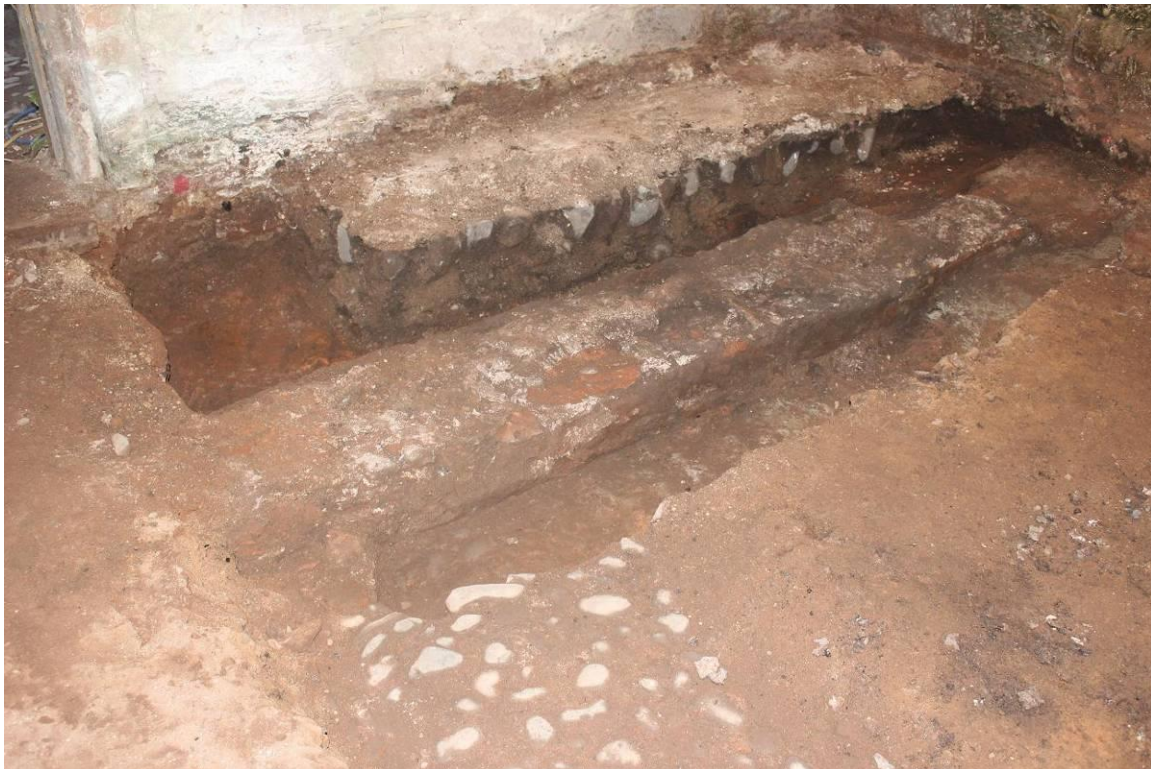
The month has seen further excavation for foundations and a drain run within the ground floor store [R0.08]. The work has revealed a wall foundation of well mortared squared rubble sandstone and successive cobbled surfaces which pre-date the present building with its heavy flagstone floor.

The earlier wall is founded on bedrock at its eastern end but overlies a thin layer of small cobbles at the western end of the trench. This appears to be contemporary with several small rock cut drains, which may have been intended to intercept groundwater seeping through weaknesses in the bedrock. All the drain runs had silted up. The two eastern sections retained evidence of thin stone cover slabs with the drain leading away from their junction towards the tail race covered by hand made bricks laid flat.

General view of features revealed by foundation trenches (looking NE. entrance door to L.). Old wall foundation on line of shorter partition trench. Large (yard?) cobbles at higher level seen in retained section behind. Cobble floor revealed in longer partition trench in foreground

The wall foundation happened to coincide with the foundation required for one of the new partitions and the structural engineer has confirmed that it can be re-used to support the partition, which means that most of the feature can be retained in situ. The cobbled surfaces have been removed only for the width required for the new partition foundations and the drain run, again retaining the greater extent of the archaeology undisturbed.

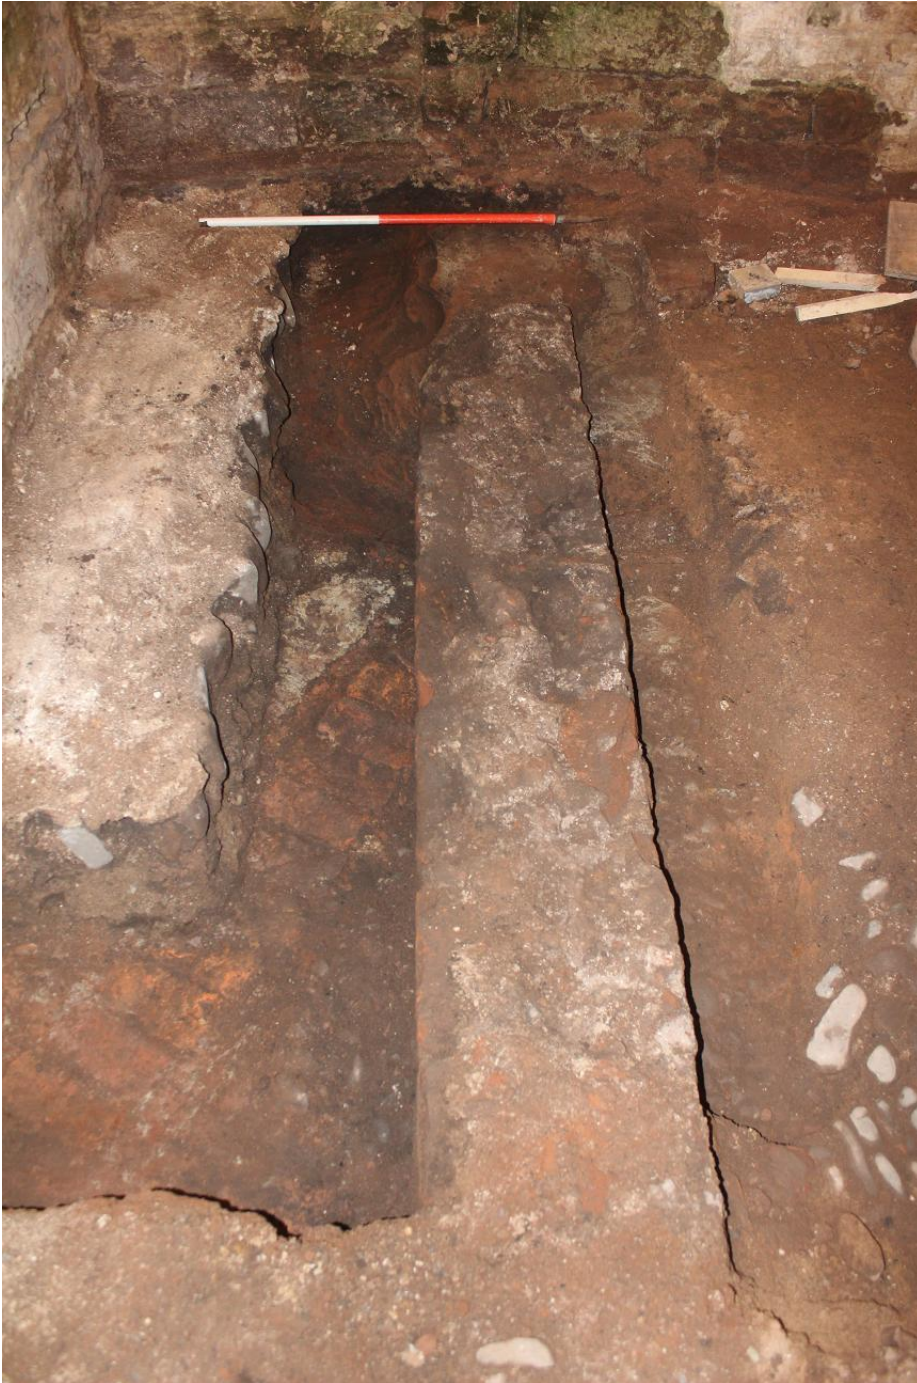
Looking along old wall foundation towards east wall of room. Brick drain covers running under wall to L. and cobbled surfaces to R. running into bedrock towards east wall

The wall foundation shows no sign of bonding with the west wall of the barn and presumably relates to an earlier building range on the site. The wall continued beyond the trench towards the west wall of the current room. On the south side of the old wall foundation, above the layer of small pebbles (and a surface, continuing at the same level, of

broken stone fragments) set in clay, was a layer of fist sized cobbles, set in clean sand. These were in marked contrast to a layer of larger cobbles set in a darker sandy fill on the north side of the wall, suggesting a floor within a building to the south and a yard surface to the north of the wall. The only dating evidence recovered from the bedding layer was two small fragments of glazed pottery suggesting a relatively recent (C18/C19) date for the cobble floor.

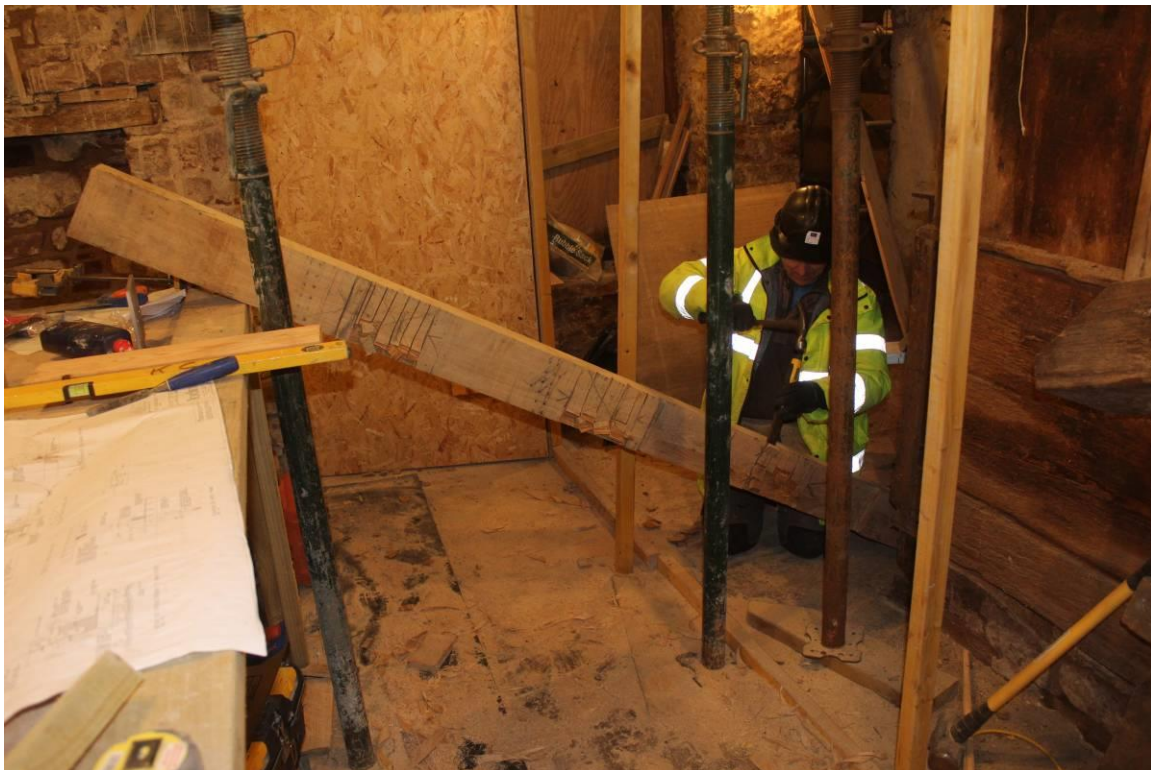
Replacement and reinforcement of structural timbers within the mill has continued, including reinforcement of the hurst timbers which support the millstones on the floor above.

Cutting rebates in a new structural timber to fit around existing elements of the hurst (right). The new timber will provide additional support to the vertical timber at the NE corner of the hurst. Acrow props in the middleground are providing temporary support to the weakened floor beam above

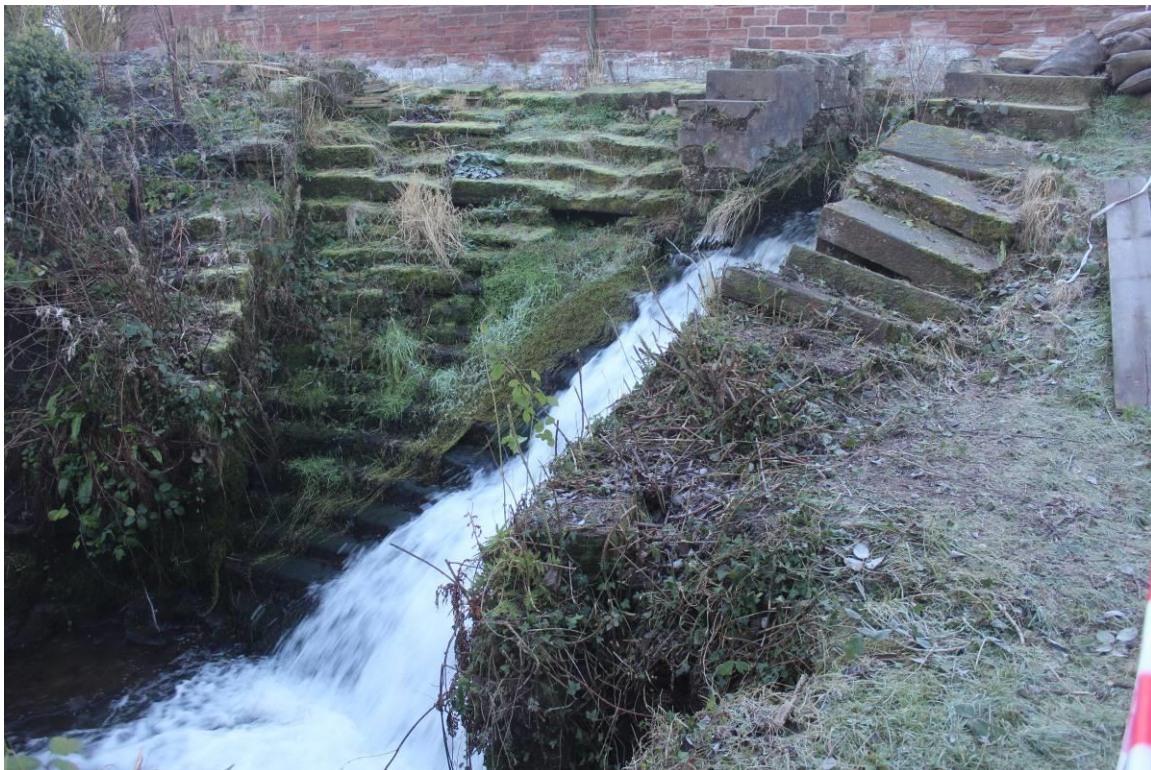
Outside the buildings clearance of vegetation on the west side of the escape race has revealed a substantial masonry retaining wall below the subsiding overlapping slabs which form a coping alongside the escape race. The improved visibility of the surviving structures will enable more detailed planning of the Phase 2 works required here.

Ivy covered masonry wall alongside the escape race with settled coping stones above

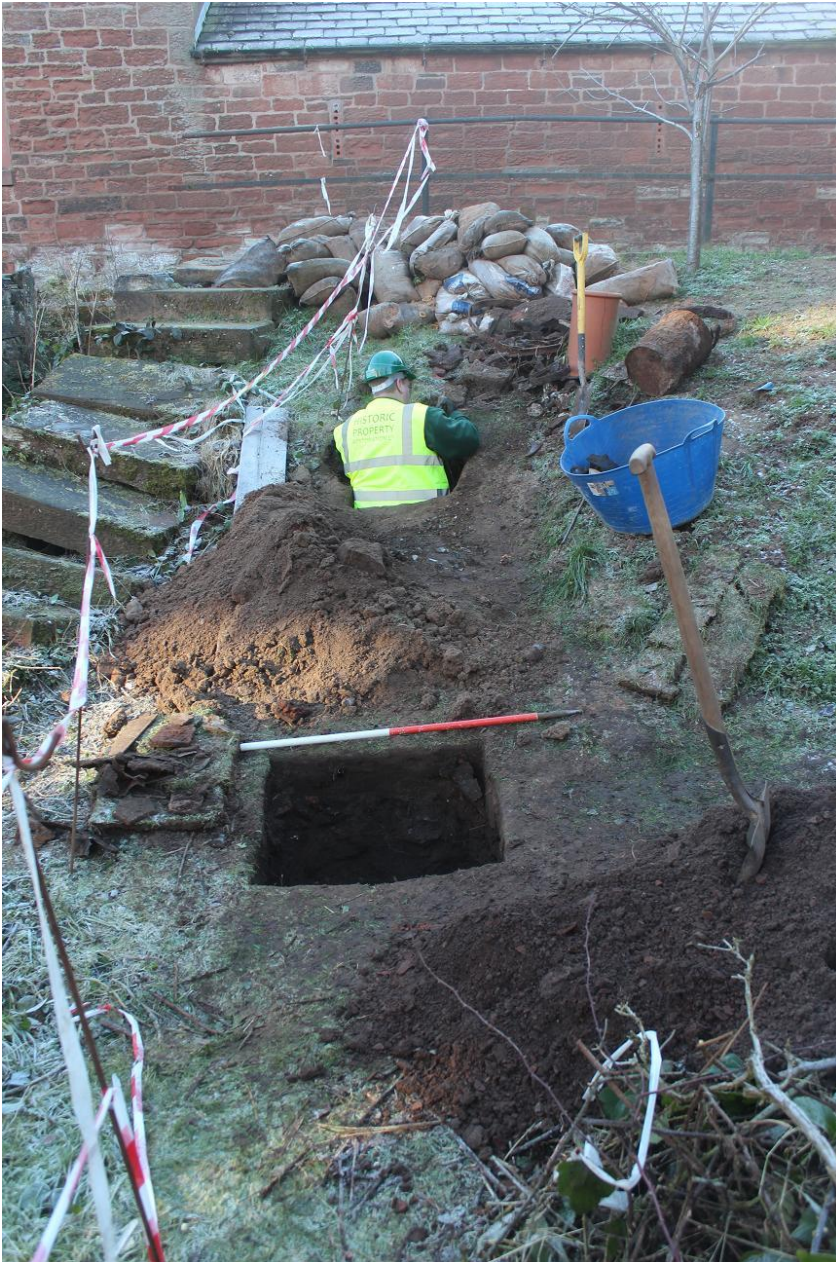
Two test pits were dug on the slope beside the escape race at the end of the month to establish the depth of the rock head. These revealed

an extensive layer of relatively recent dump deposits, consisting of metalwork, several shoes, pottery and a large quantity of glass bottles and jars – an interesting bit of social history, including several Carlisle State Management Brewery bottles, which had presumably made their way down the mill race from The George or across the yard from The Spinner's Arms if that was still going! An interesting reminder of Lloyd George's social improvement policy which sought to regulate the trade during the First World War.

Excavating test pits on the bank beside the escape race
