## Warwick Bridge Mill Progress June 2019

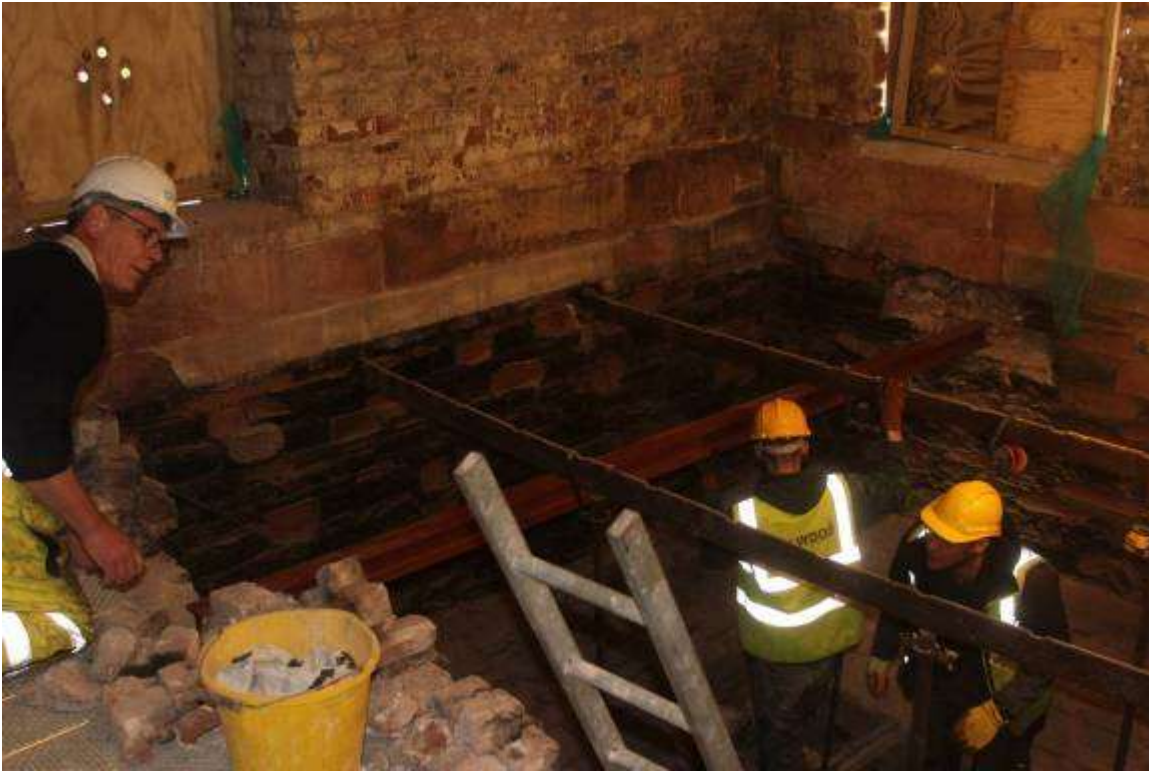
The cleaned, conserved and repaired kiln bars returned to site with the engineers and new support steelwork was installed across the kiln below the existing supporting ironwork. Pockets were cut in the stonework to accommodate the new steel beams.

**Installing the new support steelwork below the original wrought iron beams**  
With the new support in place the repaired wrought iron bars were re-installed in their original locations.

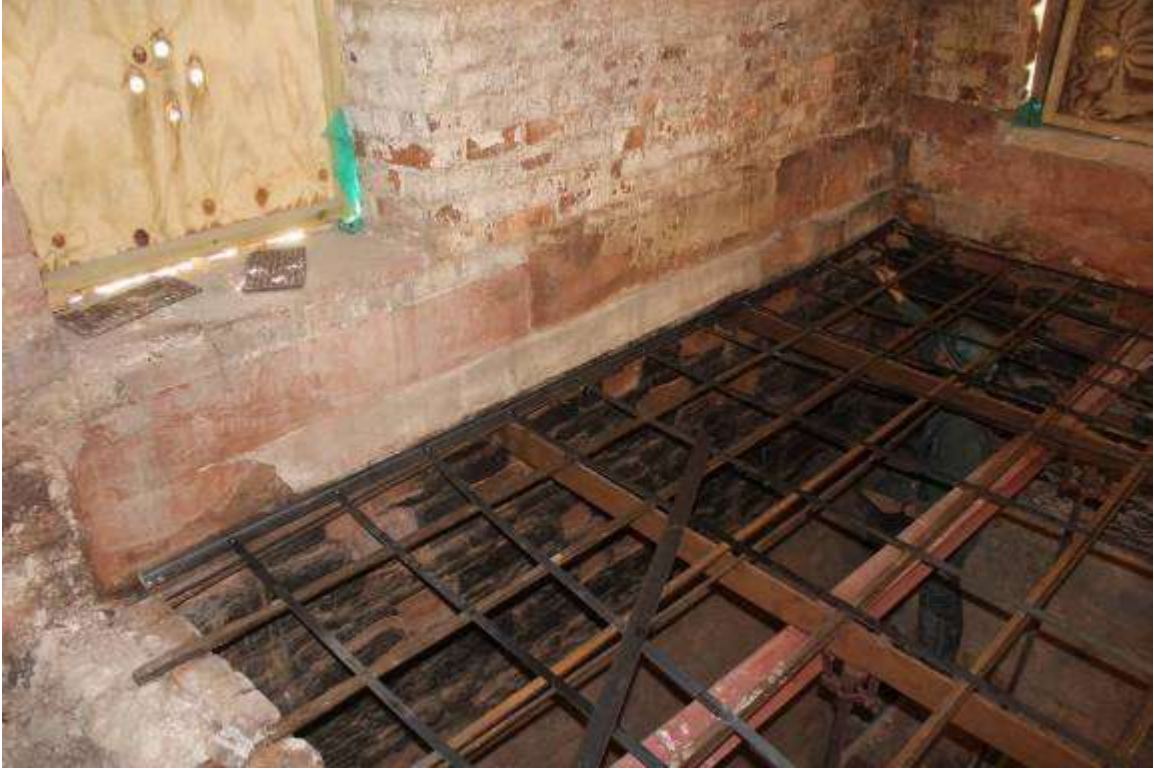
**Pointing in the reinstated wrought iron bars. New ribbon partly re-instated**

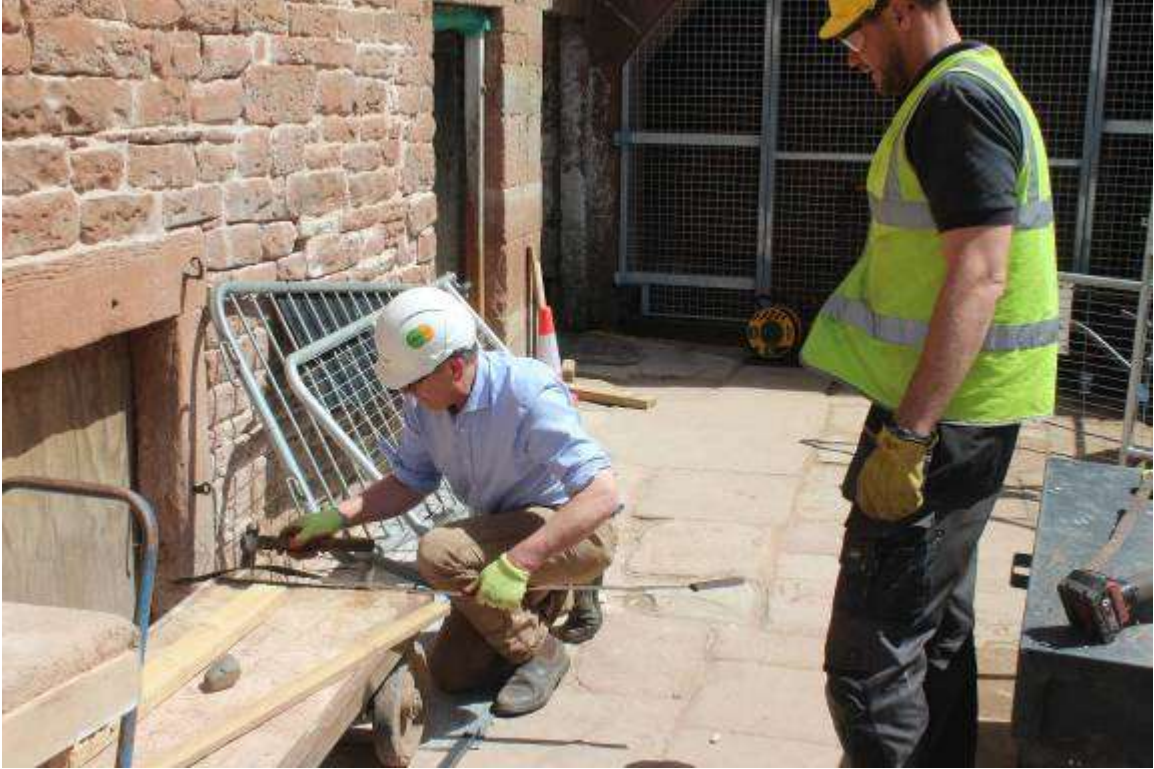
Better sections of the badly corroded wrought iron ribbon, which formed the top layer of support for the kiln tiles, were salvaged for re-instatement in the area of the kiln deck which will be shown to visitors.

**Matthew straightening a section of ribbon for re-use**

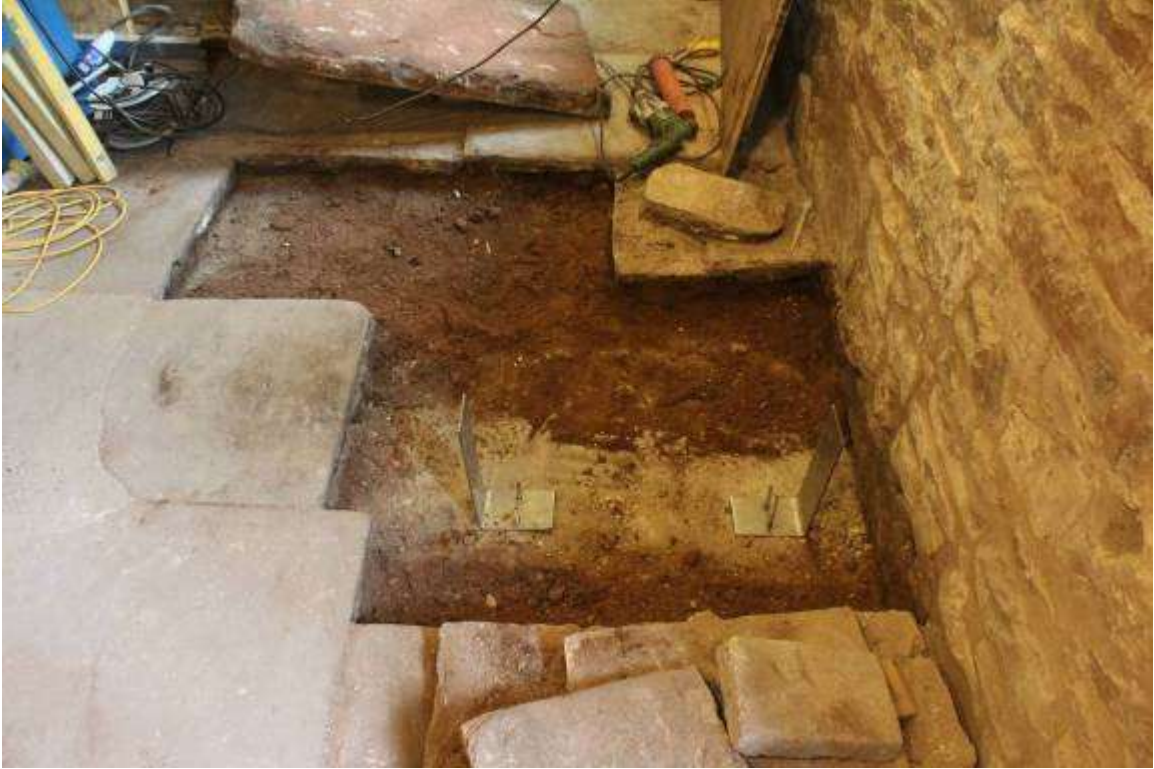
A small area of Hurst Floor paving was lifted and re-bedded to provide a level landing at the foot of the newly installed staircase leading to the Stone Floor.

**Repair underway to the Hurst Floor paving and new fixings for the staircase**

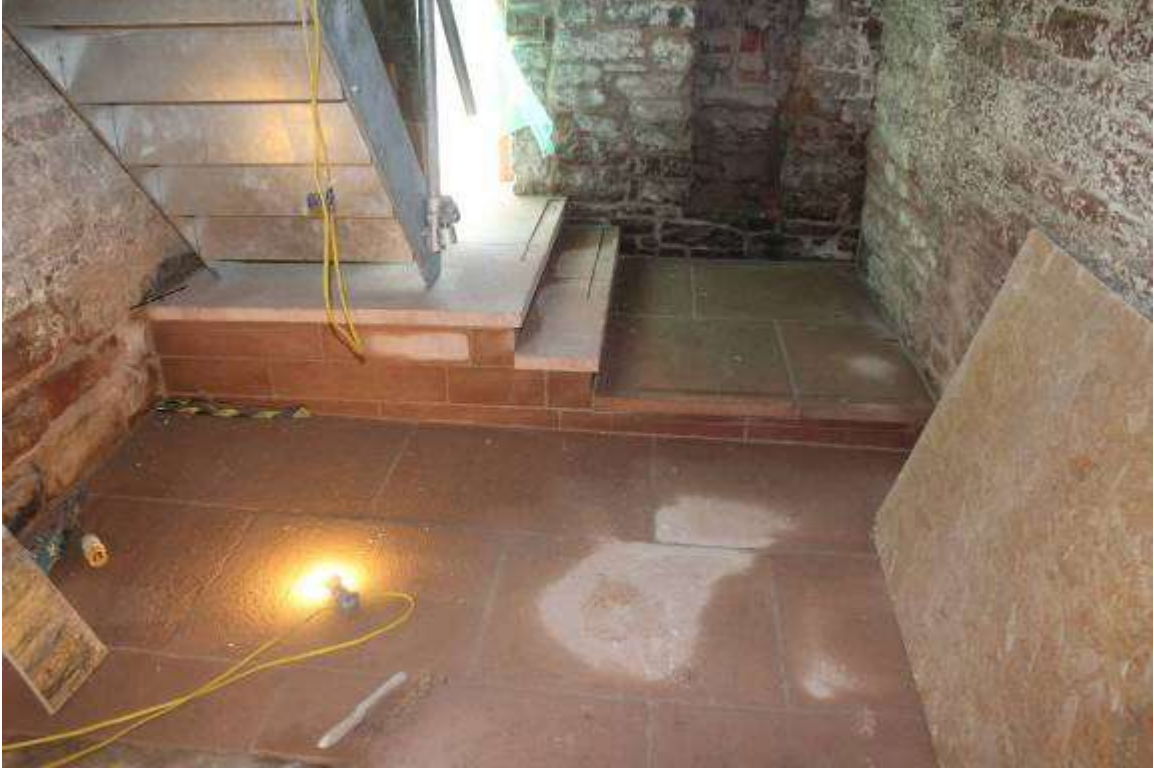
A new landing, steps and floor have been installed in the space to the east of the kiln, which will give Karen a useful workshop space in the future.

**New landing, steps and floor to the east of the kiln**

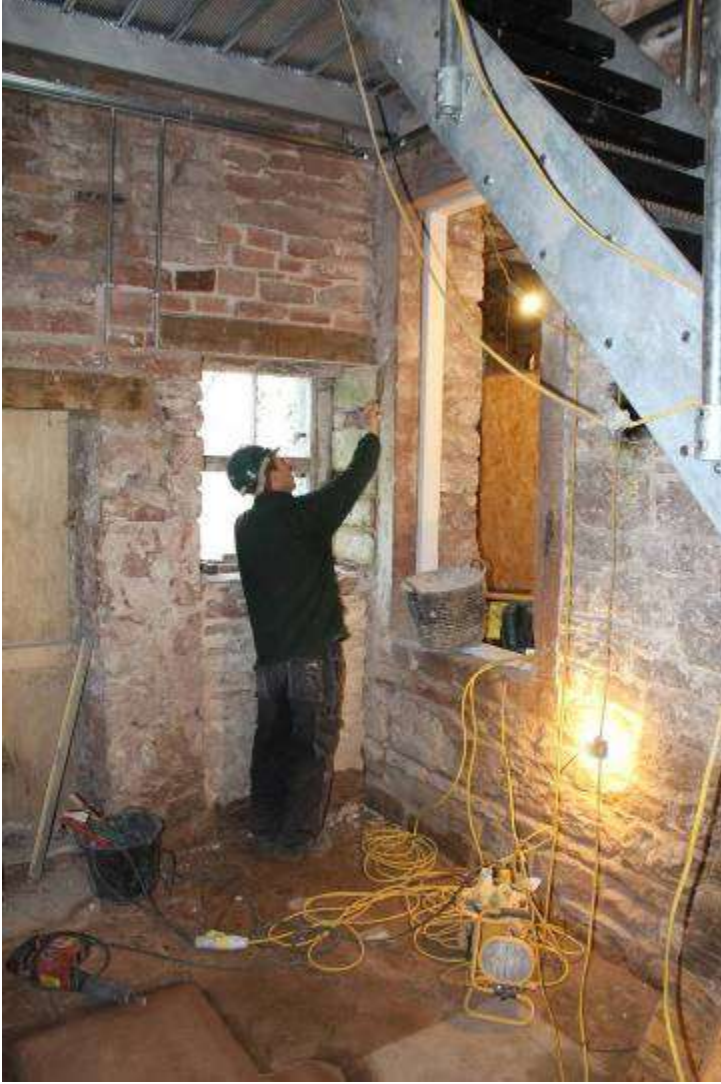
As new or refurbished joinery has been installed around the building final pointing repairs to adjacent stonework have been completed.

**Pointing around window opening in the kiln**

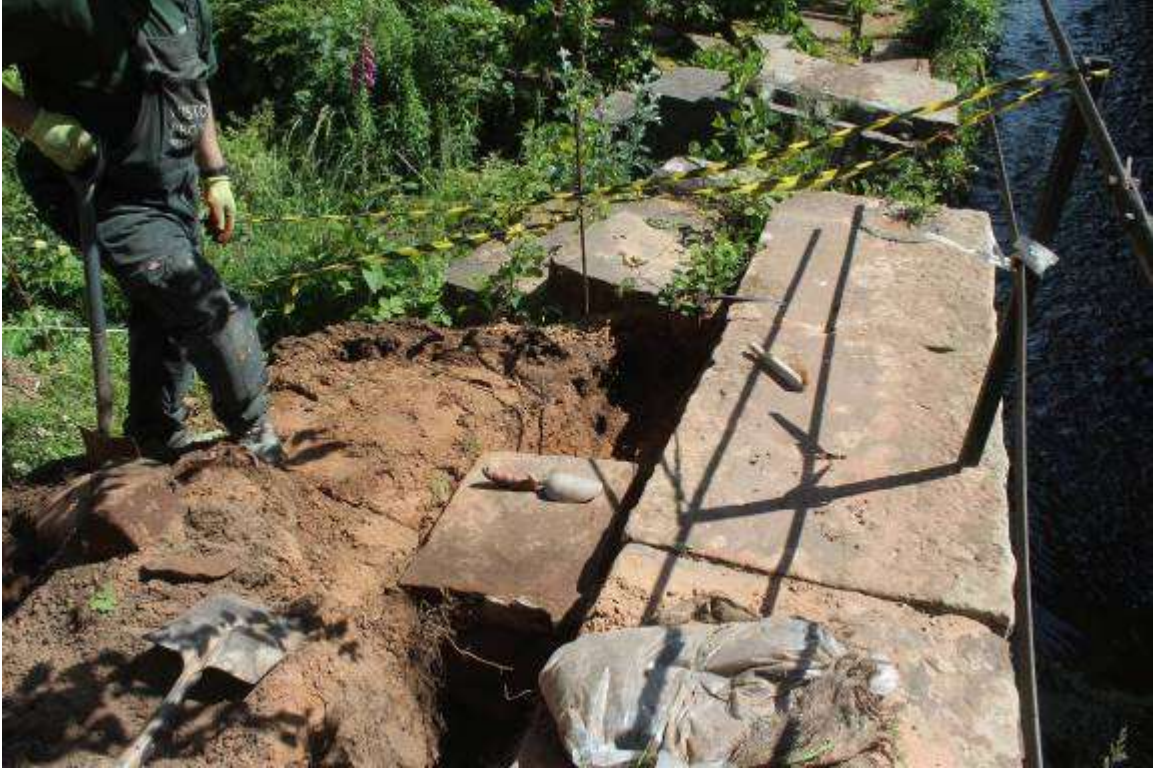
A trench was excavated from the eastern extension to the mill alongside the head race for cabling to provide power and data to the new sluice gate mechanism.

**Cable trench approaching the escape sluice position**
