Warwick Bridge corn mill progress update

Interim update to end October 2018

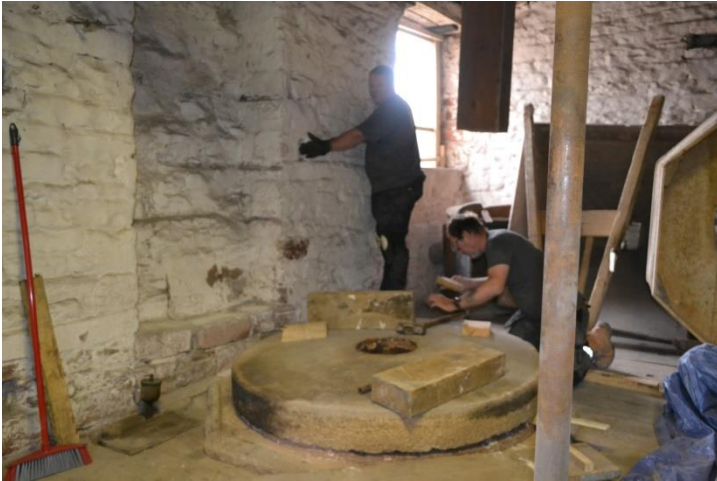
Figure 1 lifting the runner stone with levers and wedges to clean the oat stones

The millwrights have been working hard at the mill, dressing and balancing the two sets of stones that we plan to use and cleaning the other three sets. During this process we discovered that the oat shelling and milling stones at the back of the frame were in fact mismatched pairs, the runner stones being millstone grit (as we expected) and the bed stones, that are a couple of inches smaller in diameter, made from sandstone. The eastern set of French burr stones also revealed an interesting feature. When they were lifted for cleaning and dressing, they had been refaced with Carborundum. This was both a cost effective fix for worn down stones, and a popular surface for milling animal feeds in the early 20th century. The Carborundum stones will grind the bran almost as fine as the white flour, making a finer wholemeal product than the western set of stones. The natural French burr will leave the bran in large flakes for easy sorting and producing white flour.

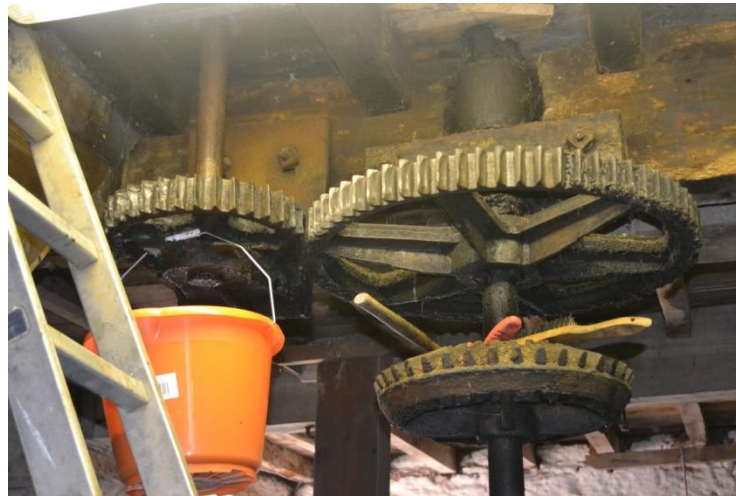
Figure 2 Gears during cleaning

The millwrights have degreased, cleaned and serviced all of the gears and shafts that enable power to be transferred from the waterwheel to the various millstones and associated machinery. They have removed an enormous build up of grease, oil and meal dust that had accumulated since the initial commissioning of the machinery and applied clean oil to the bearings for smooth operation. The waterwheel and its axle have been cleaned, and silt and other debris has been dug out of the wheel pit. They have also serviced the tenter-screws (the devices which raise and lower the runner stone to control the grade of flour produced). Other machinery they have worked on includes a bagging hopper on the ground floor and a fixed winnower and a portable winnower that had been adapted from hand crank to a belt drive sometime in the recent past. They have also been repairing a flour bin and grading machine and measured for a new heavier duty sack hoist chain, and stripped and cleaned the oat roller/crusher on the ground floor.

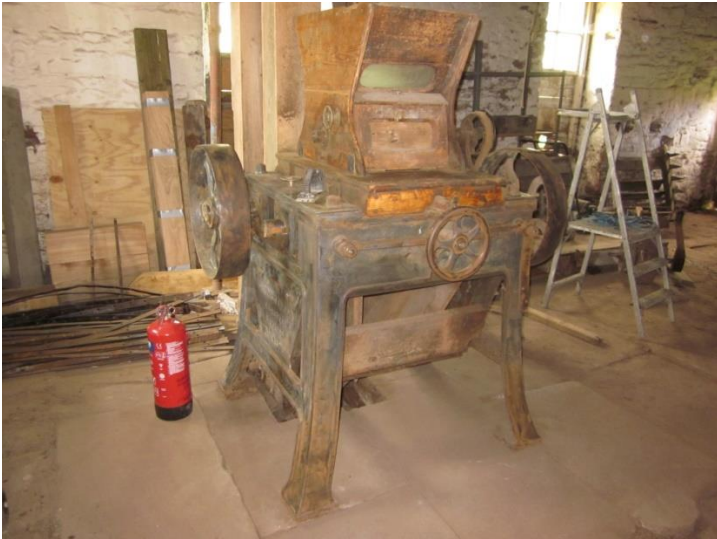
Figure 3 freshly cleaned oat roller on the bottom floor of the mill

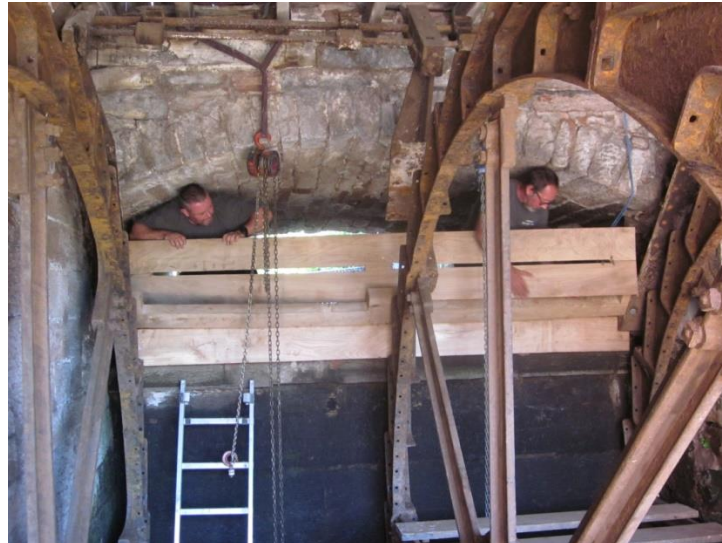
Figure 4 Fitting the Control gate in position to direct the water into the wheel buckets

On the water control front they have replaced the rotten woodwork at the head of the waterwheel, cleaned and repainted the trash grid that stops unwanted items from entering the wheel, and constructed a new elm control gate to regulate the flow of water into the buckets on the wheel. The buckets have been delivered, and had their holes adjusted to fit the rim, and are waiting, along with the new sole plates, to be fitted to the wheel once other works in and around the wheel pit have been completed. The millwrights have also continued working on the waterwheel and its related control gates. Machinery that could not be removed from the building has been covered to protect it during the repair work, and more fragile machinery has been removed off site for safe storage.

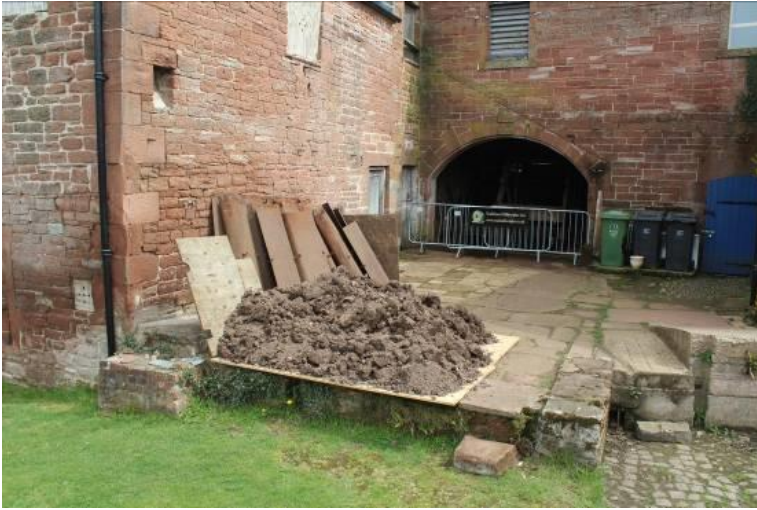
Figure 5 Fine silt removed from the headrace and the remaining buckets removed from the wheel [Photo Harry Beamish, Archaeologist]

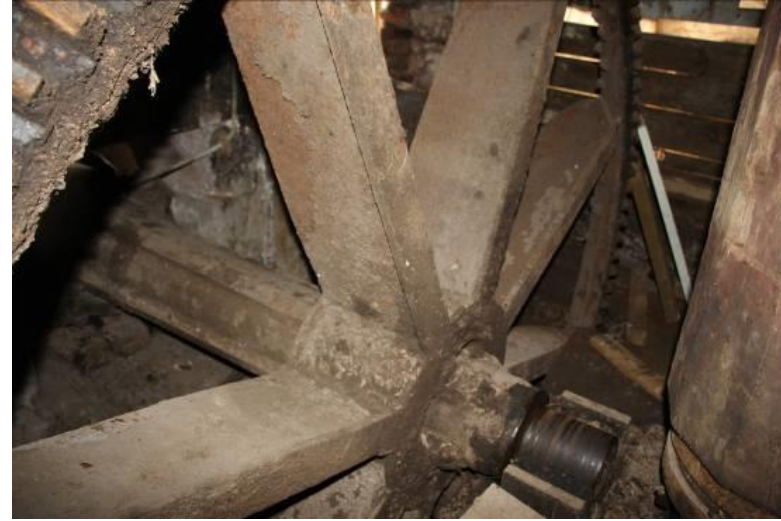
Figure 6 The inner bearing opened up for inspection The reinforcing ribs on the axle and the scale of the one piece cast iron Pit Wheel is very evident in this view [Photo: Jon McGuinness Traditional Millwrights]

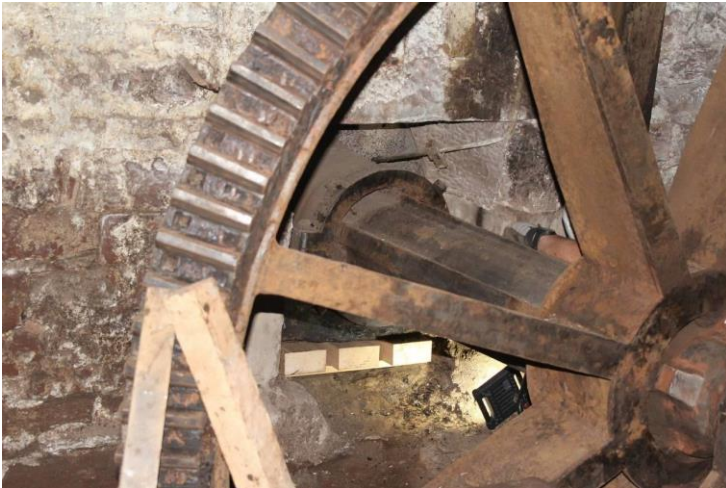
Figure 7 new packing blocks being inserted below the centre bearing of the waterwheel

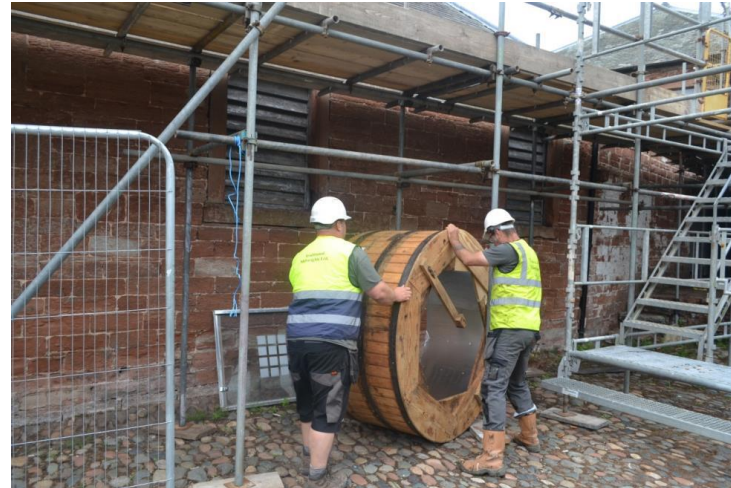
Figure 8 taking delivery of the new millstone casings

Back at the workshop they have made new sets of cevassing to fit around the bed stones of the two sets of millstones we will be using. They have cleaned, repaired and put new linings in the two sets of stone casings that will be used. They have refurbished the racks that will operate the control gate (but not

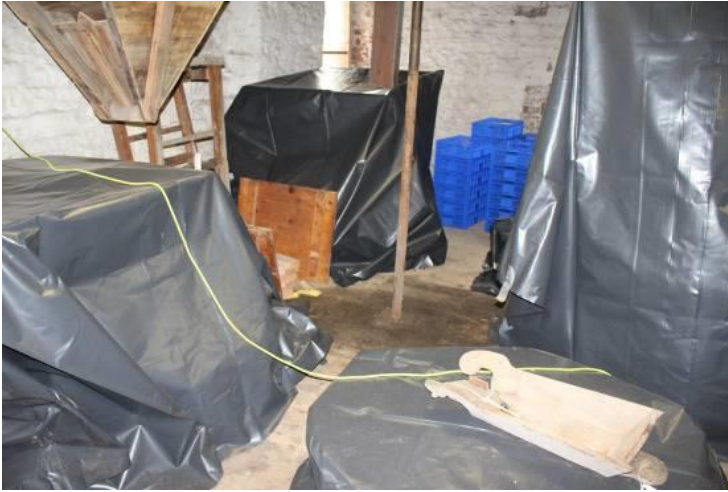
Figure 9 Protecting millstones in advance of building repairs

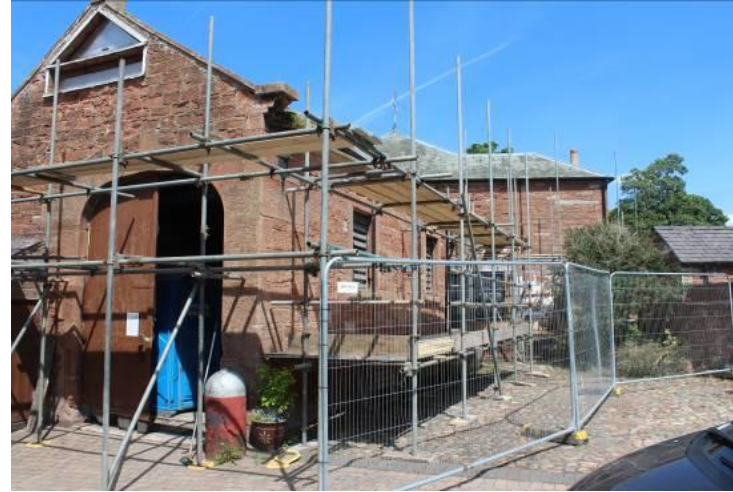
Figure 10 Scaffold erected around the barn to allow access to inspect the stonework

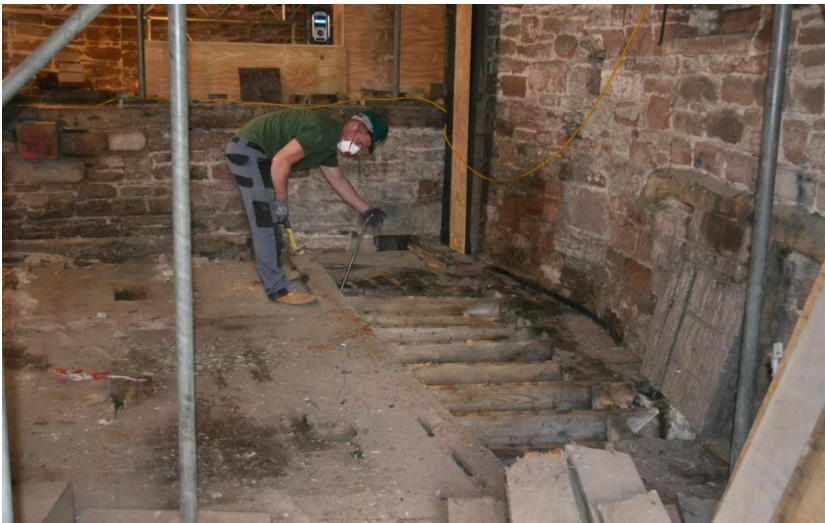
Figure 11 Checking the joist ends for damage and structural integrity

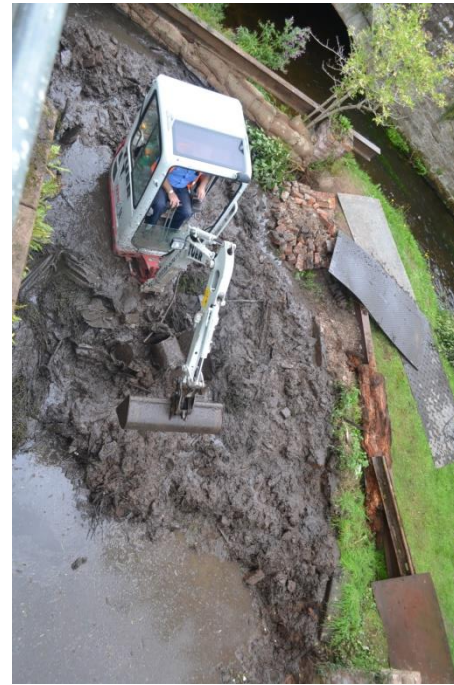
Figure 12 Clearing nearly 30 years of silt and debris from the tailrace

The main contractor, Historic Property Renovation Ltd, (HPR) started work on site during July and have concentrated their early efforts on works in and around the beck, the head and tail race, the culvert and the cascade as those were subject to a strict timetabled licence by the environment agency to protect the watercourse and potential fish stocks. These areas have been cleared of silt and vegetation build up, and damaged/missing stonework has been replaced and repointing undertaken. In conjunction with this work, they have erected scaffolding inside and outside the building, and have been inspecting timberwork for damage and evidence of any woodworm beetle invasion. Some live infestations were found and treatment by a licensed practitioner has been undertaken – including to some of the historic machinery – to ensure no further damage occurs. The external scaffolding has enabled inspection of the stonework and work has commenced on removing ivy, identifying stonework which is damaged beyond repair for replacement and re-pointing stonework in lime mortar. The barn roof has been inspected, slates removed, and tarpaulin secured in place to ensure the building remains watertight over winter and allowing work to continue to the interior. The weather has remained favourable for most of the summer period, although there was some slight flooding into the grounds during a weekend in mid October, the mill buildings were not affected.

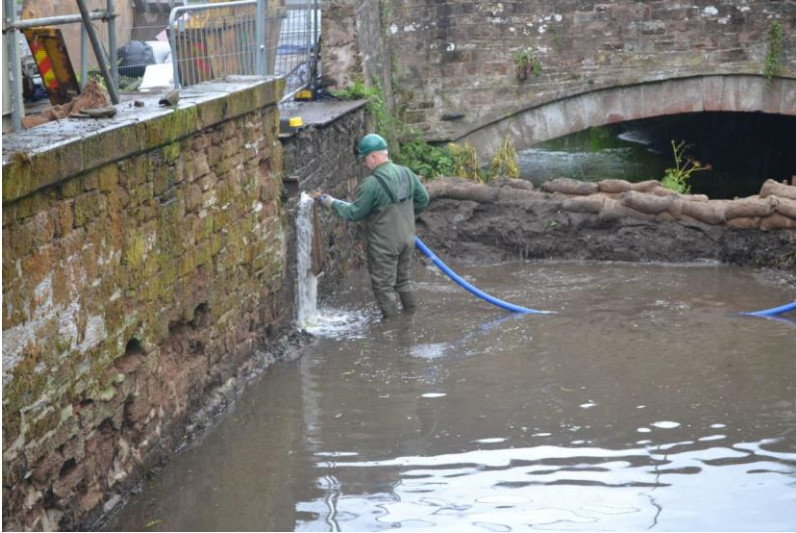
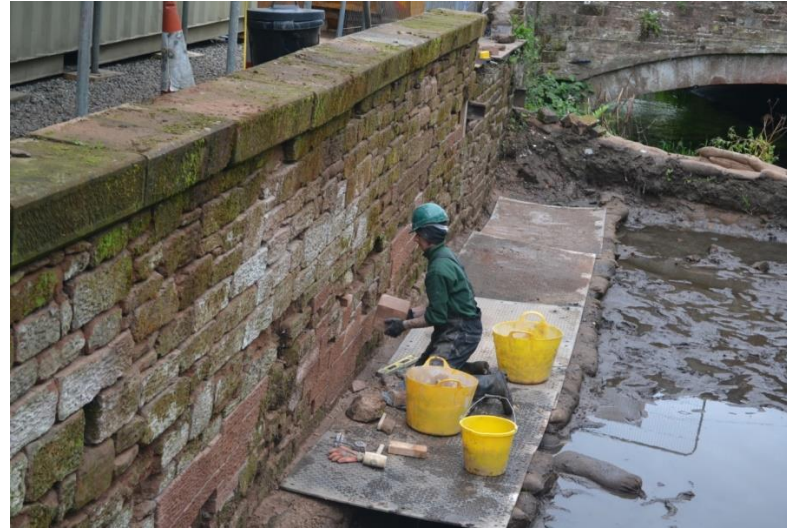
Figure 13 Tail race with sandbags in place, commencing cleaning of stonework to identify repair/repointing required and Fig 14, Mason fitting hand chiselled stones into place

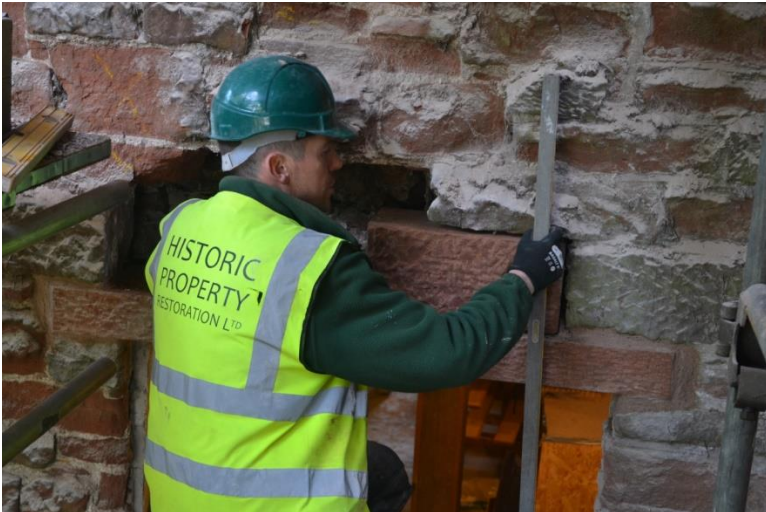
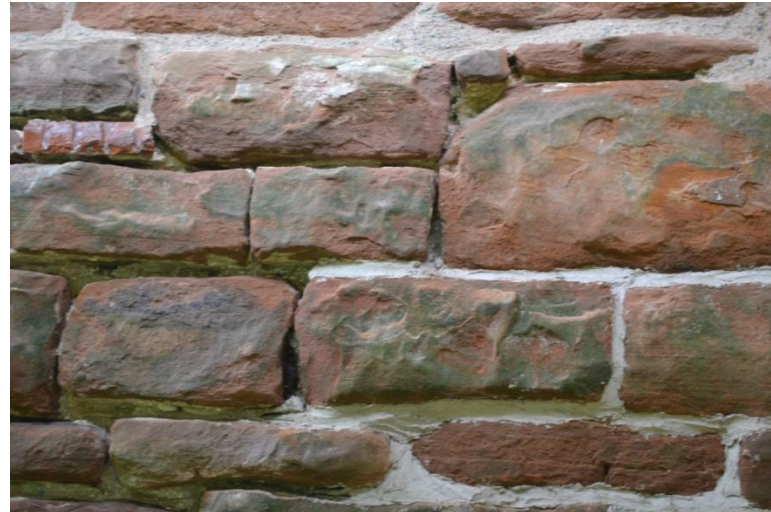
Figure 14 and 16 checking alignment of new stone inserted above a window opening and close up of new lime mortar pointing in north wall

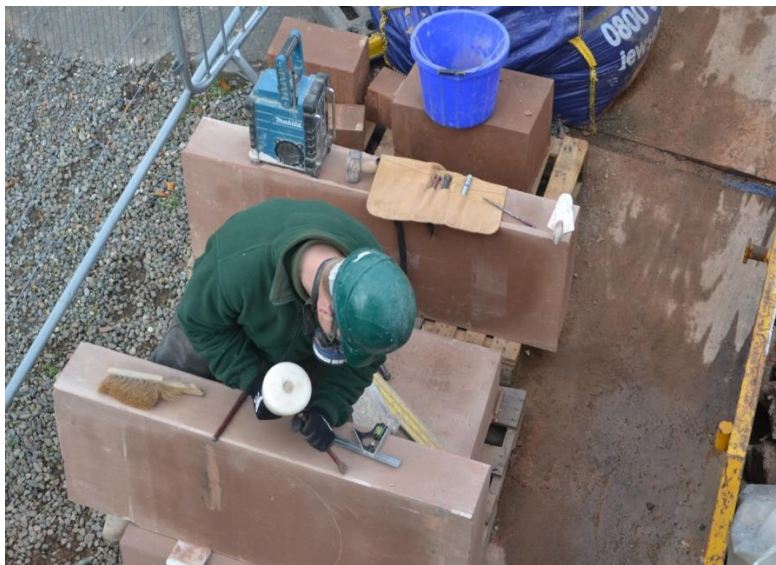
Figure 15 hand carving new coping stone for top of tailrace wall

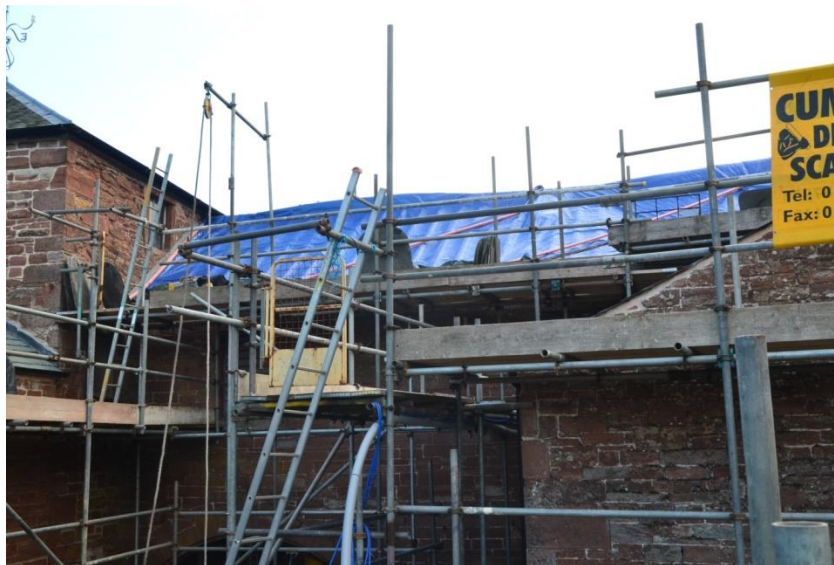
Figure 16 Slates removed from barn roof and tarpaulin in place

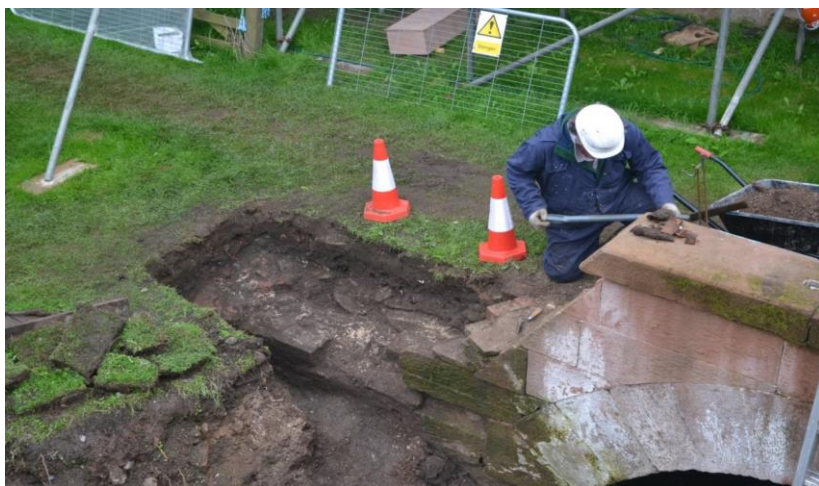
Figure 17 Archaeologist uncovering an extended wall previously hidden next to the culvert

The archaeologist has kept a watching brief on site during the work of the millwrights and the contractors, and has uncovered some evidence of earlier buildings on site, and has been taking plenty of photographs and keeping us up to date with progress on site.

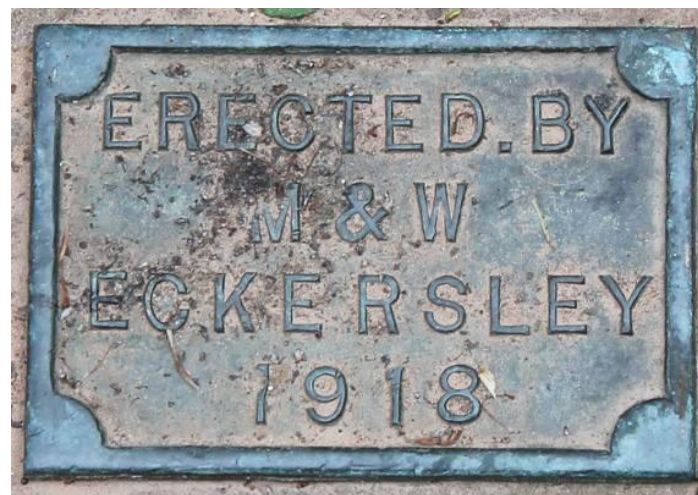
Figure 18 Plaque uncovered at the top of the head race, shows evidence of re-building of the weir
