## **Warwick Bridge Corn Mill Progress April 2019**

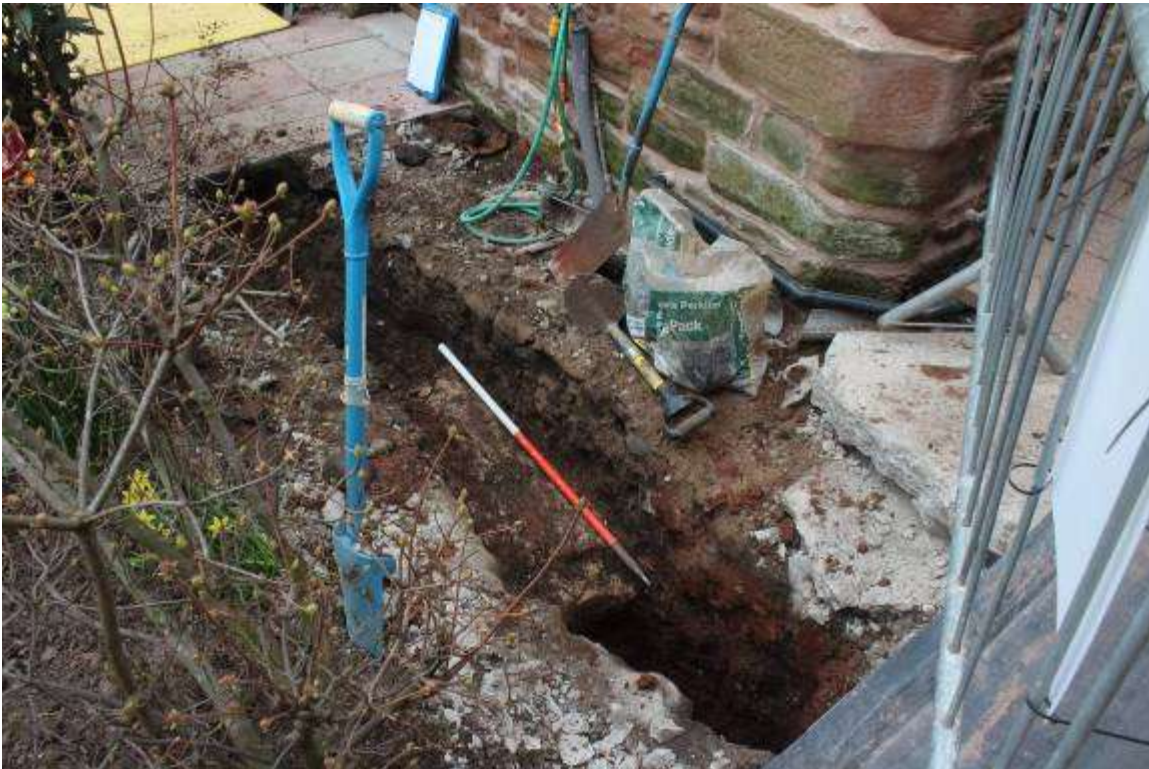
A trench alongside the store/wash house to the west of the barn revealed wall foundations extending westwards of the present building and the associated work within the store produced a piece of clay kiln tile. The thick perforated tiles were the forerunners of the Victorian cast iron plates used in the present kiln on site.

**Wall foundation extending westwards from the south wall of the wash house**

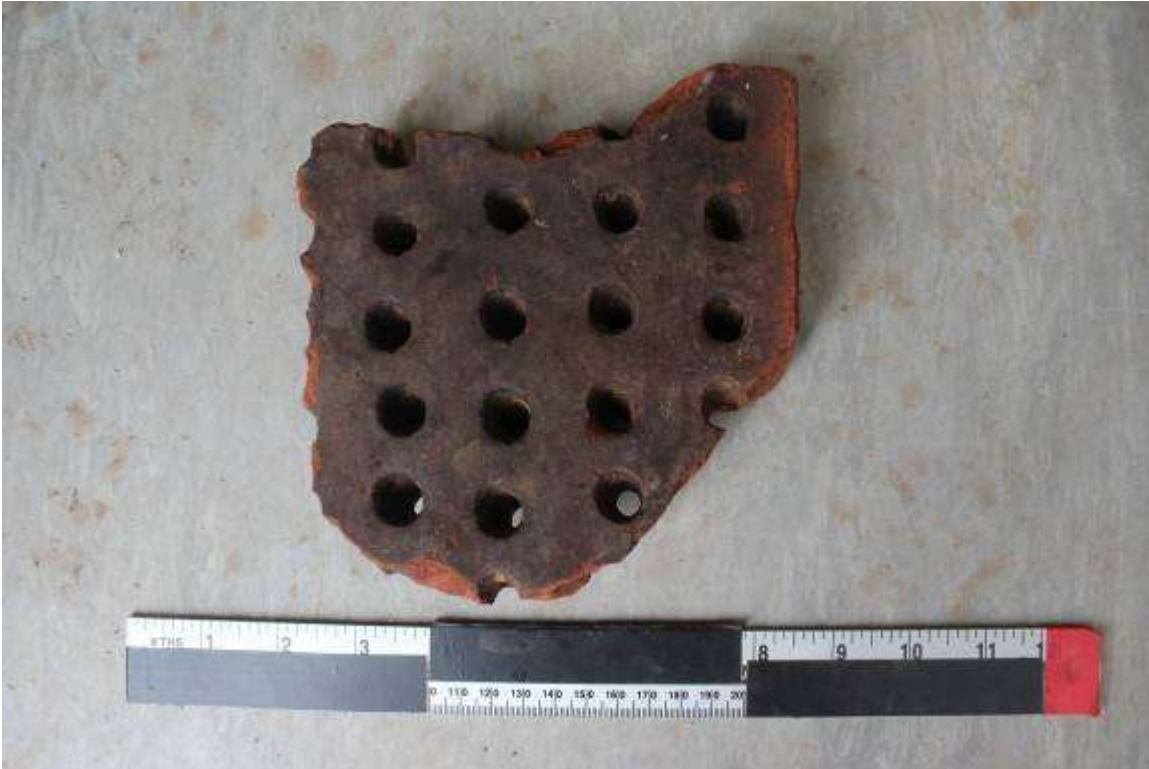
**Piece of clay kiln tile showing the tapering holes in the underside which allowed the heat to percolate through the tiles to dry the grain**

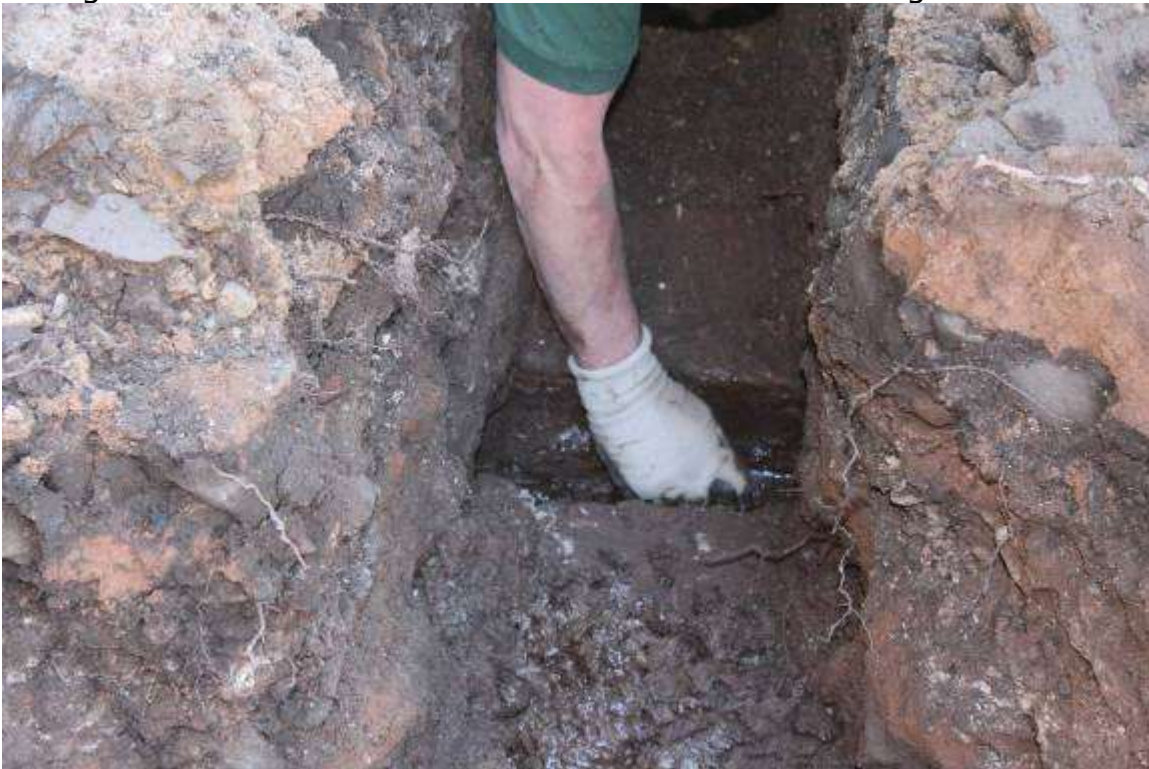
Lifting a cover stone revealed a stone built drain crossing the trench.

**Clearing silt from a stone built drain crossing the floor of the trench**

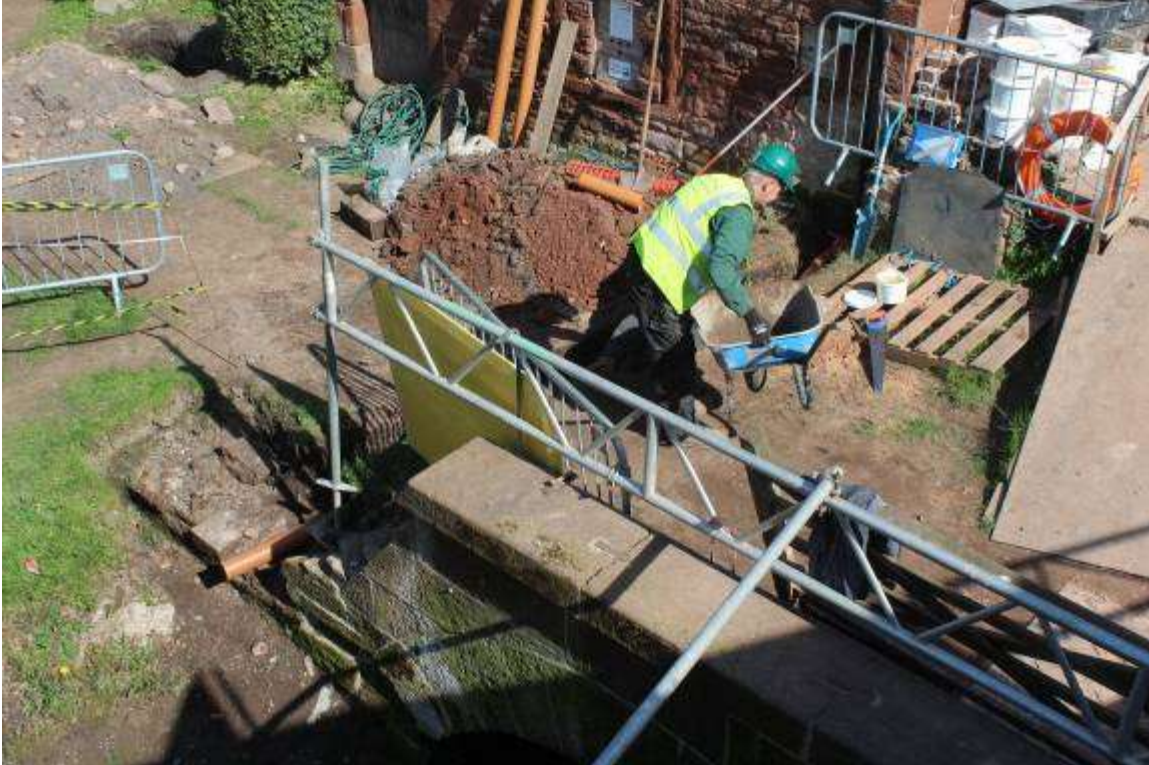
A short trench on the north side of the tail race culvert replaced an earlier plan to link with the drainage of the north side of the mill.

**Work in progress on a short run of drainage from the kiln roof to the tail race**

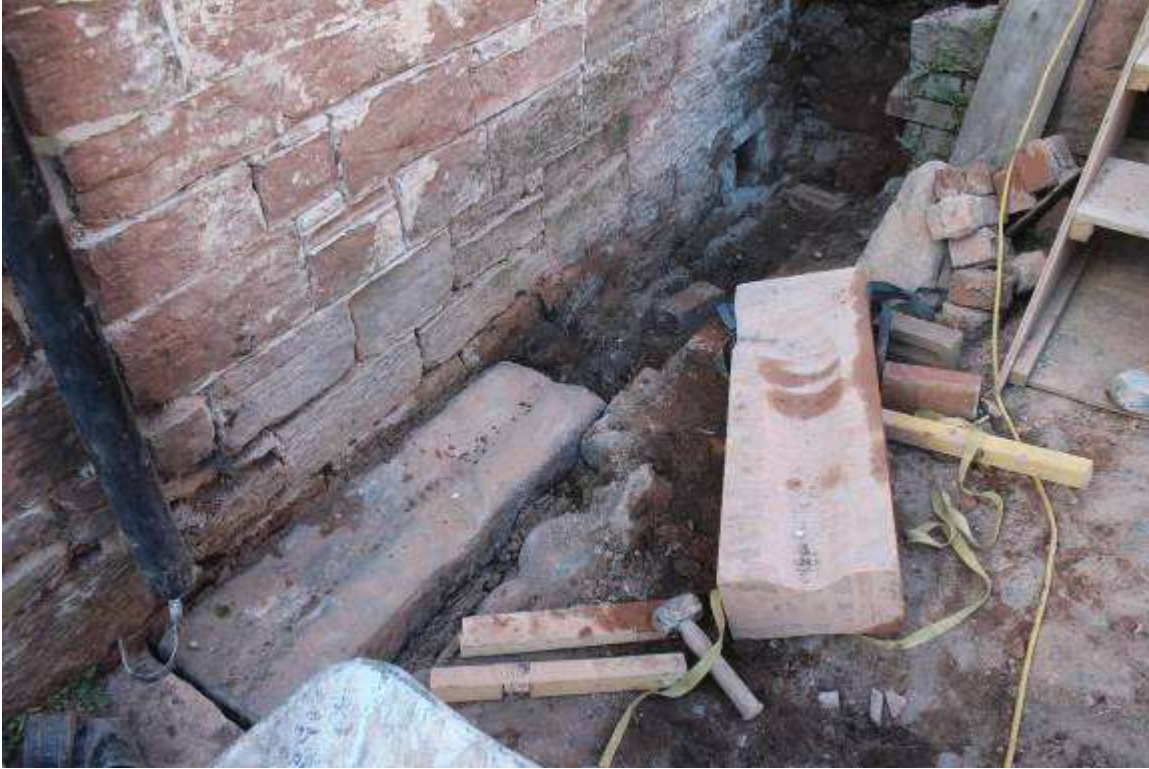
The old line of rainwater drainage below the steps on the east side of the kiln was reinstated with a new channel stone carved to turn the water into the drain passing through the barn wall and draining into the wheel pit.

**Resetting the drainage channel stones alongside the east side of the barn. A newly carved stone will turn the water into the old drain below the barn wall and into the wheel pit**

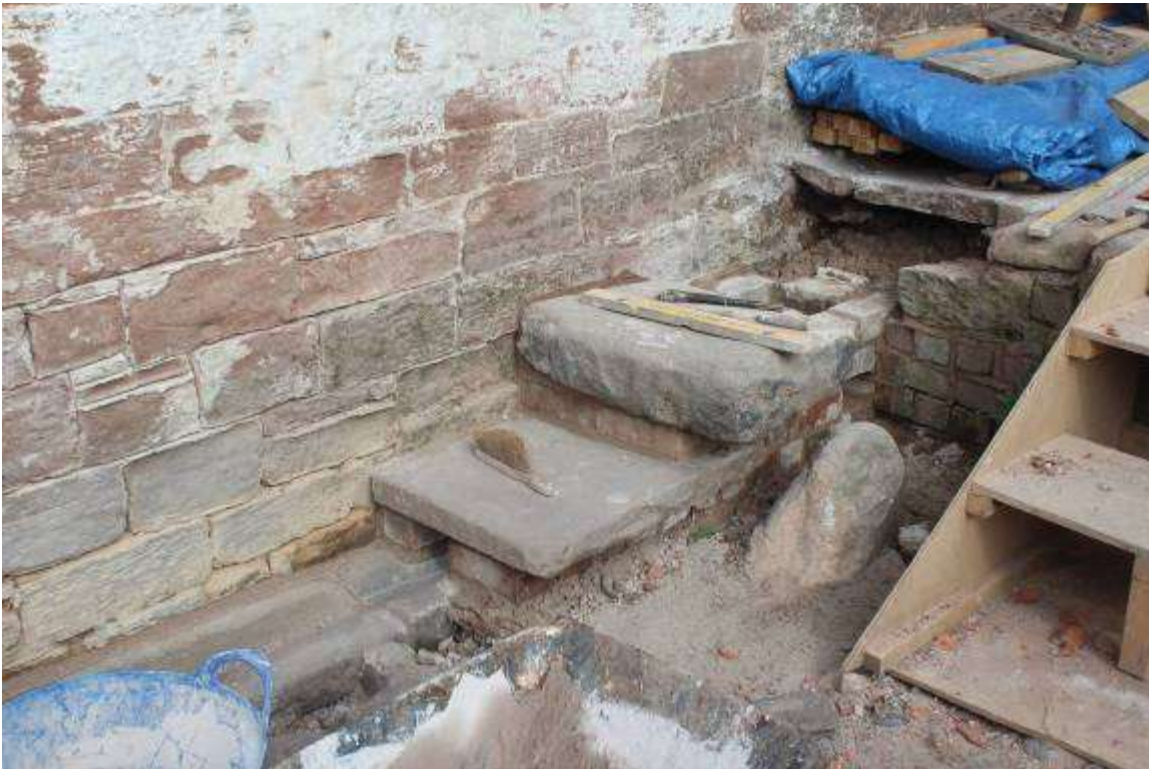
**Reinstating the steps up to the loading dock**

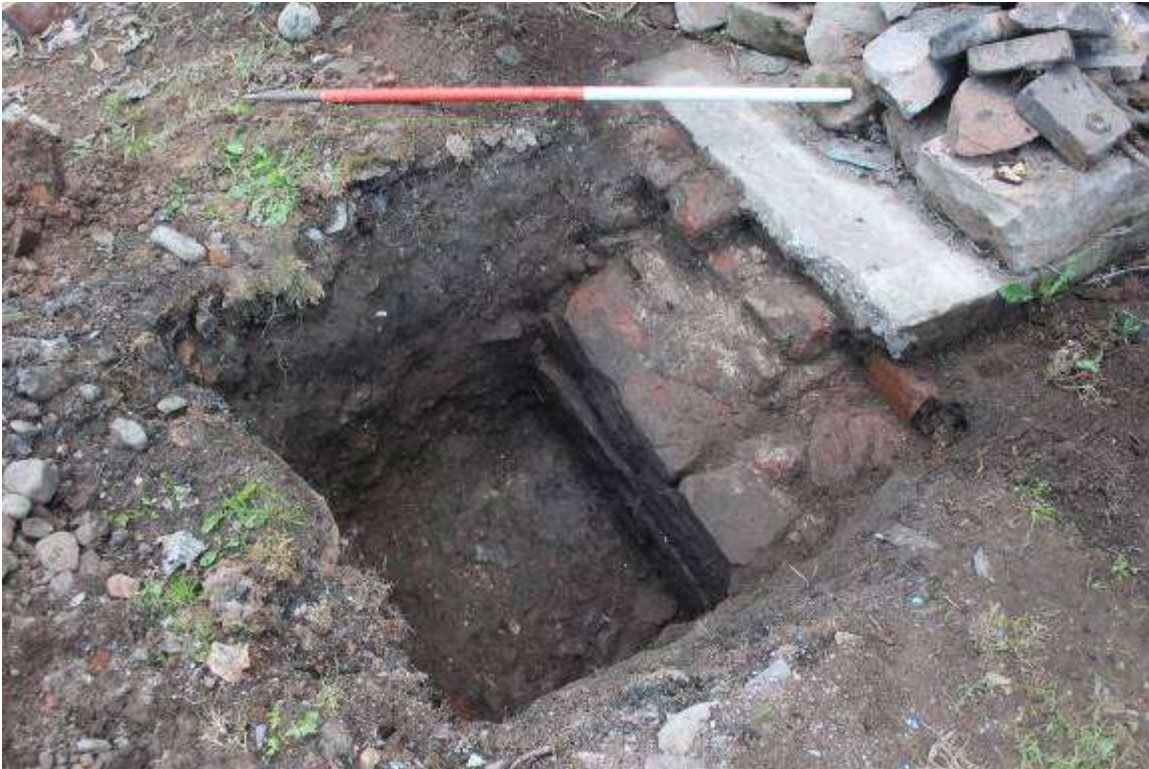
Before backfilling took place an earlier trial trench on the north side of the kiln was cleaned up and photographed.

**Stone foundation parallel with the north wall of the kiln overlain by the brick foundation and concrete slab floor of a ground floor lean-to**

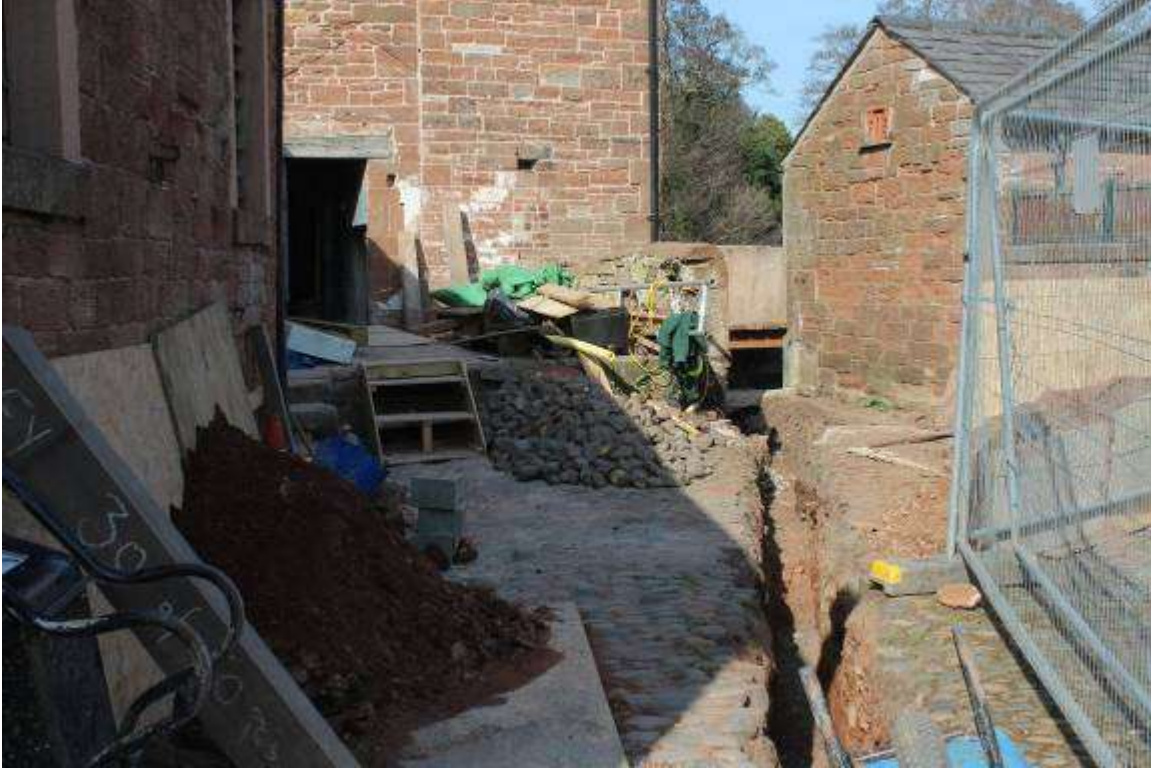
A trench was excavated across the yard to the east of the barn for foul drainage from the mill extension. This proved remarkably clean, being excavated mainly through natural deposits and weathered bedrock. At the northern end the concrete ramp behind the head race wall was cut away to accommodate a chamber and showed that the stone trough seen in the earlier trial trench survived on the east side of the concrete.

**Drain crossing the yard to the east of the barn**

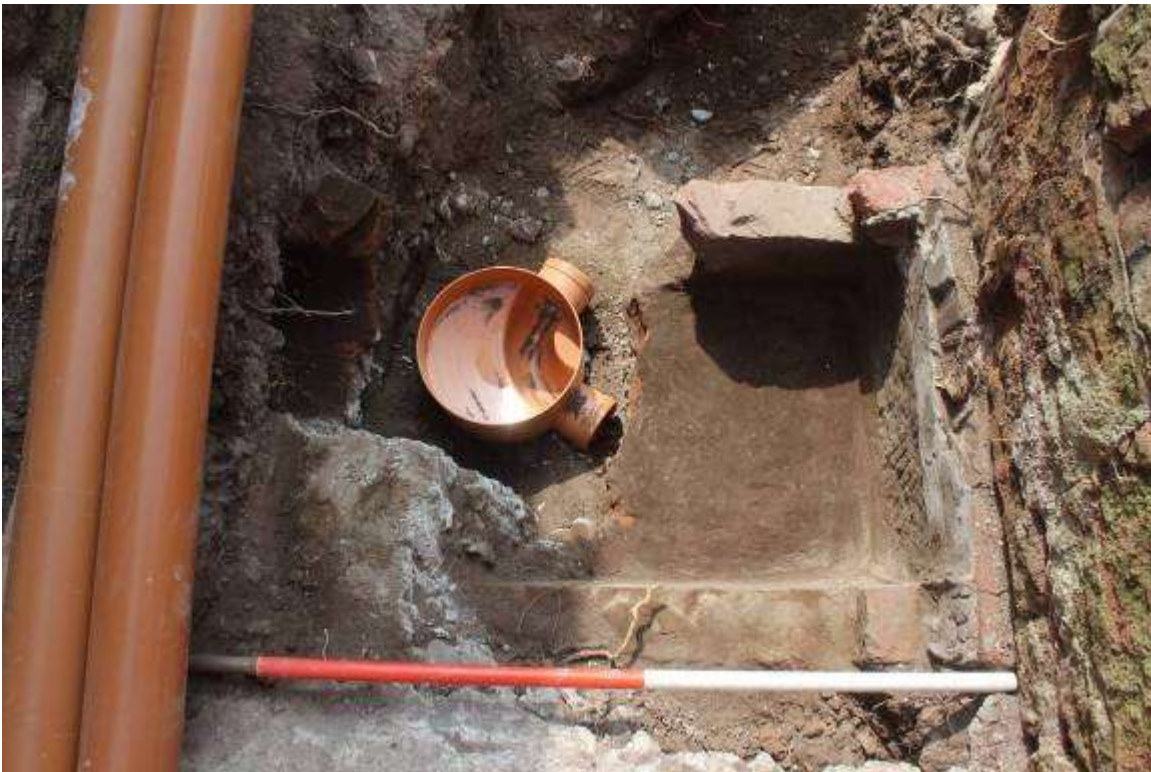
**Removing the concrete ramp cut through the stone trough below the parapet wall of the eastern loading dock (right)**

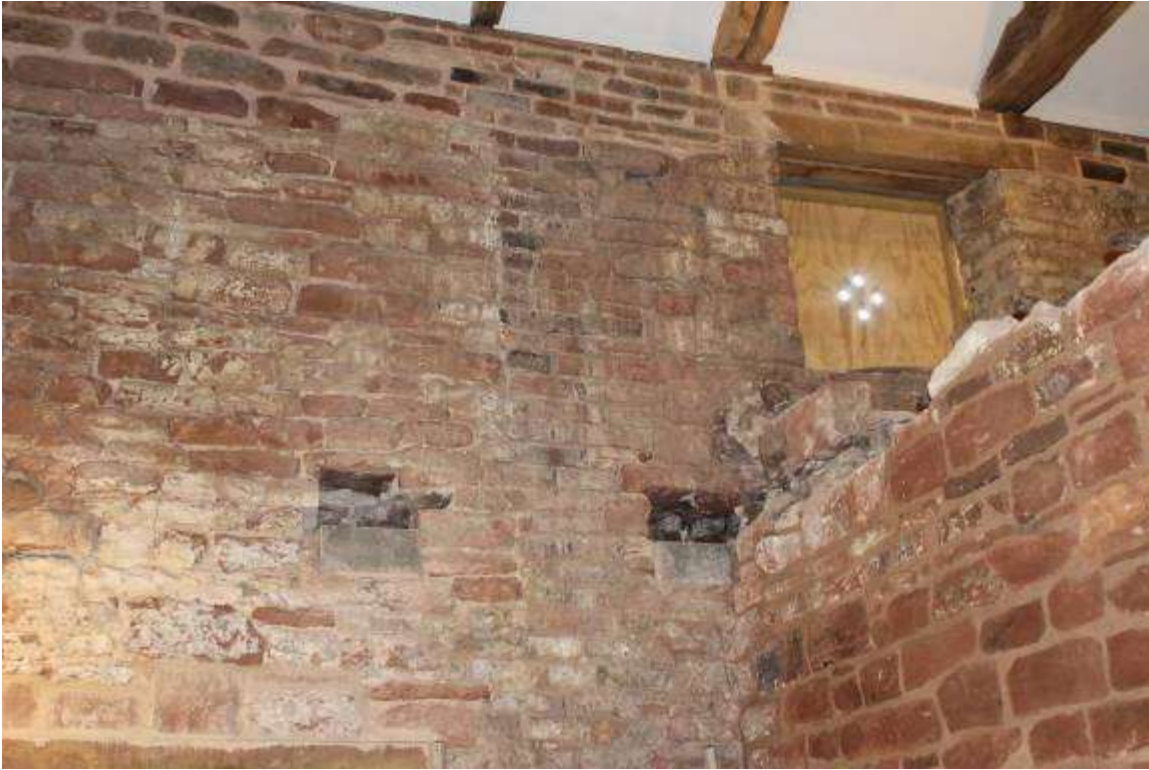
Padstones were installed to support the new steel floor and stair in the space to the east of the kiln.

**Slots in the south wall of the kiln for new padstones to support the new floor**

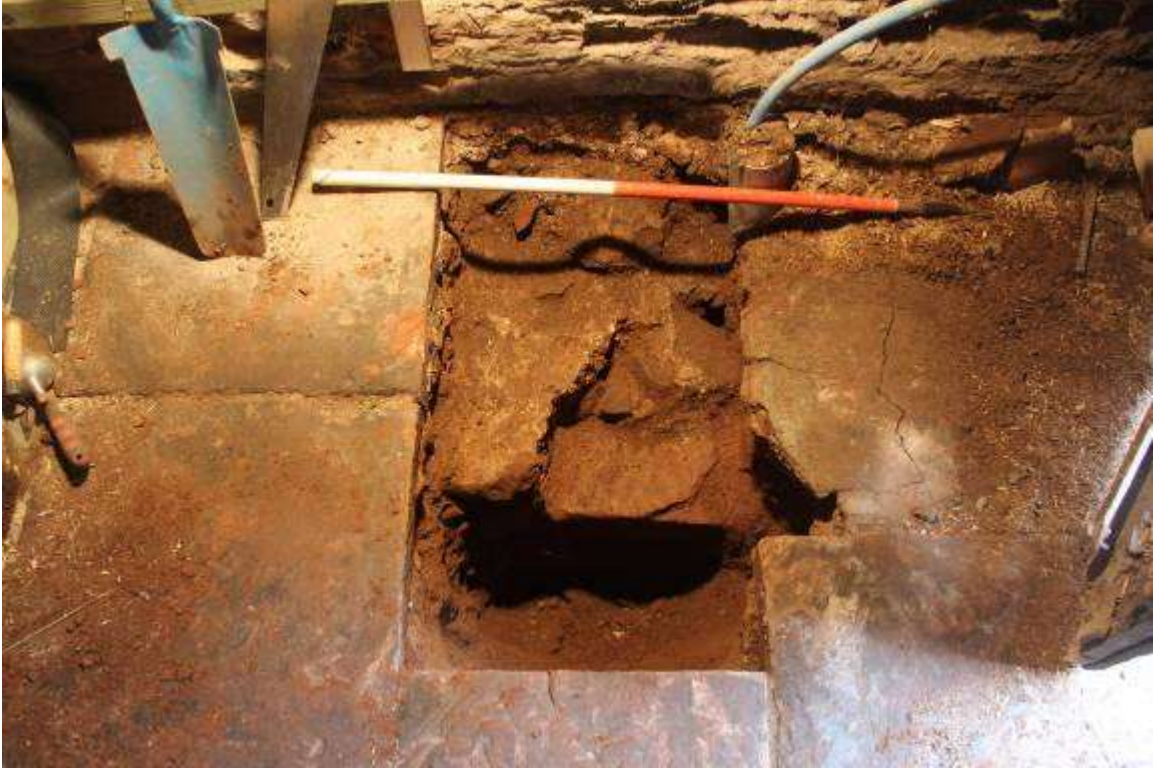
A further small trench within the south end of the barn for a new water supply showed the foundation of the earlier range on a slightly offset alignment from the present building and breaking through this produced another piece of clay kiln tile built into the wall.

**Earlier wall foundation on a different alignment from the present east wall of the barn**

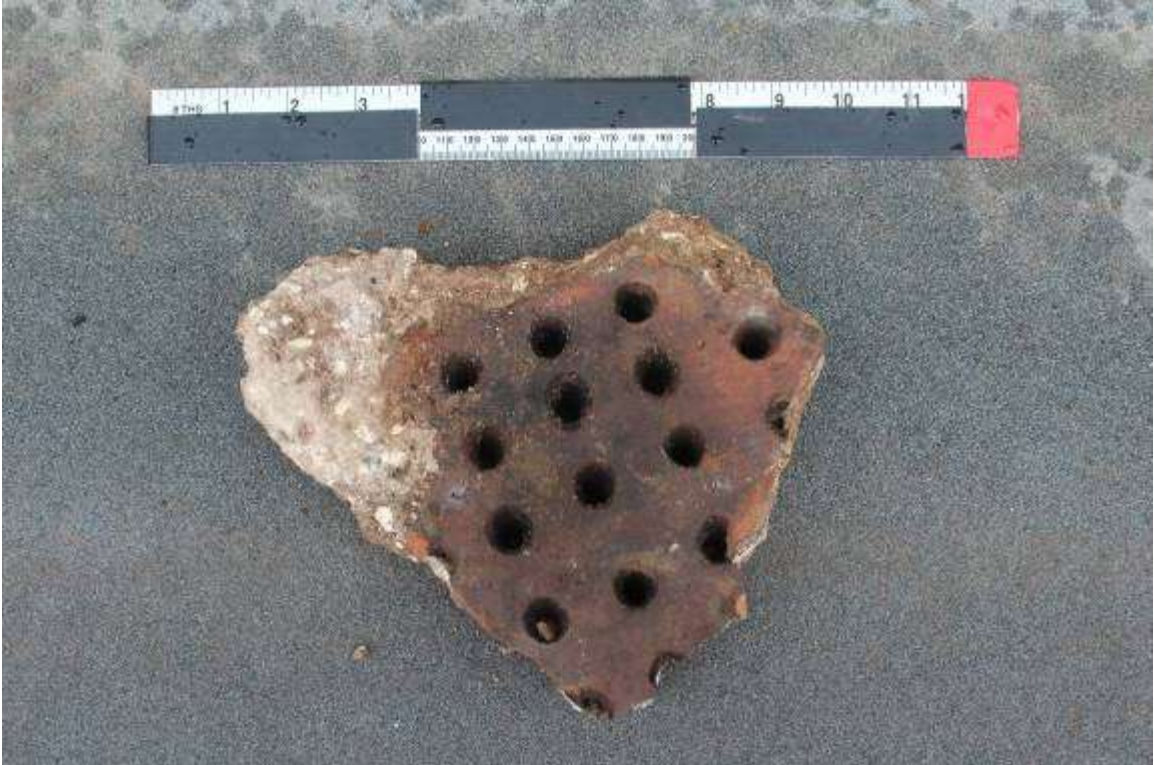
**Tile kiln fragment from the wall construction**

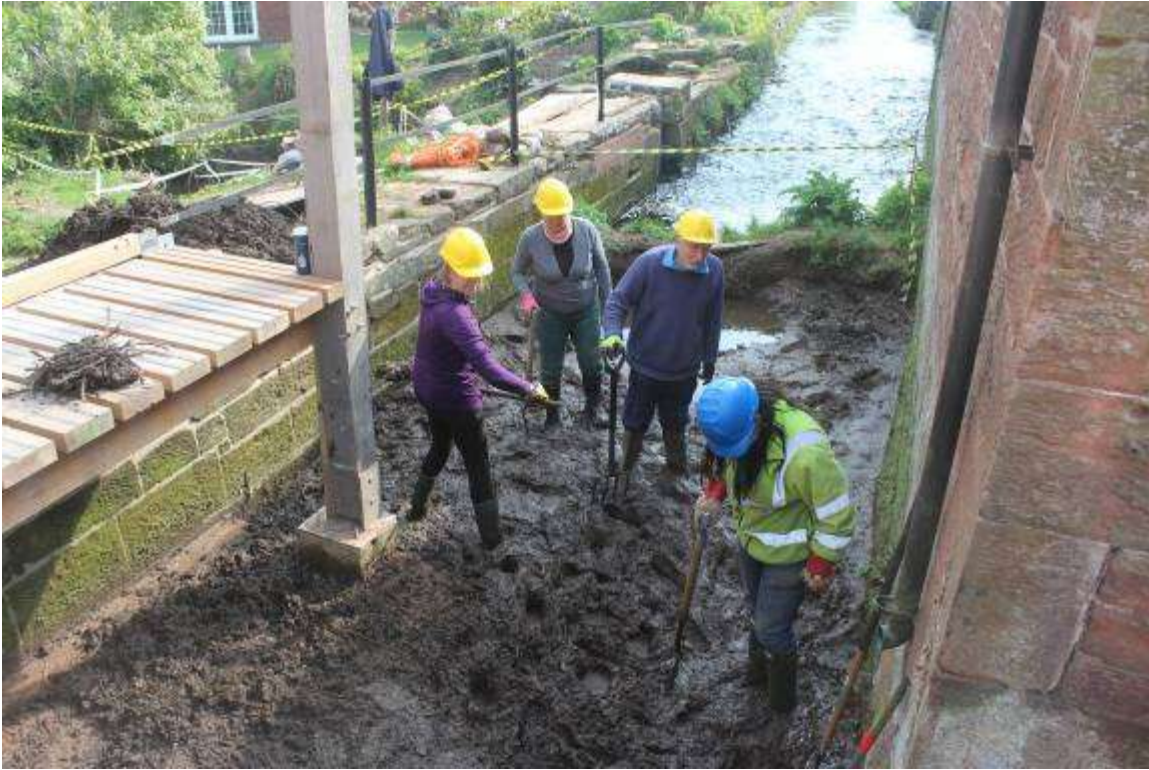
A build up of debris and silt in the head race upstream from the trash screen was cleared with the help of volunteers.

**Local volunteers working with Karen to clear the head race**
