Main Contract

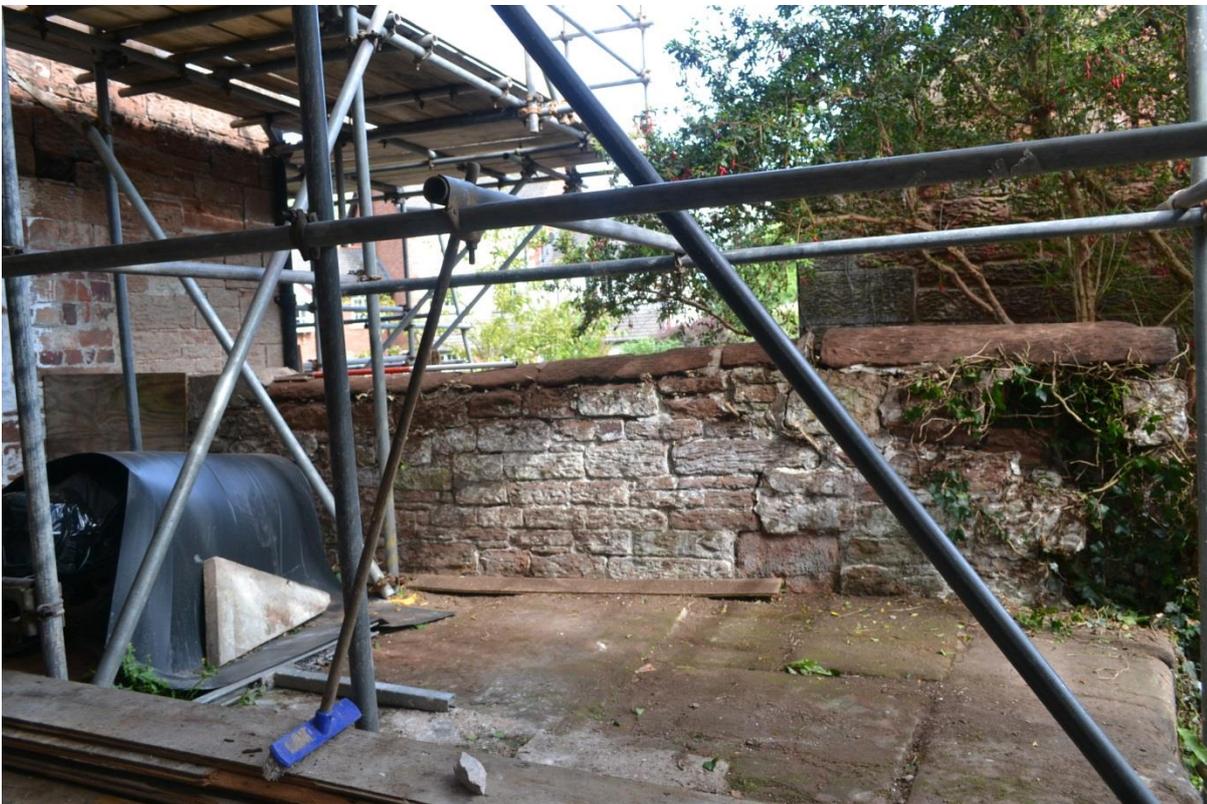
New stone has now been delivered which will be used on repairs to the tailrace and various parts of the building. The stone flags in the store have been lifted in readiness for plumbing in the water, electric and waste pipes for the new lavatories. Although the stonework in the tail race was in poorer condition than expected, and some stone has deteriorated to the point where it will need to be replaced, the headrace has fared better, mainly requiring only re-pointing. They have also cleared the wall on the top loading docks of ivy, and prepared a lot more of the north wall for re-pointing. Meanwhile Harry the Archaeologist has been excavating and recording possible evidence of an older building with added brick fireplace that has been incorporated into the structure of the Drying Kiln.

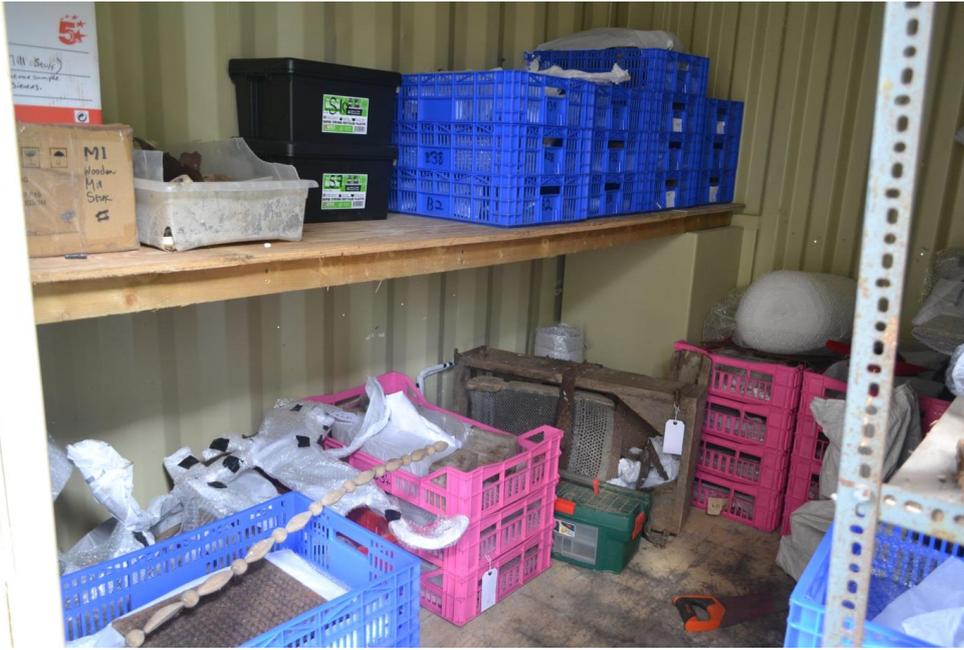
Figure 7 Small artefacts packed and moved into storage
