Warwick Bridge Corn Mill – Project Update September 2016

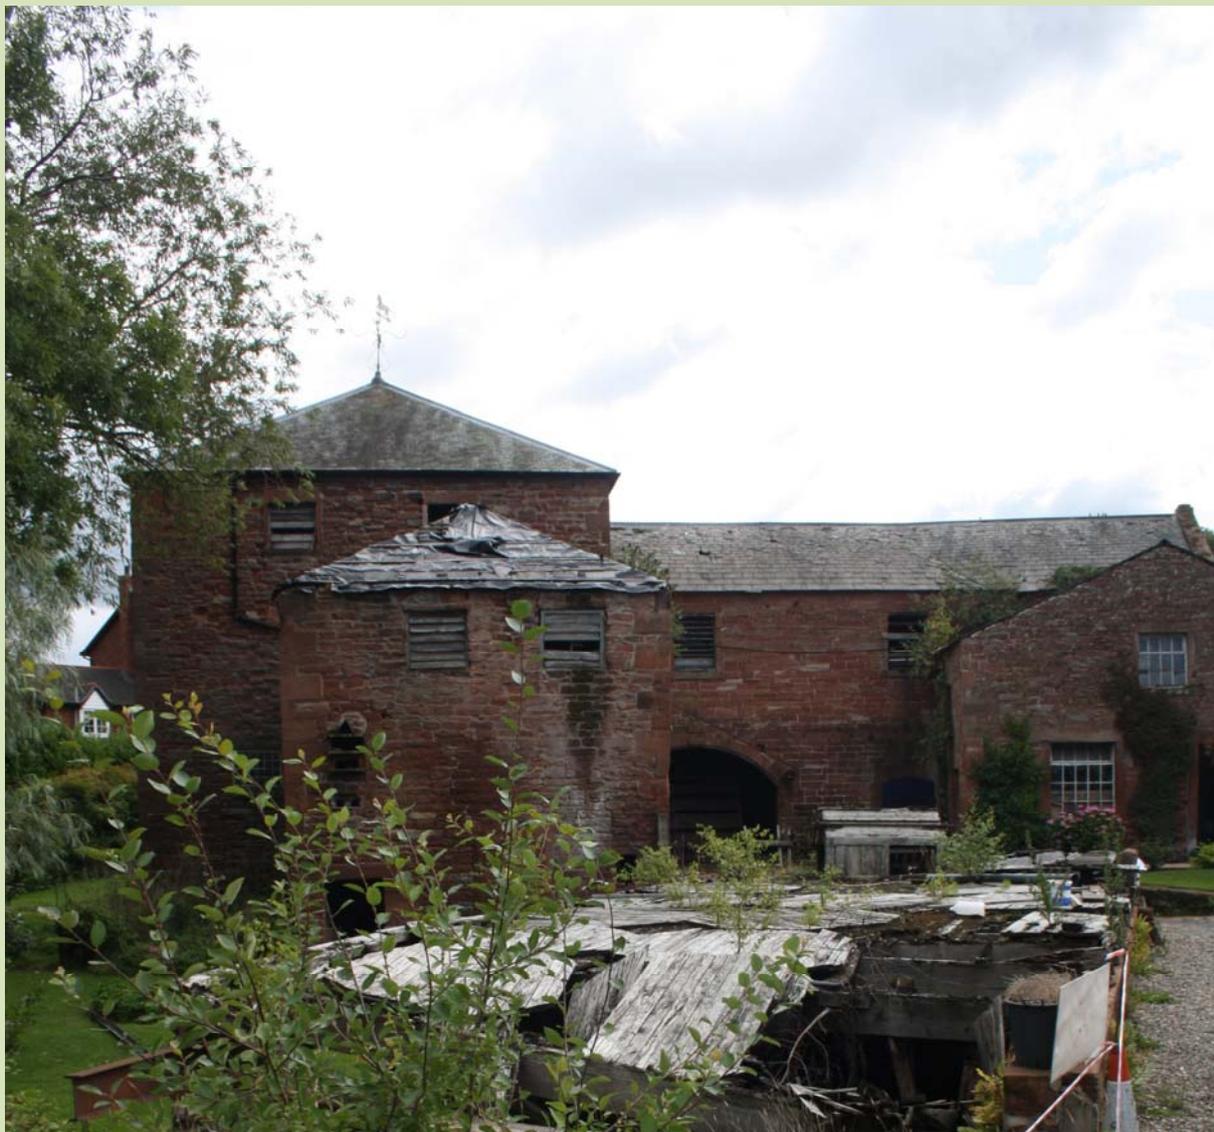
Warwick Bridge Corn Mill, Spring 2016 – the drying kiln roof protected only by plastic sheeting.

The drying kiln roof, which for many years only had plastic sheeting keeping the water out, was the most urgent area needing attention.

The roof structure has been stripped back, existing timbers repaired and **new timbers added to support the historic roof trusses**.

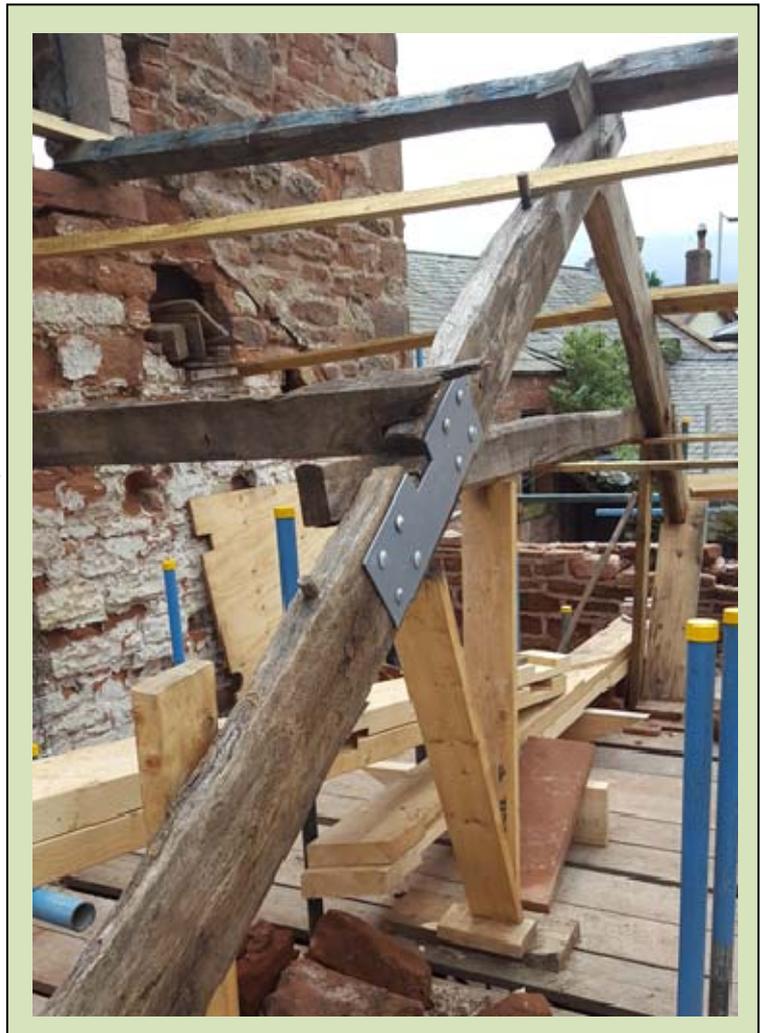
Repairs to an existing truss have been completed where the timber had fractured previously and former repairs were failing. This has been completed with a bolted metal plate that straddles the line of the fracture.

A bespoke metal plate repair to an existing roof truss.

This bespoke detail was fabricated to accommodate an existing purlin that is supported on the truss.

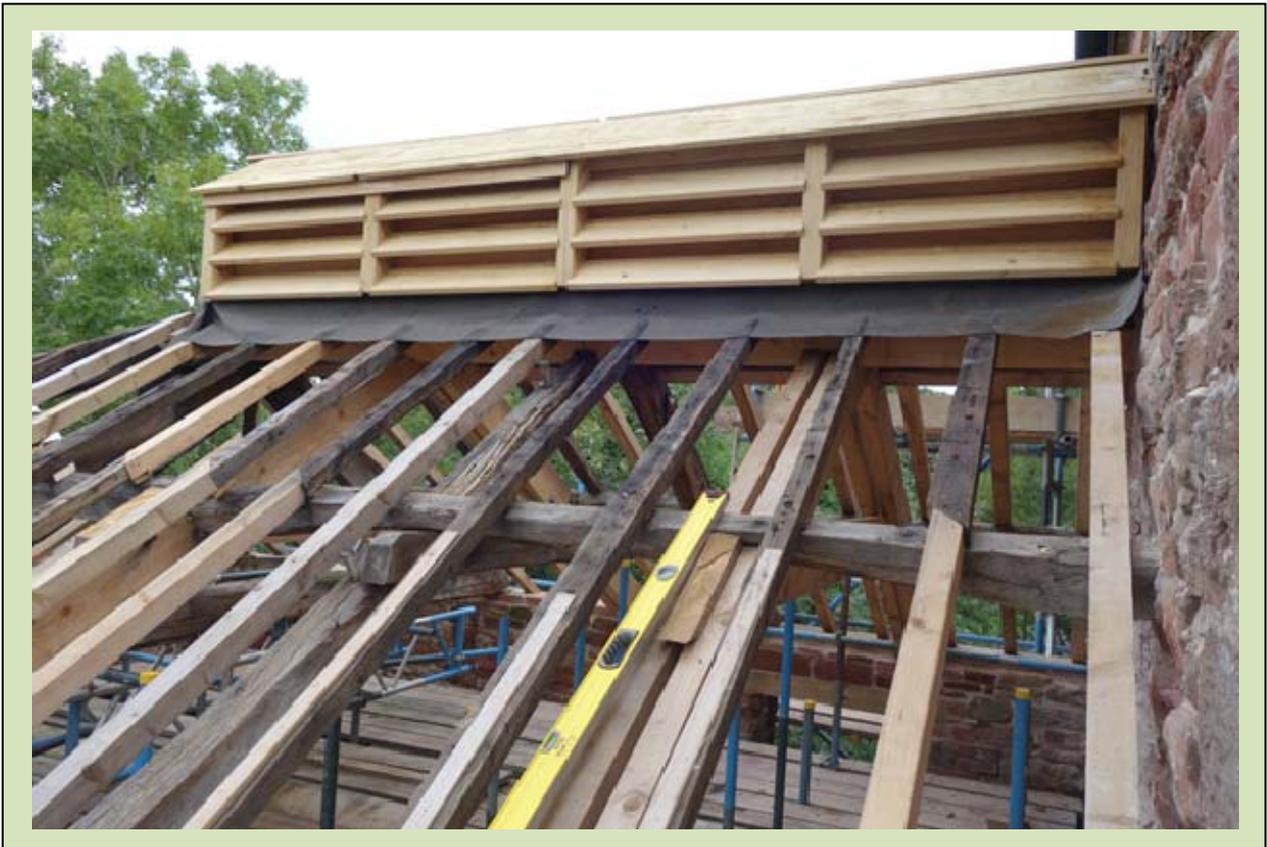
The new oak Louvre in place on the ridge of the drying kiln roof.

A new oak Louvre has been reinstated on the ridge of the drying kiln roof- this feature would have provided ventilation for the drying kiln, letting the hot air out of the building but keeping the grain below protected from the rain. The Louvre was still in situ in the early 1990s so we have been able to reinstate this feature based upon photographs and descriptions of the building.

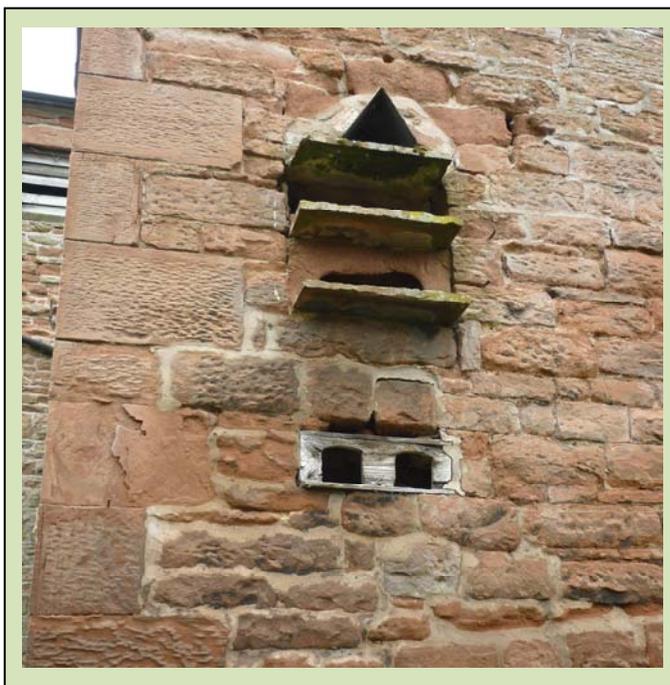
The cause of much of the erosion to the sandstone was the hard cement pointing which had been used in the past, but which increases the rate of deterioration to the soft sandstone and therefore needed to be removed.

An area of cement pointing which has now been replaced with lime.

The **cement pointing has been raked out by hand** on all the elevations of the drying kiln and the stonework has been repointed **with lime pointing; a softer, breathable mortar** which will not cause damage to the sandstone.

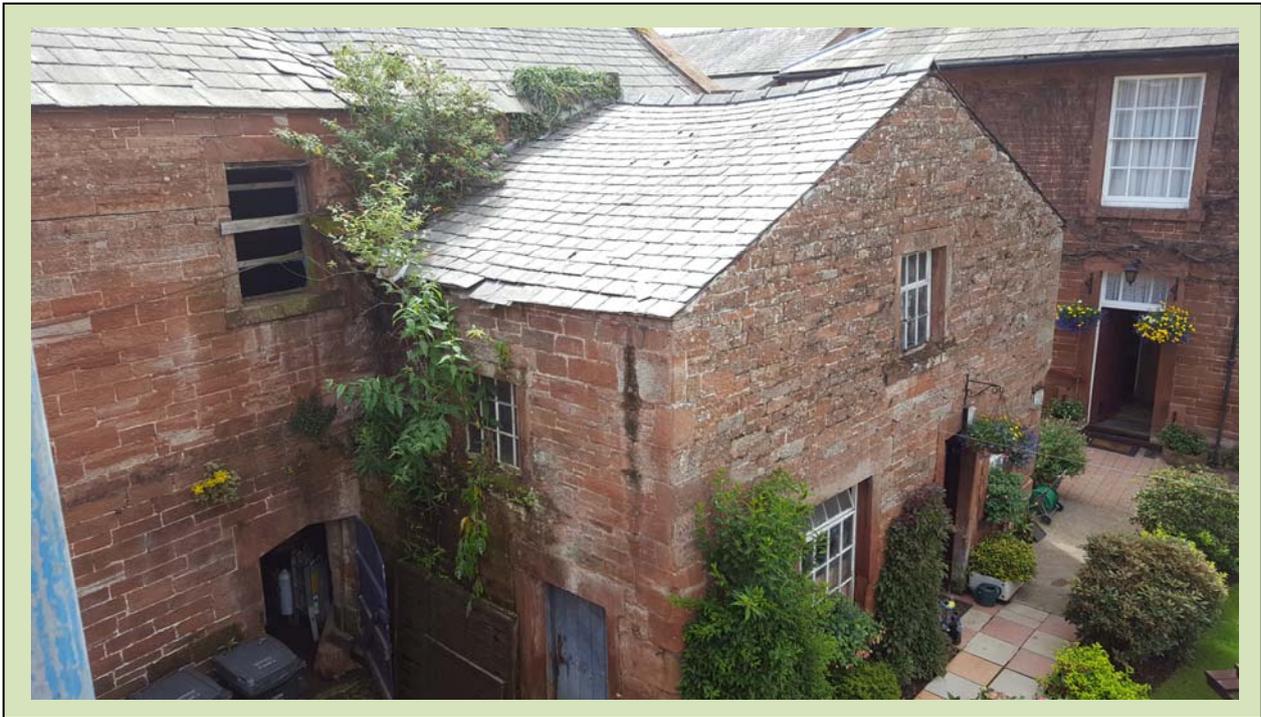
The granary range – to the right of the drying kiln - which will be the focus of work during October including roof and structural timber repairs.

During October repairs will be carried out to the roof of the granary range – the long roof to the right hand side of the drying kiln and internal timbers replaced where these are no longer structurally sound. All of this **essential work** will ensure that the building is **water-tight and in a sound condition**, ready for the winter, which we hope will be kind to Warwick Bridge this year.
